## Dryer

### Creaking Inlet Bearing Noise

# DR020.

## Long Drying Times / Radio Frequency Interference

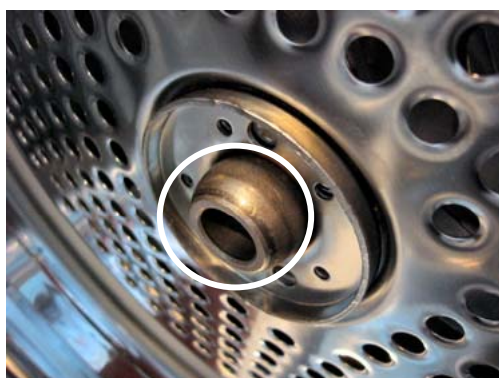
**Inlet Bearing**

**ACTION:** If a creaking noise is encountered emitting from the inlet bearing area during operation, it could be due to either lack of oil in the bearing or a defect in the housing bearing drum inlet.

Either way we would recommend fitting 'Kit Bearing Inlet', part number 479332. Included in the kit are the following components:

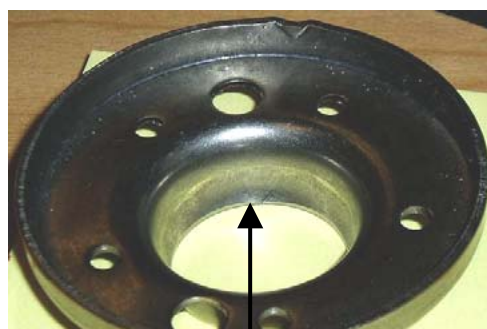
**Housing Bearing Drum Inlet**

Check for hairline cracks in the housing inner surface

There is no method to check for lack of oil in the bearing, however the bearing housing can be inspected for hairline cracks in the inner surface.

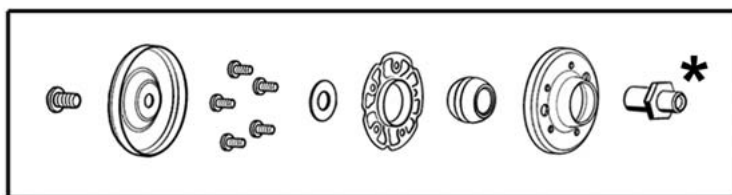
**Exploded view of inlet bearing kit components**

Part	Description
<b>479332</b>	<b>KIT BEARING INLET</b>
	1 x Drum inlet cap screw
	1 x Drum inlet cap
	5 x Inlet bearing retainer screws
	1 x Thrust washer
	1 x Inlet bearing retainer
	1 x Inlet drum bearing
	1 x Bearing housing
	1 x Shaft*
	1 x Instruction sheet

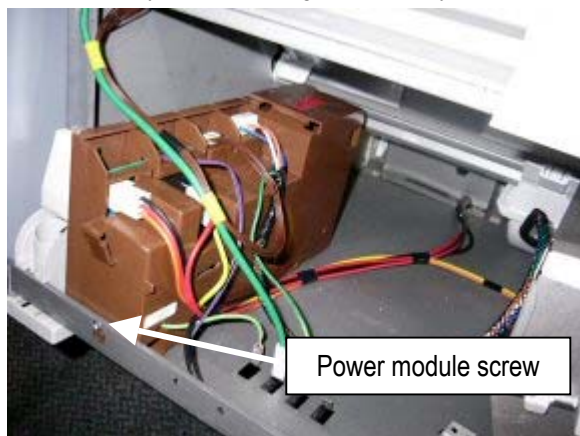
**ACTION:** The screw that secures the power module to the base panel (see photo below) is used by the electronics to provide a ground (earth) reference. If the screw is missing or not tightened sufficiently it can cause either long drying times (up to 3 hrs) or radio frequency interference. It is recommended that this is the first thing to check for either of these problems.

This is not a safety issue as the ground is only used as a reference rather than an electrical grounding.

**Note:** When fitting or re-tightening the screw be careful not to over-tighten it to the point where it can strip (the screw only needs to be 'nipped' up).
