SERVICE BULLETIN

AT08-001

April 3, 2008

2007 MAXIMA; MIL 'ON' W/DTC P0840 OR P0845

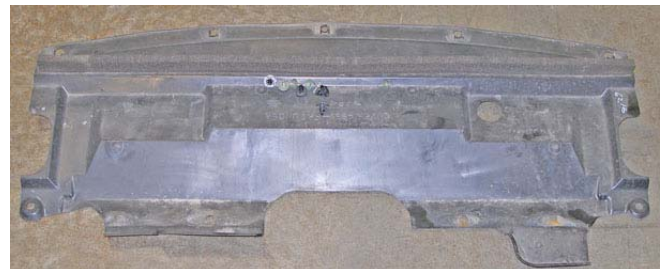
Figure 1

4. Remove the undercover from below the front bumper cover (see Figure 1).

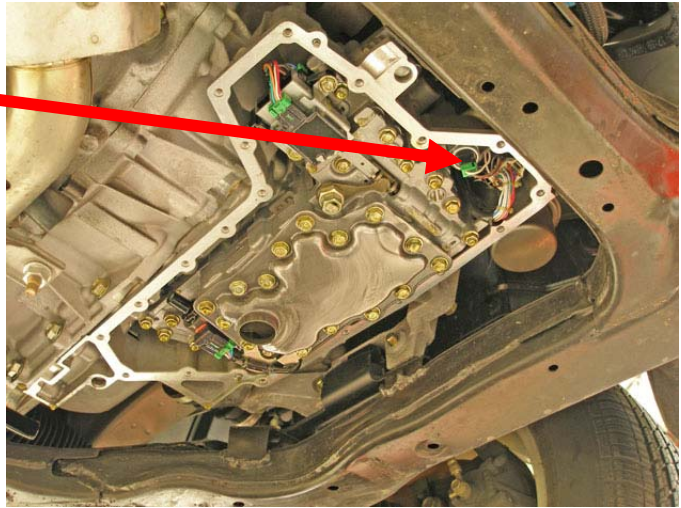
Figure 2

1. Remove the Primary Oil Pressure Sensor Assy

2. Replace it with the one listed in the Parts Information section of this bulletin.

TORQUE: 10.8-14.7 N.m
(1.1-1.5 kg-m, **95.6-130.1 in-lb**)

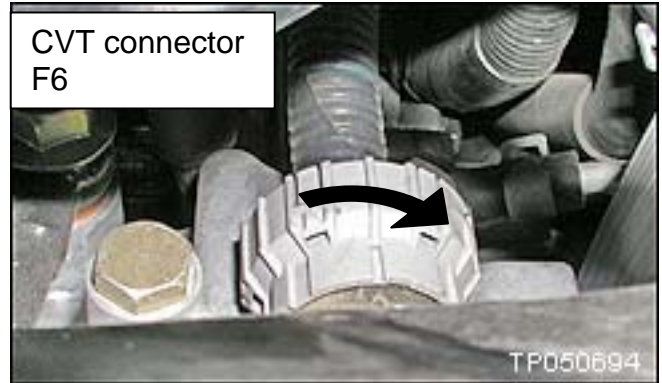
Figure 3

1. Disconnect the CVT harness connector F6 by turning in the direction shown in Figure 3.

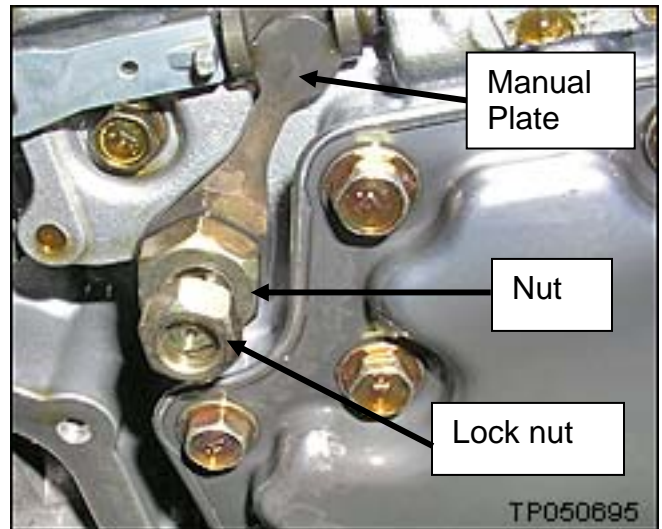
Figure 4

2. Remove the nut and lock nut to remove the manual plate.

17. Align the manual plate with the notch in the manual valve.

NOTE: First, tighten 19 mm nut, then tighten the 14 mm lock nut with the specified tightening torque.

- Use a Torque wrench to tighten both the 14 mm and 19 mm nuts; same torque specification for both:

TORQUE: 20.6-23.5 N.m
(2.1-2.3 kg-m, **15.1 - 17.3 ft-lb**)

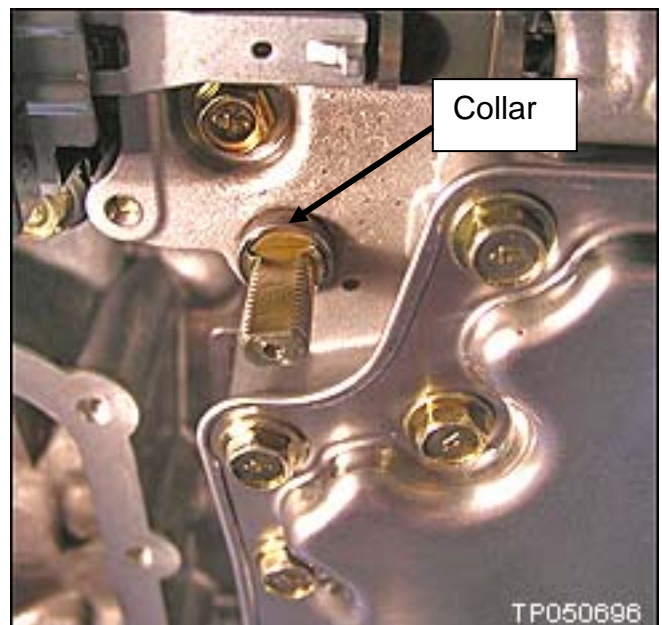
Figure 5

3. Remove the collar from the manual shaft.

16. Re-install the collar on the manual shaft (see step 3, Figure 5).

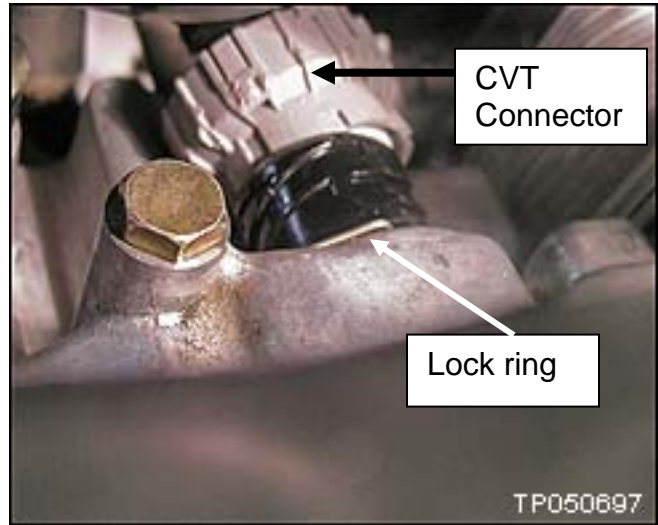
Figure 6

4. Remove the large lock ring holding the CVT connector to the transmission case (see Figure 6).

- Push the transmission side of the harness down inside the transmission case to remove it.

19. Reinsert the CVT connector with locking ring into the case as shown in step 4, Figure 6. Make sure that the locating notch is properly engaged.

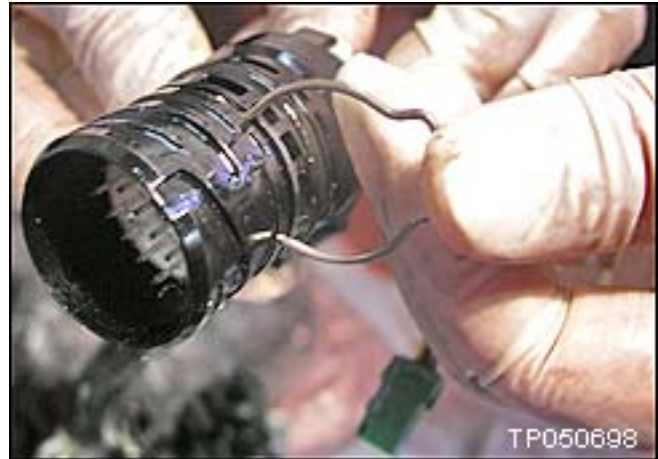
Figure 7

- Transmission side of CVT harness connector and lock ring shown removed from the transmission case.

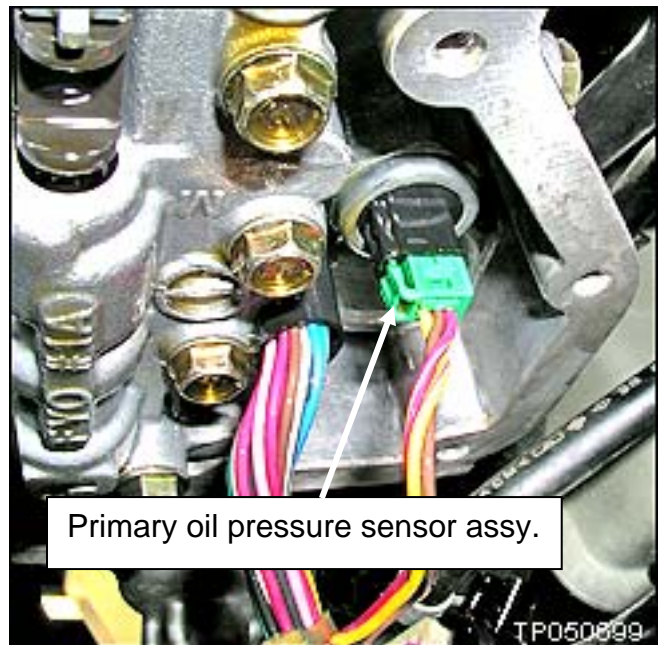
Figure 8

5. Disconnect the harness of the Primary oil pressure sensor assy.

18. Reconnect the harness to the primary oil pressure sensor (see step 5, Figure 8).

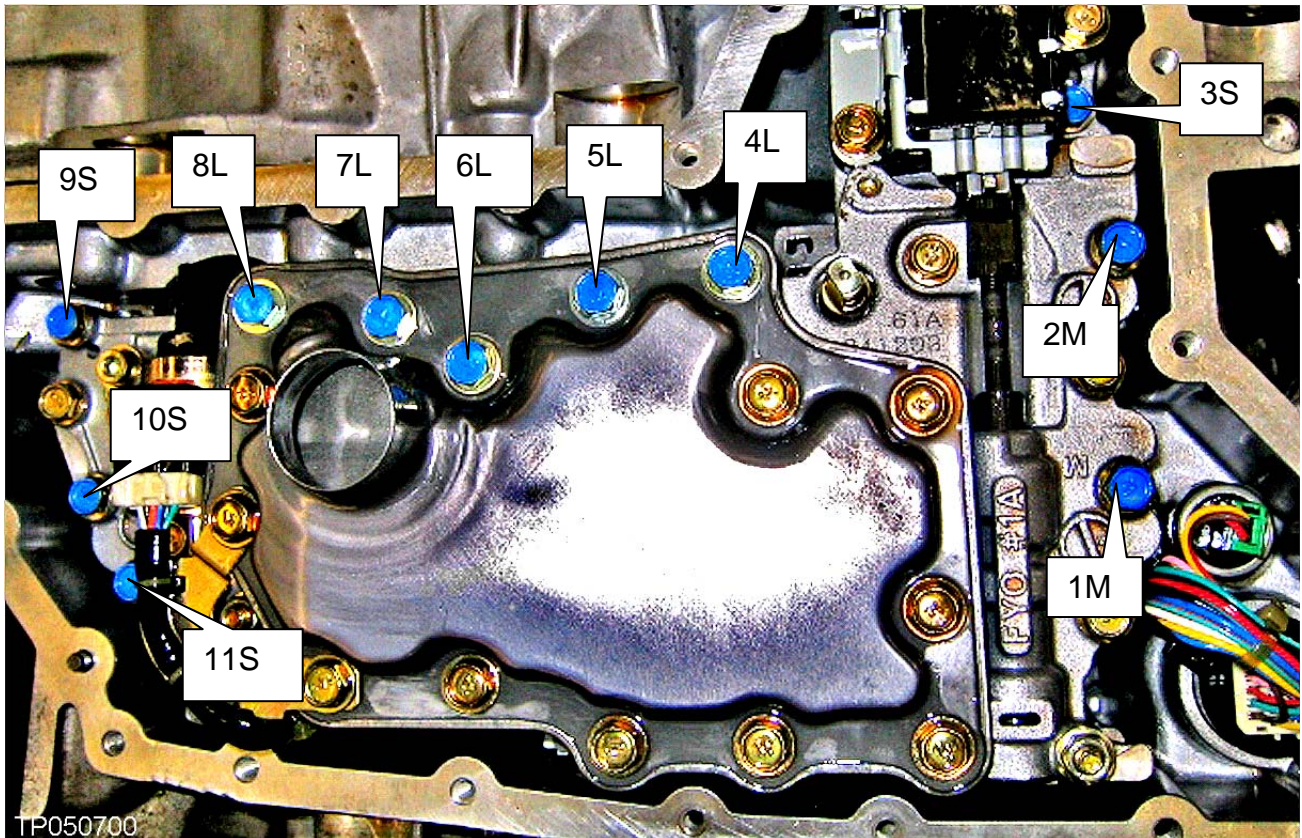
Figure 9

6. Remove the bolts attaching the valve body to the transmission (see Figure 9).

- There are 11 bolts shown and numbered for convenience.
- There are 3 different length bolts which are identified by:

S-short

M-medium

L-long

- Tightening torque: 6.9-8.9 N.m (0.7-0.9 kg-m, **61-78 in-lb**).
- Torque sequence as per Figure 9: 6-7-5-8-4-9-3-10-2-11-1.

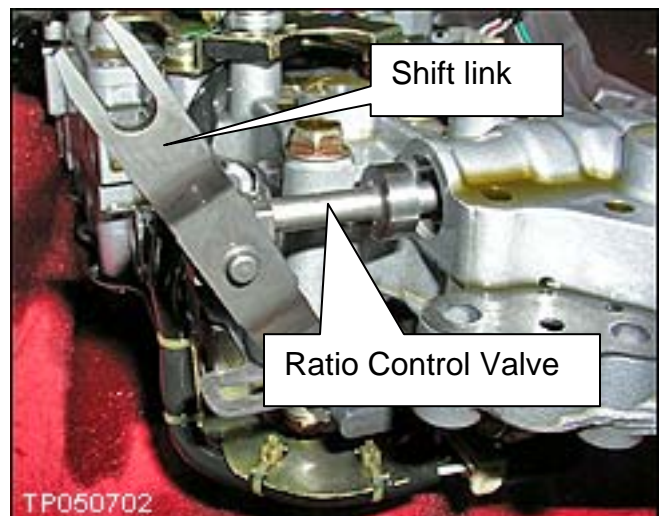
Figure 10

7. Remove the valve body.

- Note the position of the Ratio Control Valve and attached shift link.

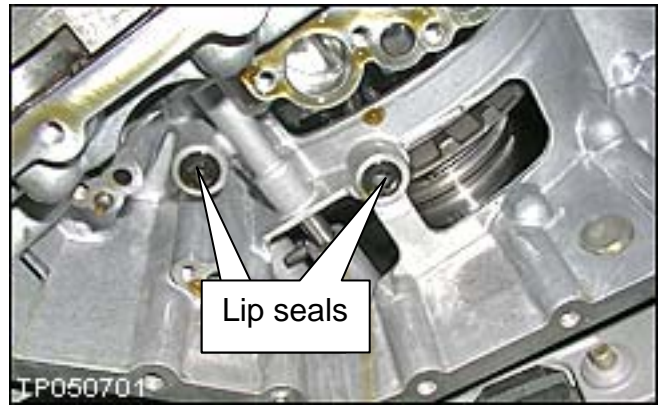
Figure 11

8. Make sure you replace the 2 lip seals shown in Figure 11.

- Do not reuse the old lip seals.
- Use petroleum jelly to keep the new lip seals in place during reassembly.

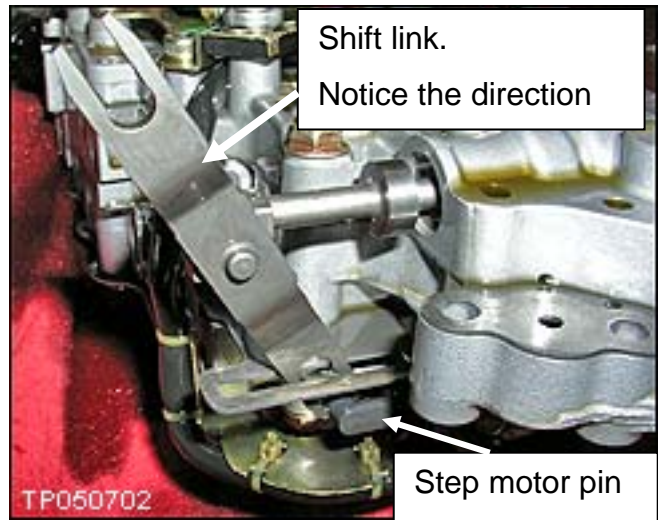
Figure 12

9. Carefully remove the valve body assembly, being careful not to allow the Ratio Control Valve to fall out.

- If the Ratio Control Valve does fall out, check the condition of all surfaces especially the edges for damage.
- Confirm (double check) the direction of the shift link and the bottom of the shift link around the step motor pin (see Figure 12).

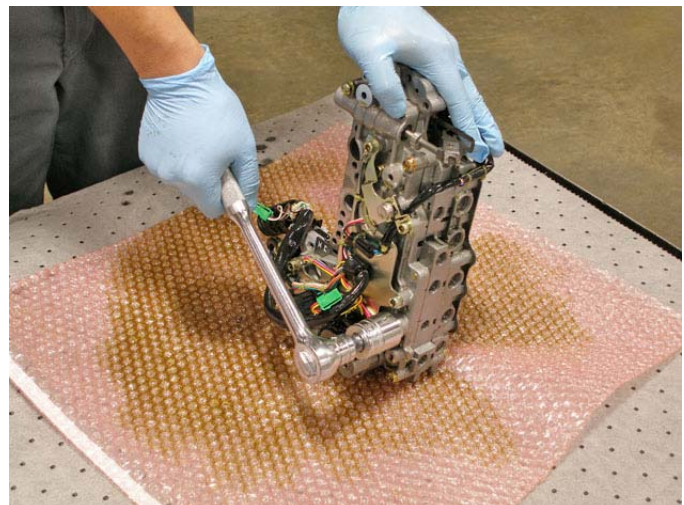
Figure 13

10. On a clean and lint-free surface, stand the valve body on-end and hold it as shown in Figure 13.

Remove the Secondary Oil Pressure Sensor.

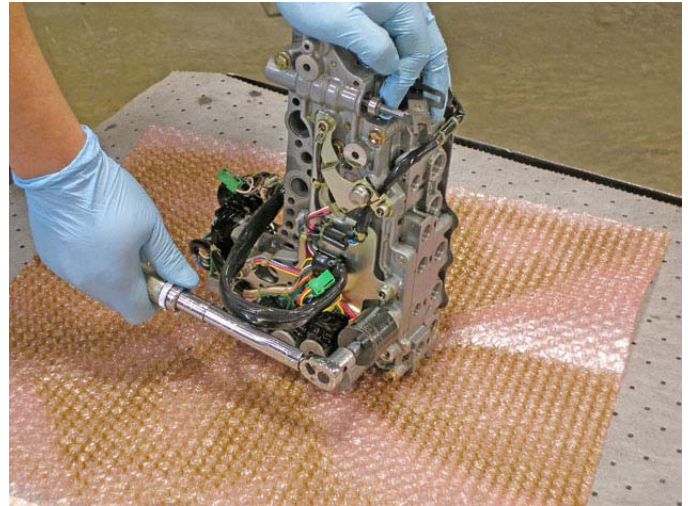
Figure 14

11. Replace the Secondary Oil Pressure Sensor Assy. with the one listed in the Parts Information section of this bulletin.

TORQUE: 10.8-14.7 N.m
(1.1-1.5 kg-m, **95.6-130.1 in-lb**)

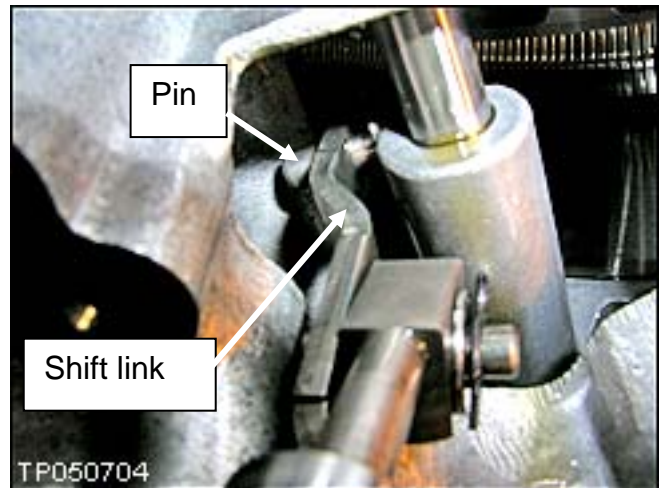
Figure 15

12. Install the valve body and shift link with the fork end of the shift link around the pin as shown in Figure 15.

- After you install the new valve body, make sure the upper end (forked end) of the shift link is positioned around the pin. Space is very limited in the work area.
- Install the CVT dip stick and make sure there is adequate clearance between the dipstick and the harness.

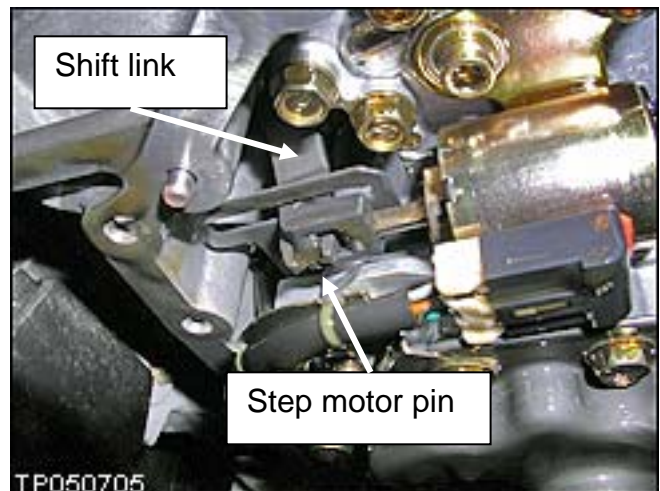
Figure 16

13. While you are doing Step 12 above, the lower end of the shift link must stick through the bottom of the step motor pin as shown in Figure 16.
