Tank disassembly and service guide E520/E720/E820/E920

Note to Service Technician:
This service guide covers complete tank disassembly with special emphasis on main-shaft/flywheel removal and tank seal replacement.

Tank main shaft seal replacement service guide:

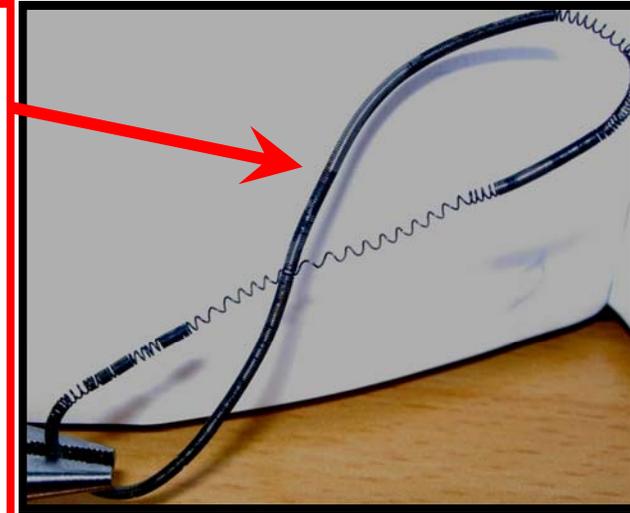
In late March 2009, we swapped what seemed at the time to be the hundredth tank onto the test machine. But this tank was to provide the break through we'd been seeking. With less than 50 hours of usage, this tank had a telltale puddle of rusty water at the rear of our E316 test unit's tank shaft. We pulled it apart, and discovered a rust colored stain on the inner rim of the main shaft seal. Taking out the spring was a revelation...Instead of our specified stainless steel spring (shown middle, lower right) we instead discovered a mild steel spring (shown upper right) that had failed due to minor corrosion.

This was the answer we'd been seeking. The slightly corroded spring could not handle the minute oscillations of the main shaft and allowed water to seep along the main shaft into the bearing housing. We immediately contacted the supplier, who confirmed that this was indeed not a stainless steel spring.

Corroded, non stainless spring quickly loses ability to maintain shape, causing just enough distortion of the seal to allow seepage along the mainshaft through to the bearings.

From this date onward, we have been using only stainless steel springs (as we had for the first 5 years). And since this date, we've not received a single warranty claim for tank failure on any product manufactured after this fault was discovered.

We are completely certain that this is the source of the leaking tanks and now only use stainless steel springs inside our main shaft seals. We have procedures in place to prevent this happening again and apologise for the inconvenience it has caused a number of our distributors.

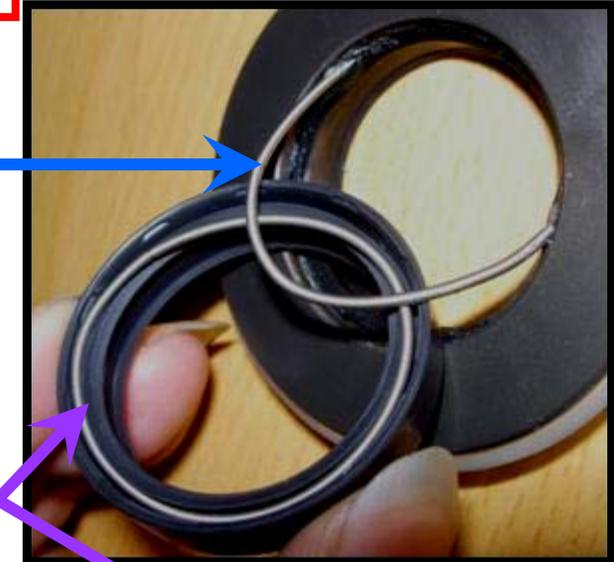
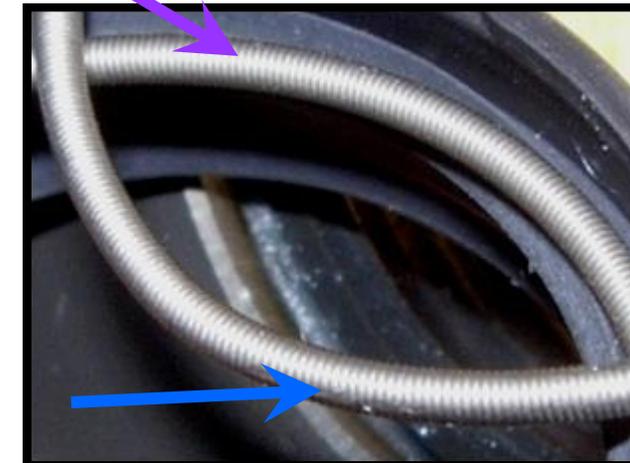
A correct spec stainless steel mainshaft seal spring after 6 months in water, and 4 years after production, alongside our current stainless spring. As pictured, the springs are identical.

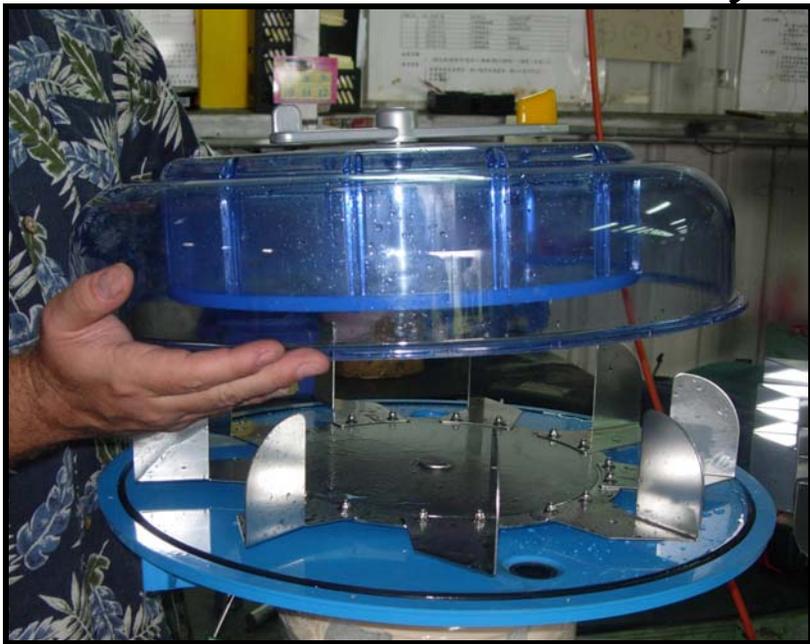
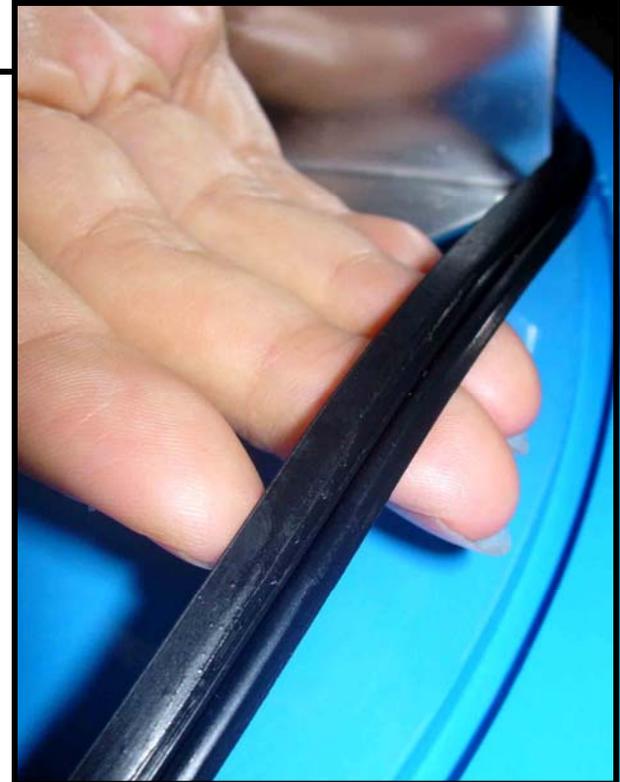
Start by removing Polycarbonate shell. Once the M3x12mm tank screws (12x) have been removed, use a rubber mallet and drop cloth and tap gently to break loose the outer tank seal. Remove the upper section of the tank, and inspect the O-ring for any signs of cracking tearing or binding. Replace if needed.

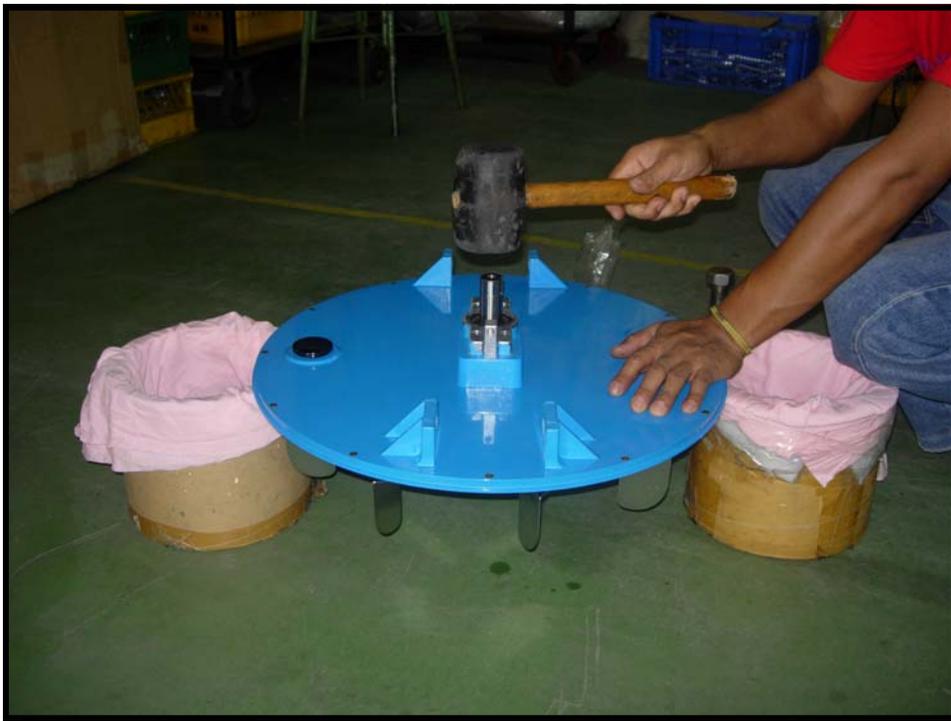
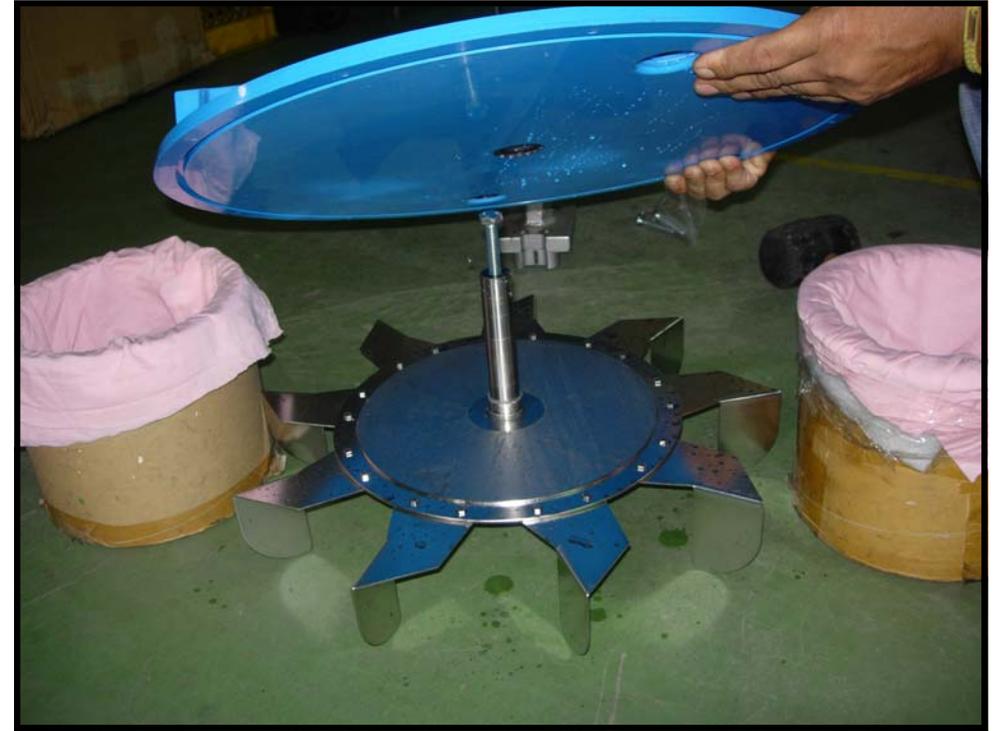
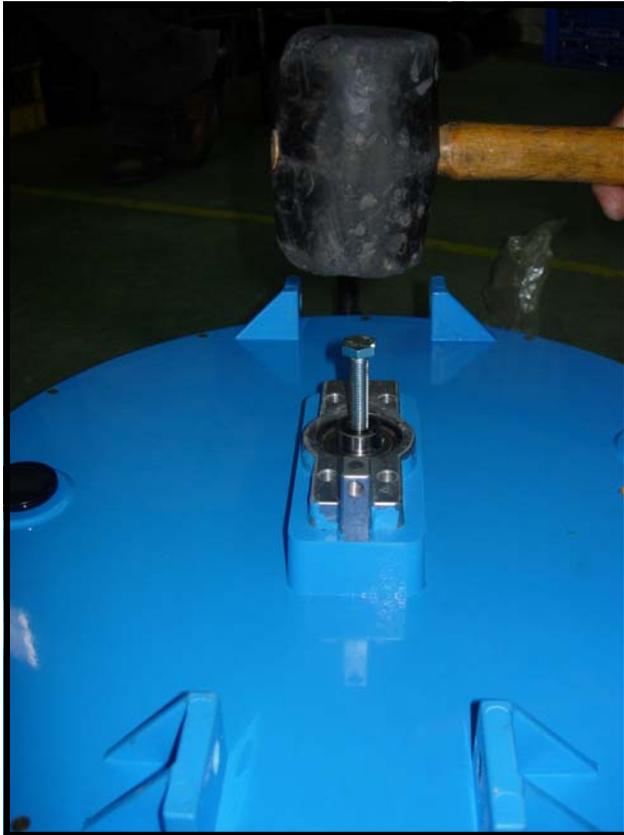
Removing the flywheel/main shaft

Next, flip the tank back over and find a suitable location to drive the flywheel mainshaft through as pictured; such as the ends of two tables, workbenches or even two chairs. Use a rubber mallet to drive the mainshaft through the tank-back. Screw a M10 bolt into the mainshaft rear to help drive the mainshaft out as shown.

Note: The flywheel mainshaft is heavy. Allow the assembly to drop onto a soft surface underneath. The impeller blades are also sharp, use care when handling.

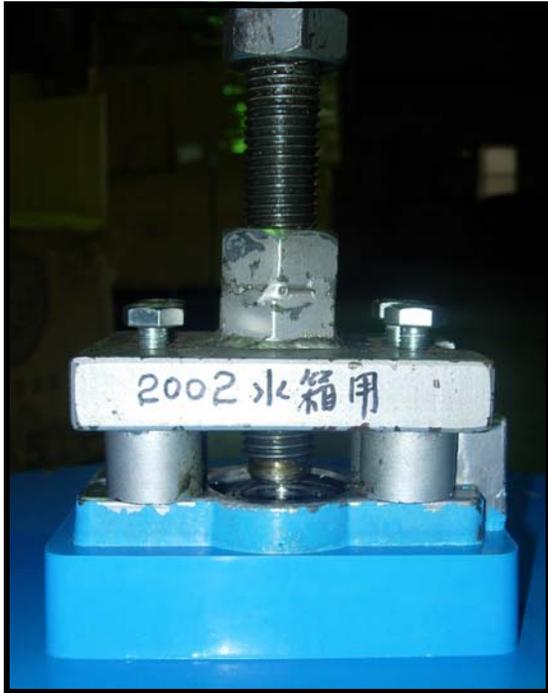
Removing the flywheel/main shaft with the FDF Flywheel shaft puller P/N13300

First, attach the FDF flywheel shaft puller to the rear of the SMC tank aluminum housing and tighten the four bolts as shown. Then, with a large open-end or crescent wrench, slowly turn the main puller bolt clock-wise until the flywheel is forced through the housing and out of the tank.

Note: Use a towel or other soft surface underneath to avoid damage when the flywheel/mainshaft assembly drops out of the housing.

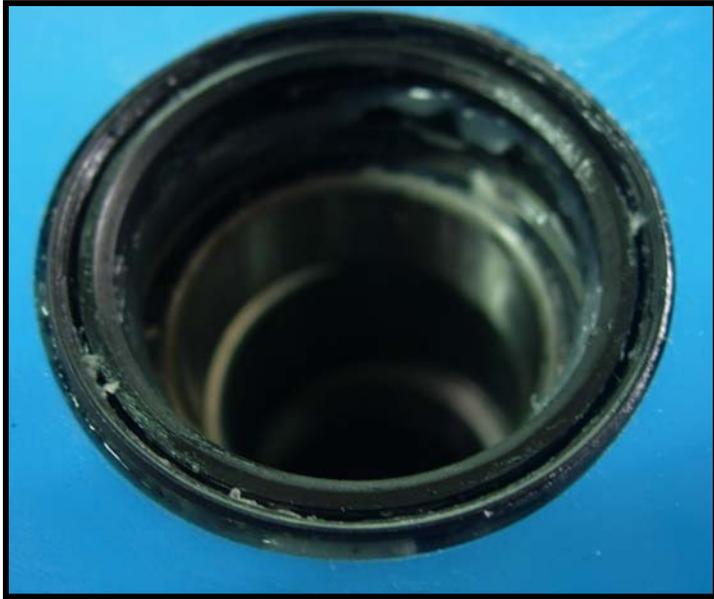
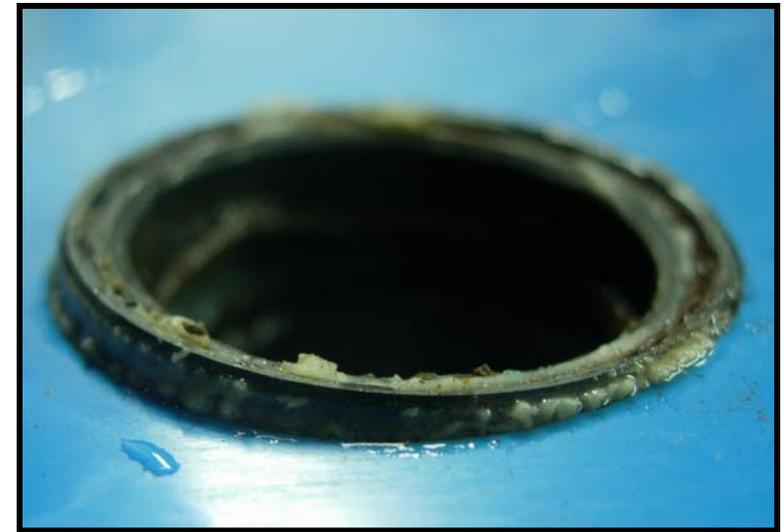
Tank shaft seal Inspection:

On the left is a healthy tank shaft seal, the silicone glue and packing grease maintain their original color. The integrity of this tank shaft seal has not been compromised. The bearings will show no sign of water damage and run smoothly. If there are no issues with the tank bearings, the bearings and tank shaft seal can be left in place and the tank re-assembled.

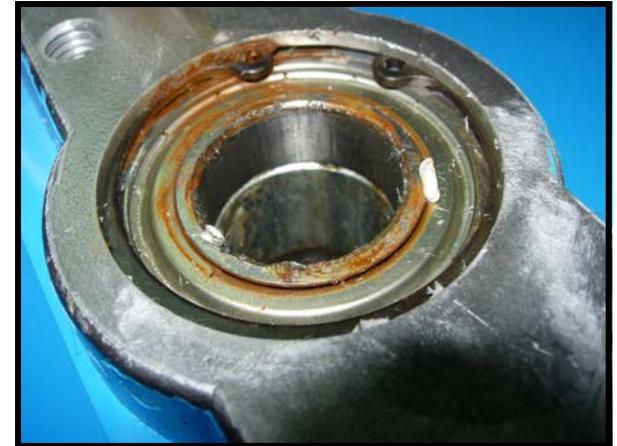
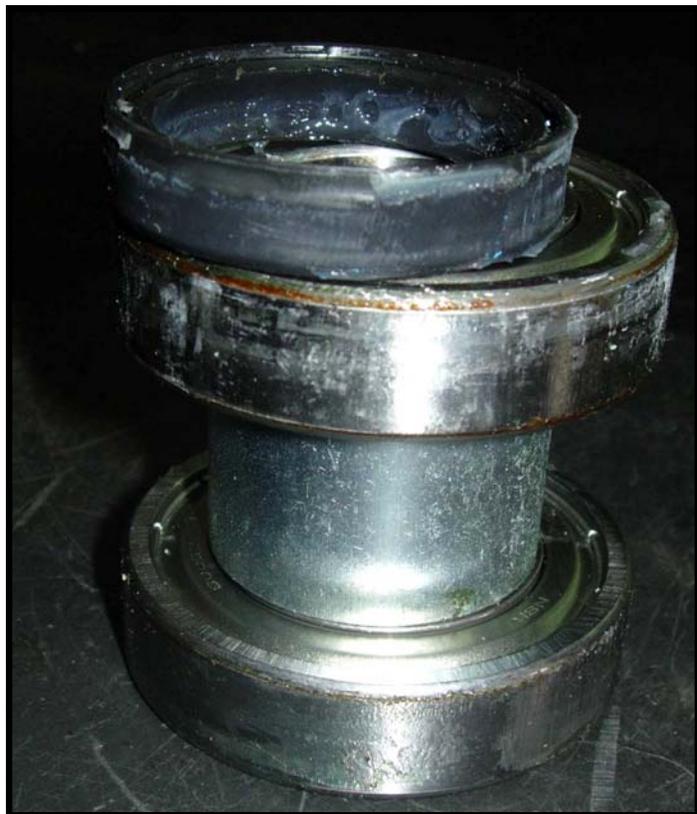
The right seal has been compromised. Telltale signs are the discolored silicone and the propensity for the tank seal to pop out of position when the main-shaft/flywheel assembly is removed. The seal (part number 10025) tank bearings (part number 10012) spacer (part number 10145) and C-clip (part number 10186) will be replaced in the tank shaft seal kit.

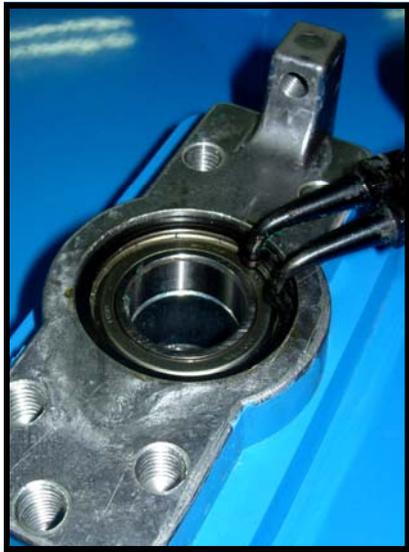
1. Remove C-clip from rear of aluminum housing

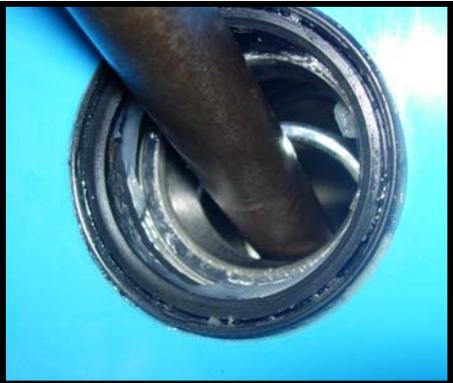
2. With small drift and hammer, lightly tap out and remove the rear bearing

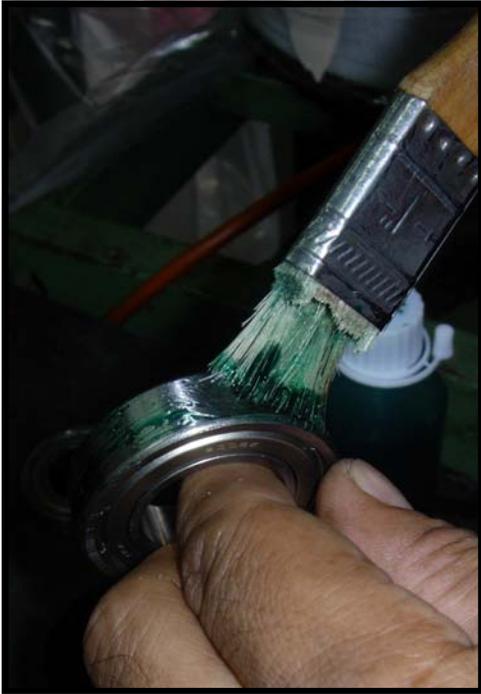
1. Clean inside of aluminum housing. Add thread locker to the outside of the bearing and to the inside of the aluminum housing where the two bearings will be located. Note that the service tech will be required to rig up a tool of some kind to tap the front tank bearing in. An example of the set up we use at the factory is shown below. A simple washer and metal spacer will also work. Check that the bearings are rotating smoothly once seated in the housing.

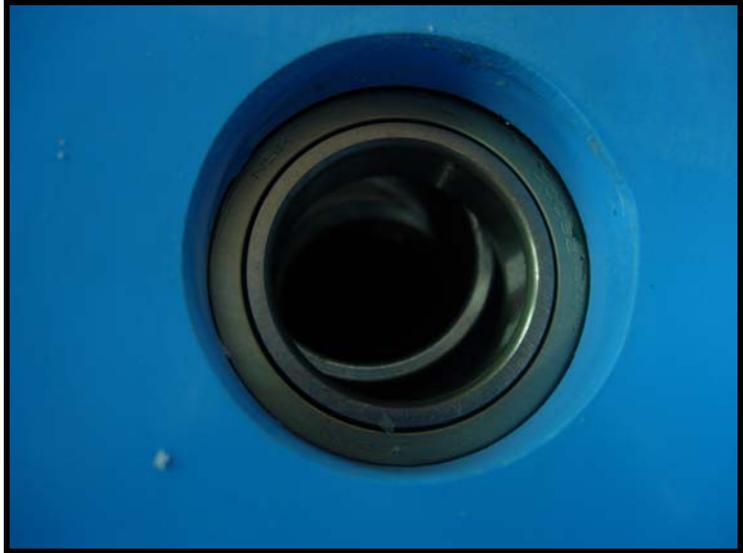
1. Carefully remove any residual matter (silicone glue or grease) from the SMC seal housing walls before pressing in the new seal housing.

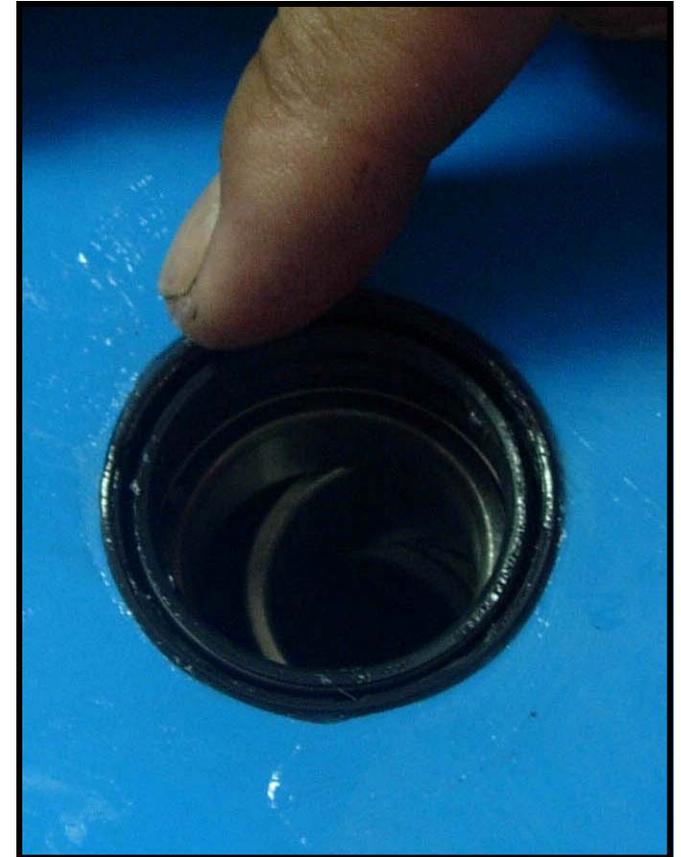
2. Apply silicone glue to the outside of the NBR tank seal prior to pressing the seal into the SMC tank back. Standard fish tank grade Silicone is required.

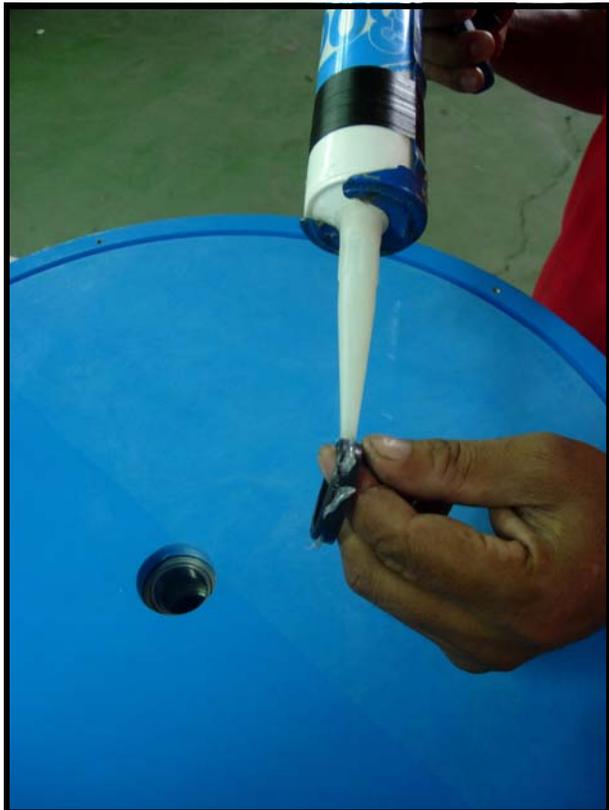
3. Tap the seal into place lightly with a rubber mallet until flush with SMC. The excess silicone glue will be pushed upward from the sidewall between the seal and SMC seal housing. With your finger, use this excess silicone to create an extra barrier by covering the an area extending approx 2cm from the outer SMC wall with the excess silicone, paying special attention to the "lip" area of the housing. Then clean out any remaining silicone located between the "lips" of the seal before proceeding. Allow a few minutes for the initial setup of the silicone glue before moving on to the silicone packing grease.

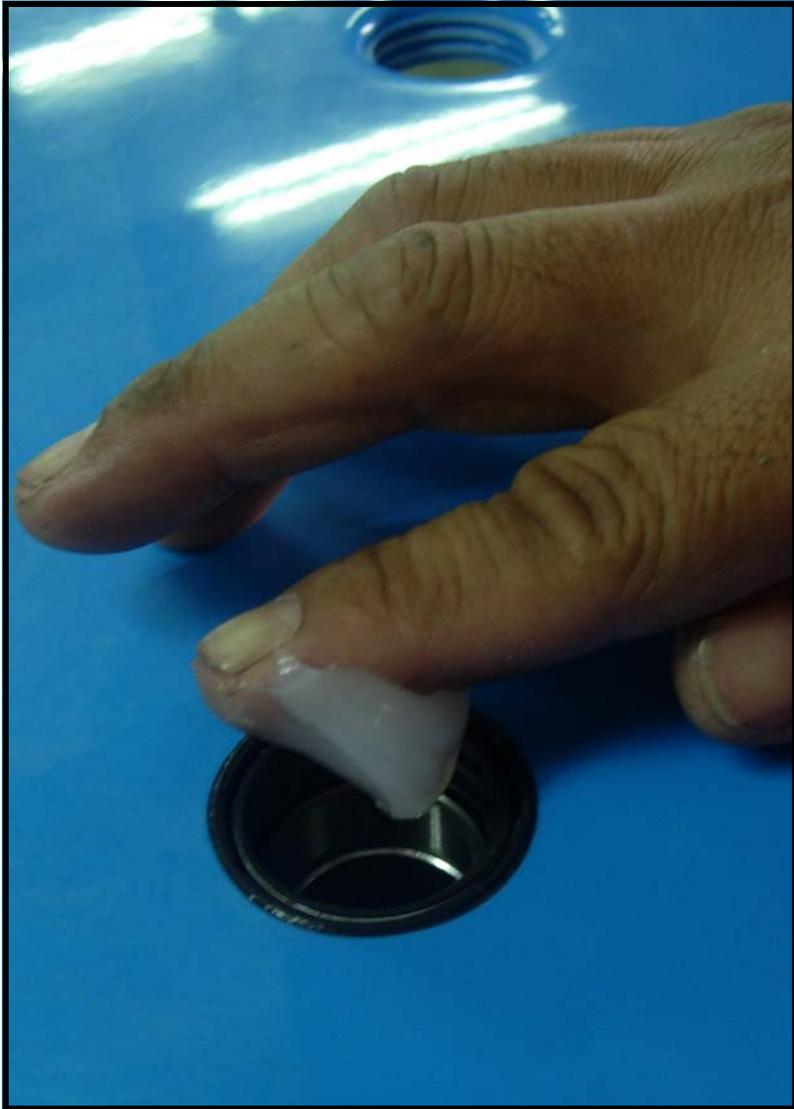
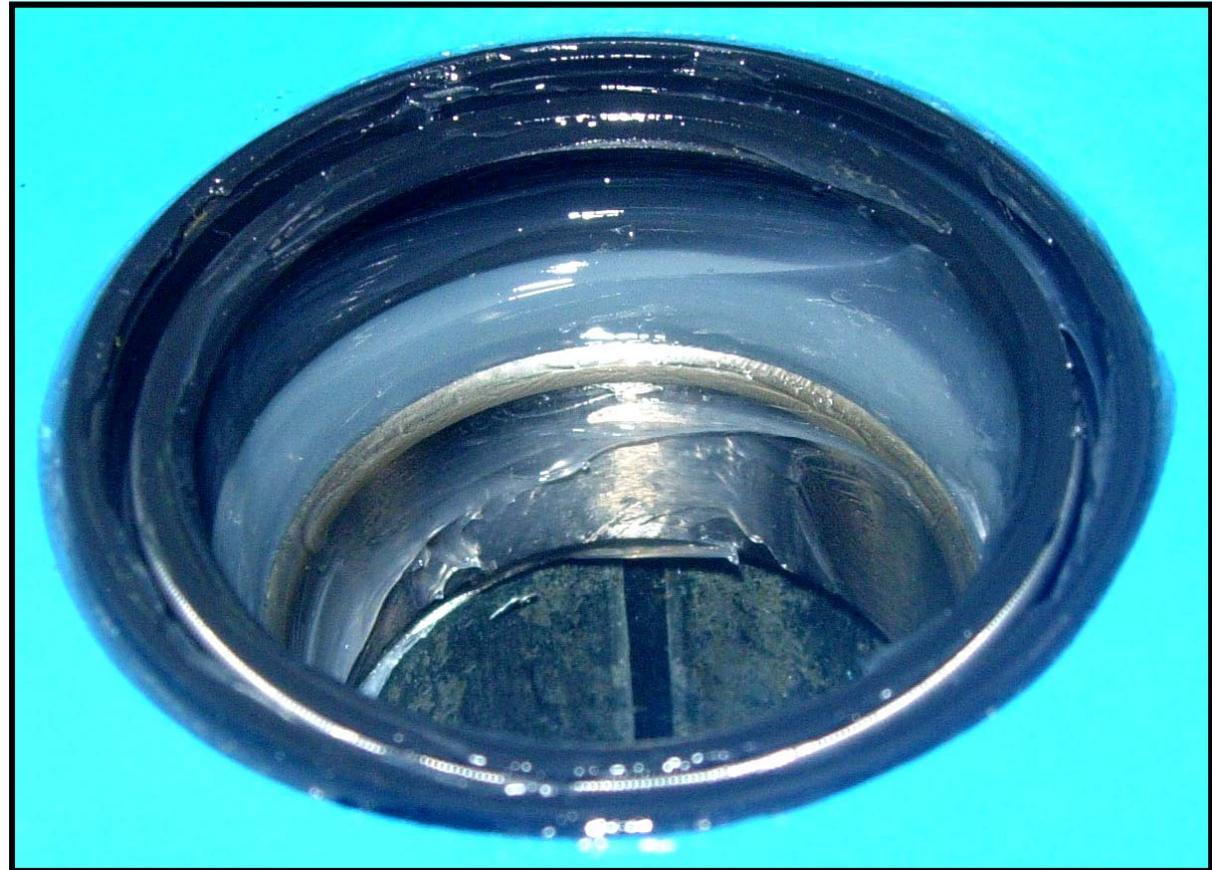
Silicone Grease Packing:

Apply a generous amount of Silicone grease (standard O-ring grease) to the inside of the seal and pack the area between the rear of the seal and the front bearing with a liberal amount of O-ring grease. Above right is an example of a properly prepared tank shaft seal .

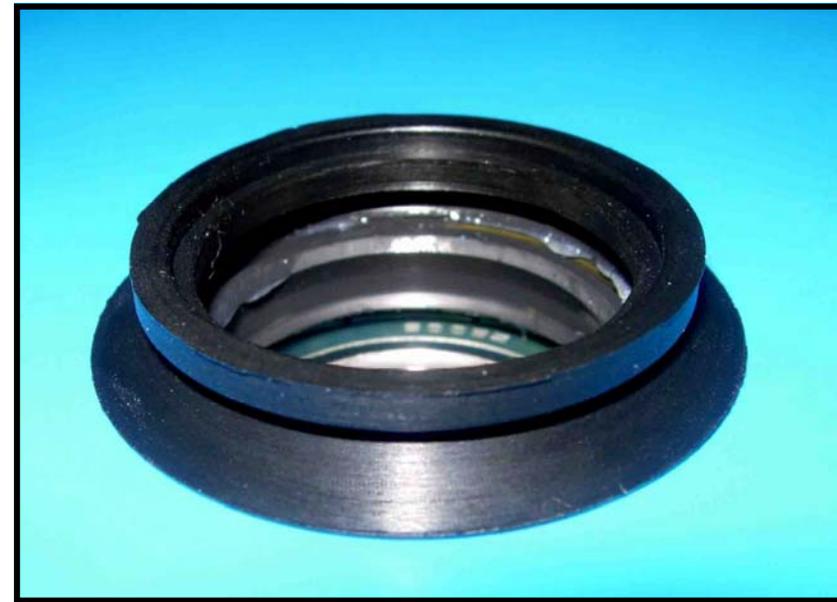
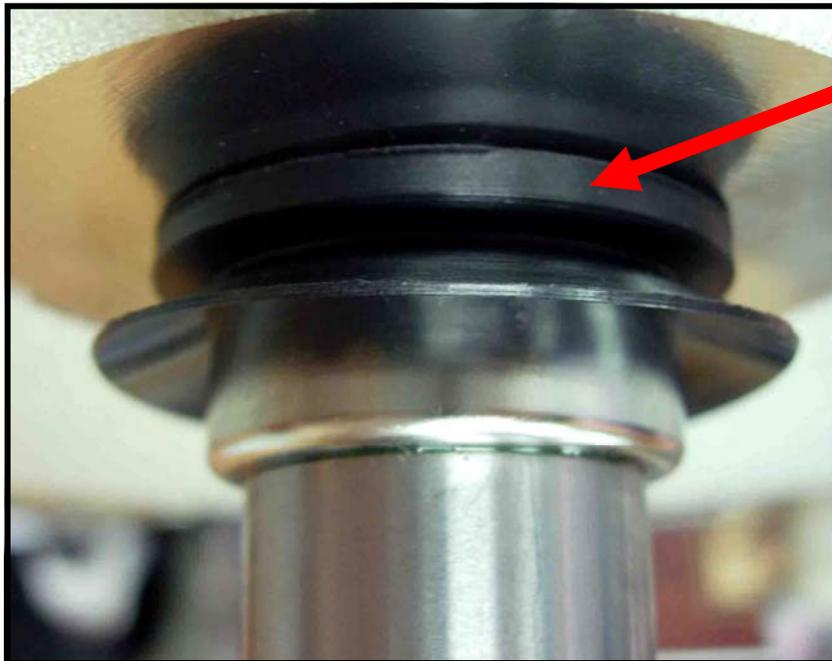
Cup seal addendum:

Once the bearings, mainshaft seal and spacer have been replaced, this cup seal slides onto the mainshaft as shown bottom left and right before the flywheel shaft is re-installed through the SMC tank back (as directed in the service notes). **Shown upper right (without the flywheel mainshaft for effect) is the cup seal.** It will help direct water away from the mainshaft seal, thus reducing wear and tear and greatly extending the longevity of the replacement parts. This is especially helpful for the S250/S350 series rowers. Note distributors holding existing FDF9E kits without the cup seal can order them (Part number #13025) FOC by contacting our Production Manager in Taiwan (Note freight charges are the responsibility of the Distributor), Michael Botti. **Email address as follows: michaeljbotti@gmail.com. Tel: 886 3 478 3306 ext#45**

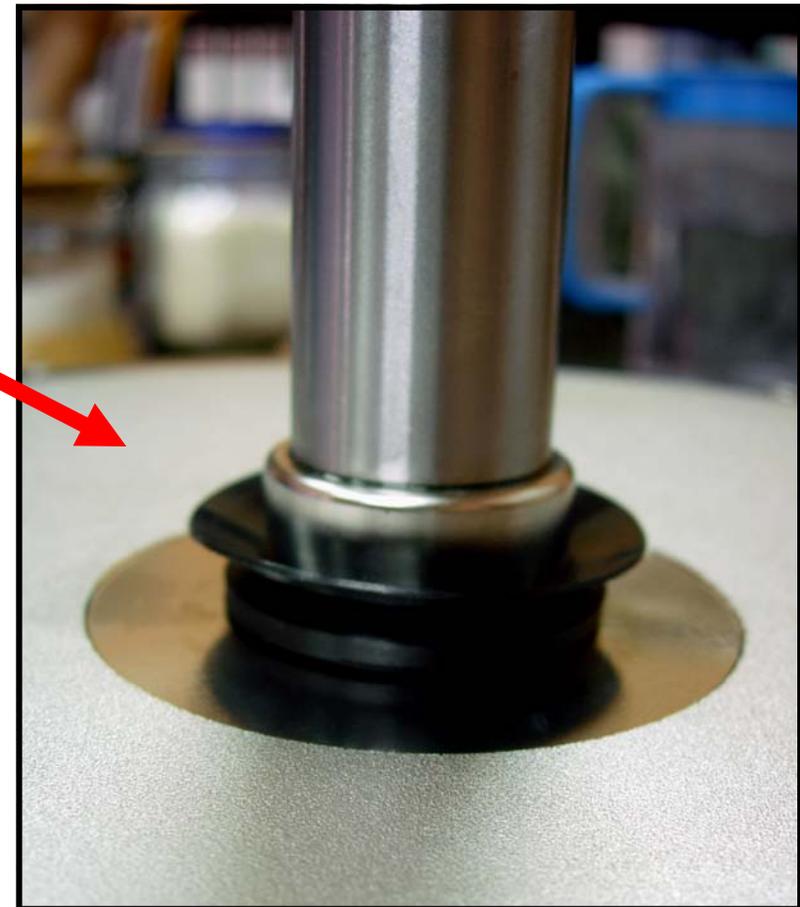
Slide the cup seal onto the flywheel mainshaft juts prior to re-assembly as shown:

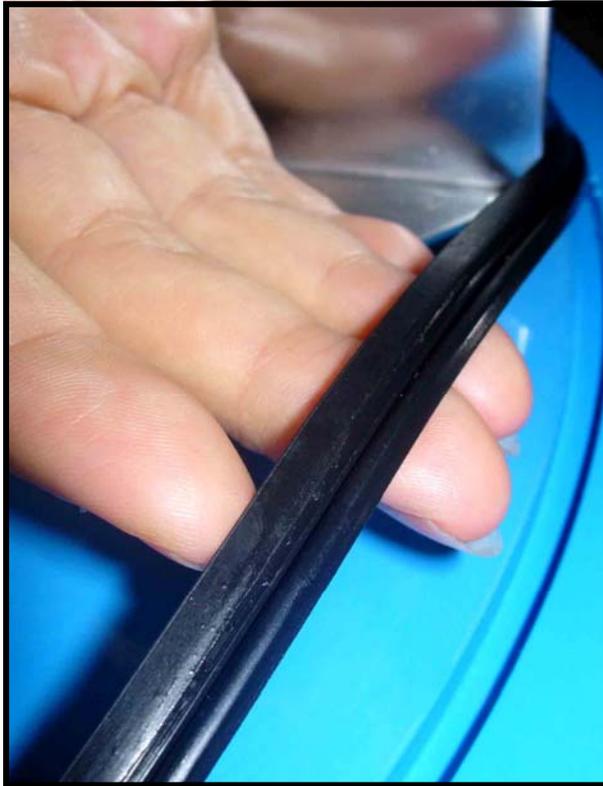
1. Lay the O-ring into the SMC O-ring groove, making sure it is flat and flush before securing the PC cover. An improperly laid and prepared O-ring will seep water over time. If the seal is excessively dry, then add a light coat of silicone grease.

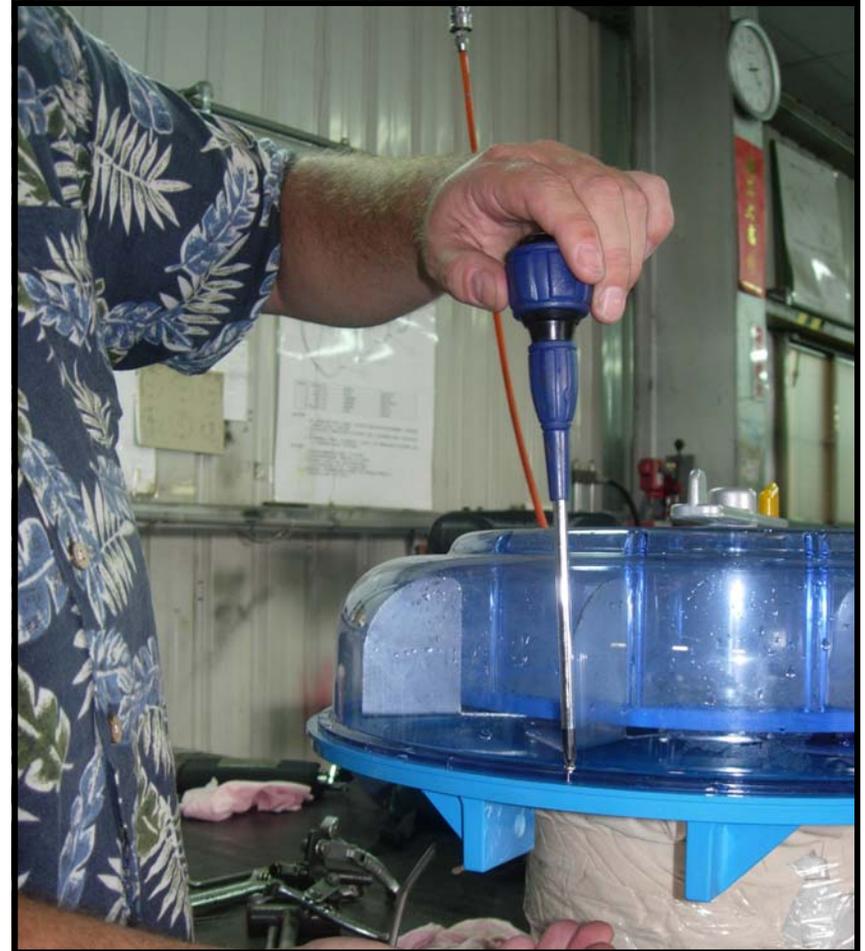
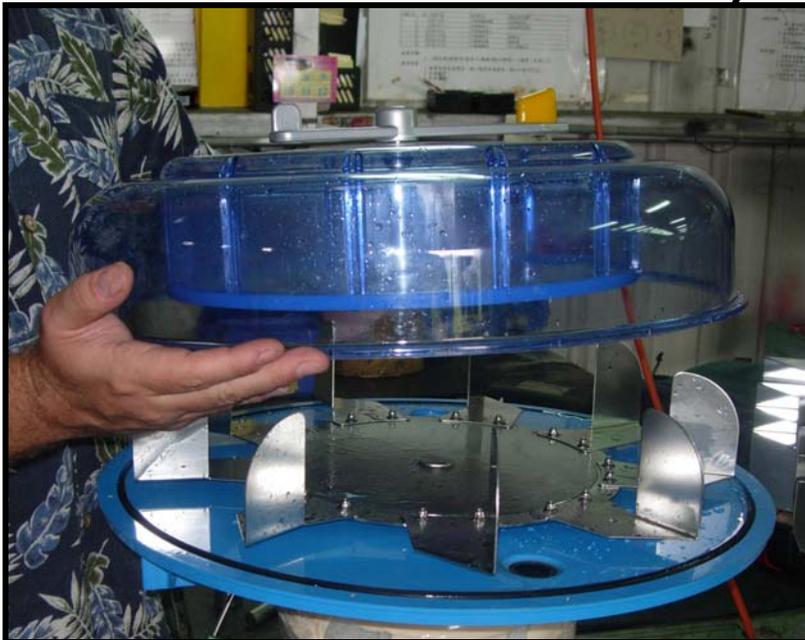
2. When attaching the PC cover, use a cross pattern with the screws. If a power tool is used, the lightest setting is more than enough to establish a seal. **Note over tightening the tank screws will readily crack the PC cover!**

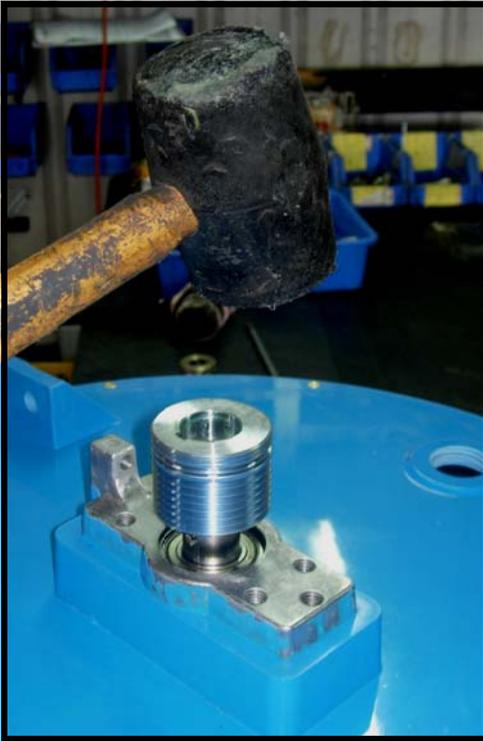
1. Reinstall the Small belt pulley onto the main-shaft. Remember to keep the keyway positions on the shaft and pulley lined up as you go.

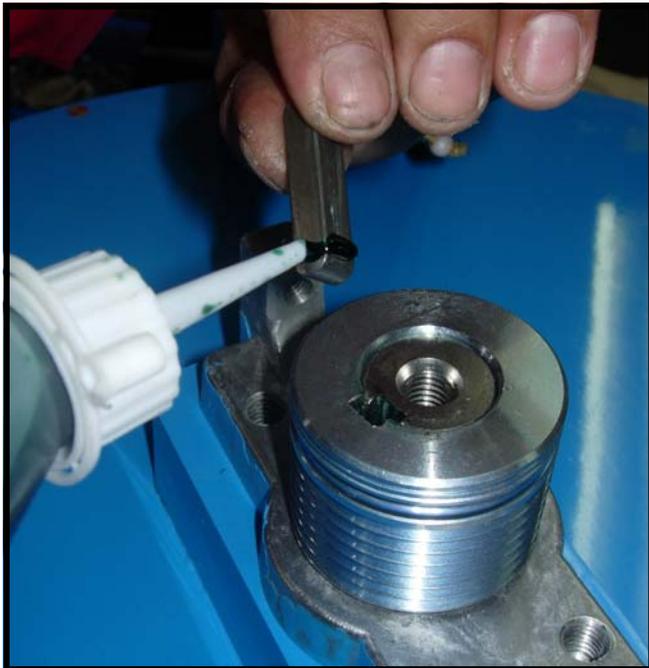
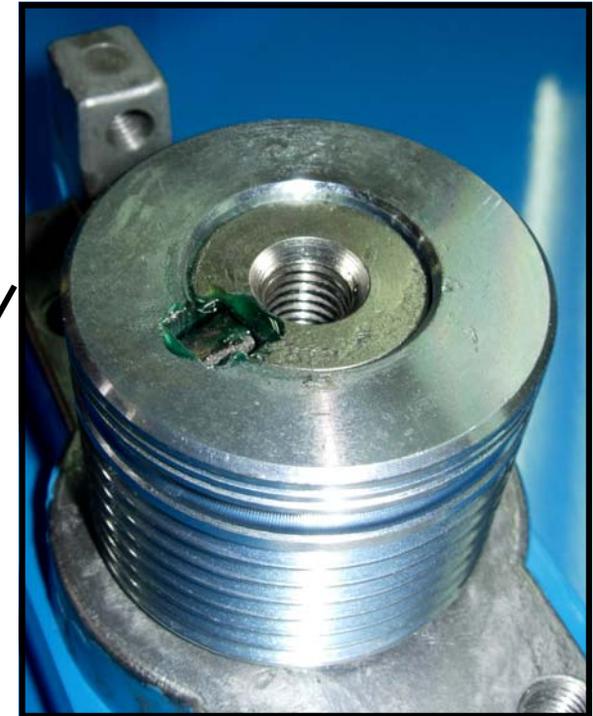
2. Apply thread locker to the keyway before knocking into place. Use a drift or heavy bladed screwdriver to drive the keyway into place as shown upper right.

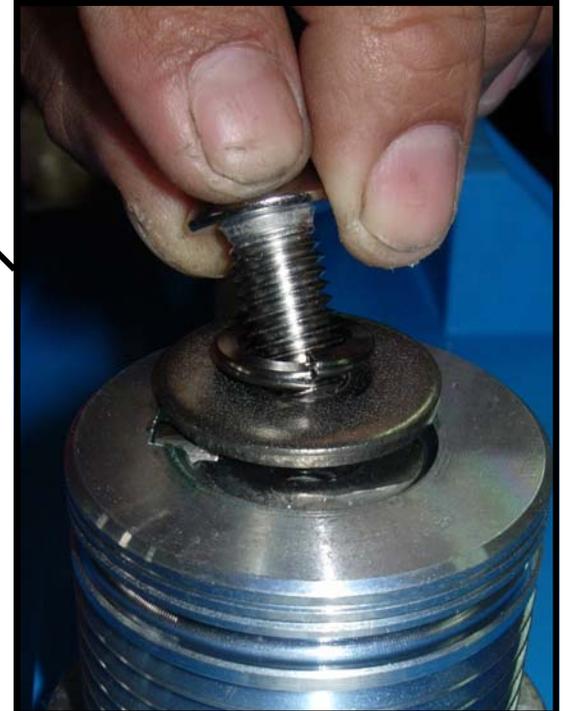
3. The Keyway, small pulley and main-shaft assembly. To finish, reinstall the washer, spring washer and tank shaft bolt
