**Target audience: Medical Engineers / Biomedical Engineers**

| <b>Affected device</b> | <p>Volumed <math>\mu</math>VP7000 Premium,<br/> Volumed <math>\mu</math>VP7000 Classic Plus<br/> Volumed <math>\mu</math>VP7000 Lite</p> <p>Syramed <math>\mu</math>SP6000 Premium<br/> Syramed <math>\mu</math>SP6000 Classic Plus</p> |

**Concern: Flat ribbon cable check 04/2012**

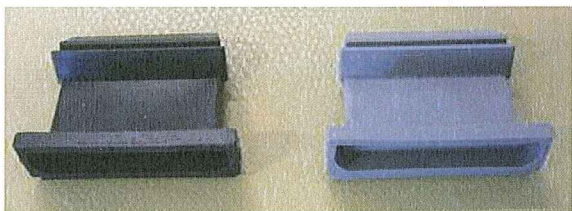
The ribbon cable, which connects the display PCB with the main PCB of the above mentioned pumps, may show aging effects after a certain time. This aging effect reveals mainly in stiffening of the isolation of the ribbon cable where the ribbon cable is in contact with the hinge.

The stiffening of the isolation of the ribbon cable can be prevented by insertion of two special plastic foils between the hinge and the ribbon cable as shown in picture 1.

In the case of Volumed®  $\mu$ VP7000 it was also necessary to optimize the hinge. Therefore *arcomed ag* has developed a new hinge for the special plastic foil (picture 2) and it is recommended to use this new optimized hinge together with special plastic foils.

| <p>Picture 1: Special plastic foils to prevent the stiffening of the insulation of the ribbon cable.</p> | <p>Picture 2: <u>left</u> (black, old hinge) <u>right</u> (grey, new hinge, optimized for the special plastic foils)</p> |

Flat ribbon cable complete (with hinge and plastic foil) can be ordered at *arcomed ag* (item number 70242 for Syramed  $\mu$ SP6000 and item number 76269 for Volumed  $\mu$ VP7000).

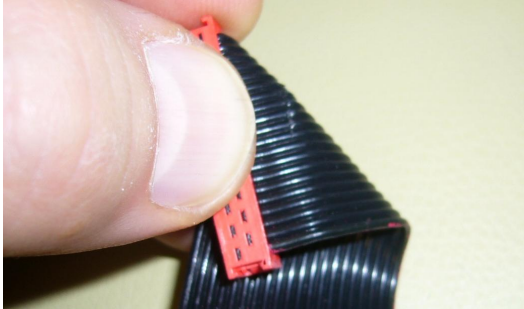
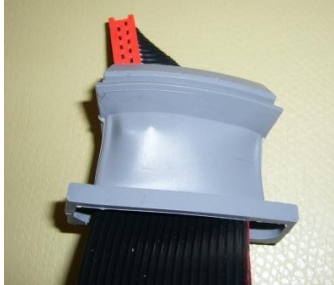
| 3. | <p>Turn down the ribbon cable slightly as shown in picture 1 and put over the grey hint as shown in picture 2.</p> <div style="display: flex; justify-content: space-around;"> <div data-bbox="316 965 842 1272"> <p>Picture 1: Preparing of ribbon cable for insertion of hinge.</p> </div> <div data-bbox="1002 965 1337 1249"> <p>Picture 2: Pulling the hinge over the ribbon cable</p> </div> </div> |

*arcomed ag* recommends to change the hinge and to add two special plastic foils above and under the ribbon cable.

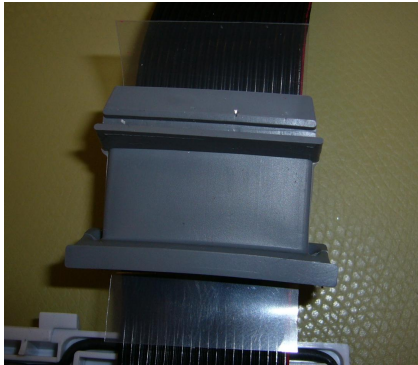
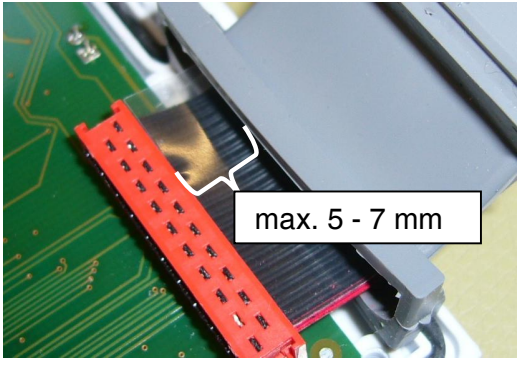
| 4. | <p>Insert plastic foil between hinge and ribbon cable (picture 3):</p> <div style="display: flex; justify-content: space-around;"> <div data-bbox="368 1442 788 1805"> <p>Picture 3: Insertion of plastic foil</p> </div> <div data-bbox="911 1442 1430 1805"> <p>Picture 4: ideal placing of the foil compare to the hinge.</p> </div> </div> |

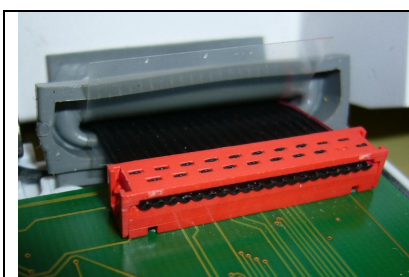
Prior to start the change process, please check if the ribbon cable is connected to the display print with aid of a fix connector (picture 3) or via a separable connector (picture 4).

Picture 3: Fix connector

- A) If the ribbon cable has a connector as shown in picture 3, than please send the ribbon cable with the display print to the following address:

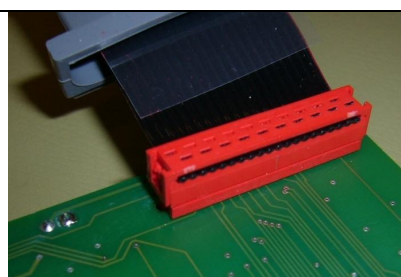
Picture 4: Separable connector

*arcomed ag* Tech. Support  
 Althardstrasse 150  
 CH-8105 Regensdorf
- B) If the ribbon cable has a connector as shown in picture 4, than please proceed as follows:
  - Dismantle the ribbon cable for the main PCB as well as from the display PCB. (See service manual 6.2.1 and 6.2.2).
  - Check the new ribbon cable if plastic foils are between the hinge and the ribbon cable.
  - Connect the new ribbon cable to the display PCB and be aware that the upper plastic foil sticks out of about 4 – 5mm from the hinge. (Picture 5).
  - Reassemble the door as described in the service manual chapter 6.2.2.

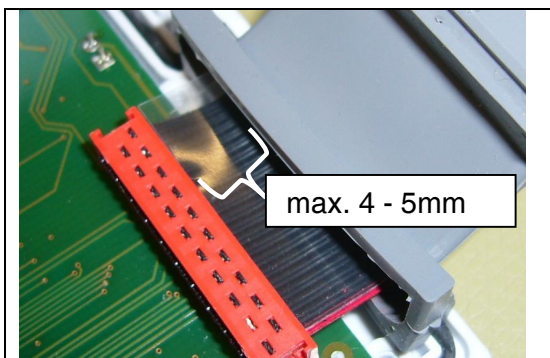
Picture 5: Ideal placing of plastic foil compare to hinge and connector

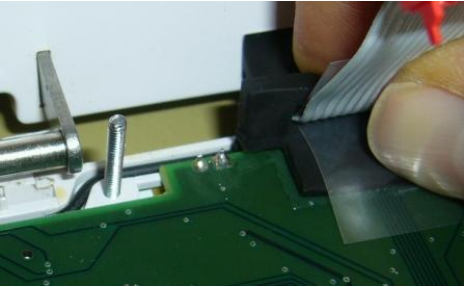
| 4. | <p>Glue the new hinge to the display PCB (see photo below)</p> <p>As glue <i>arcomed ag</i> recommends HENKEL: SICOMET ® 8400.</p> |

*arcomed ag* recommends to change the ribbon cable. Mount a new ribbon cable complete with polyester foil and new grey hinge.
