BT11-031

## 2009-2011 G37 CONVERTIBLE; SQUEAK / RATTLE / BUZZ NOISE FROM ROOF AREA

**APPLIED VEHICLE:** 2009 - 2011 G37 Convertible (HV36)

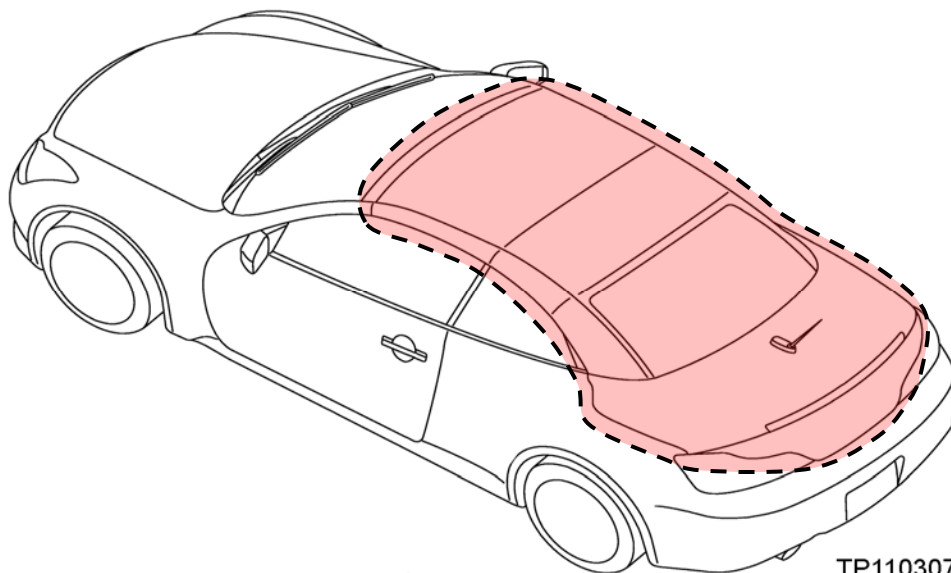
TP110307

There is a squeak, rattle, or "buzz" type noise coming anywhere from the retractable hard top or trunk area while driving.

Perform all repairs as outlined in **SERVICE PROCEDURE**.

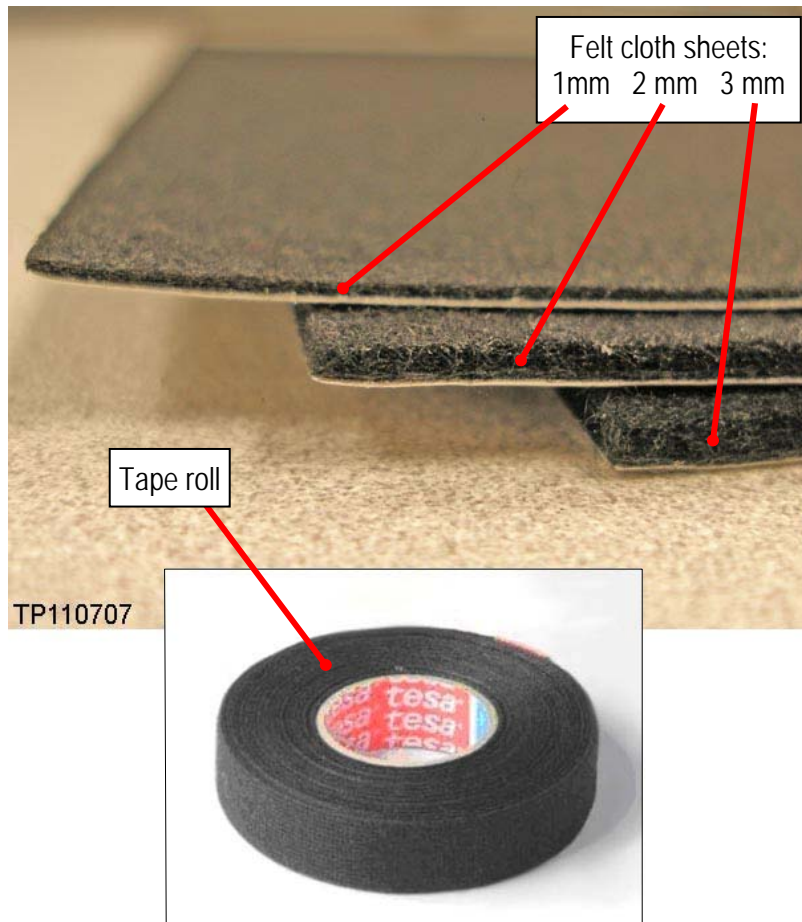
## Felt cloth and tape kit

Thickness	Size	Qty	Locations
0.45 mm (19 mm wide) (Tape roll)	19 x 50 mm	8	Plate, and rear roof <u>upper</u> garnish clips
	10 x 50	1	Rear rib locator
	19 x 900	1	Rear rib edge
	19 x 530	1	Front roof garnish
1 mm (Sheet)	10 x 50	17	Various Clips
	30 x 35	5	Rear rib emboss
	10 x 100	2	Rear roof lower garnish
2 mm (Sheet)	20 x 300	4	Rear rib
	20 x 80	2	Center roof panel pin
	20 x 20	2	Headlining mount
3 mm (Sheet)	10 x 20	2	Plate
	20 x 30	6	Flipper door
	15x15	2	Parcel shelf (adjusting screw)

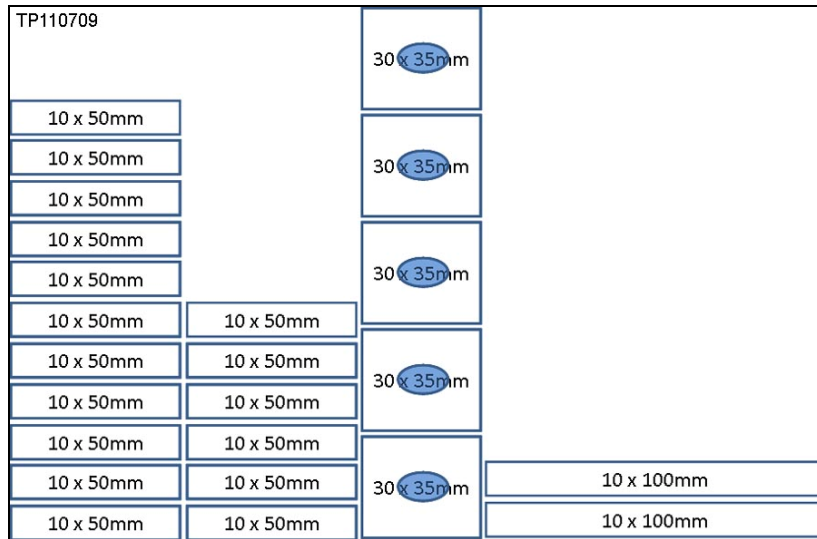
1 mm sheet

Here are examples on how to cut out pieces from each felt cloth sheet:

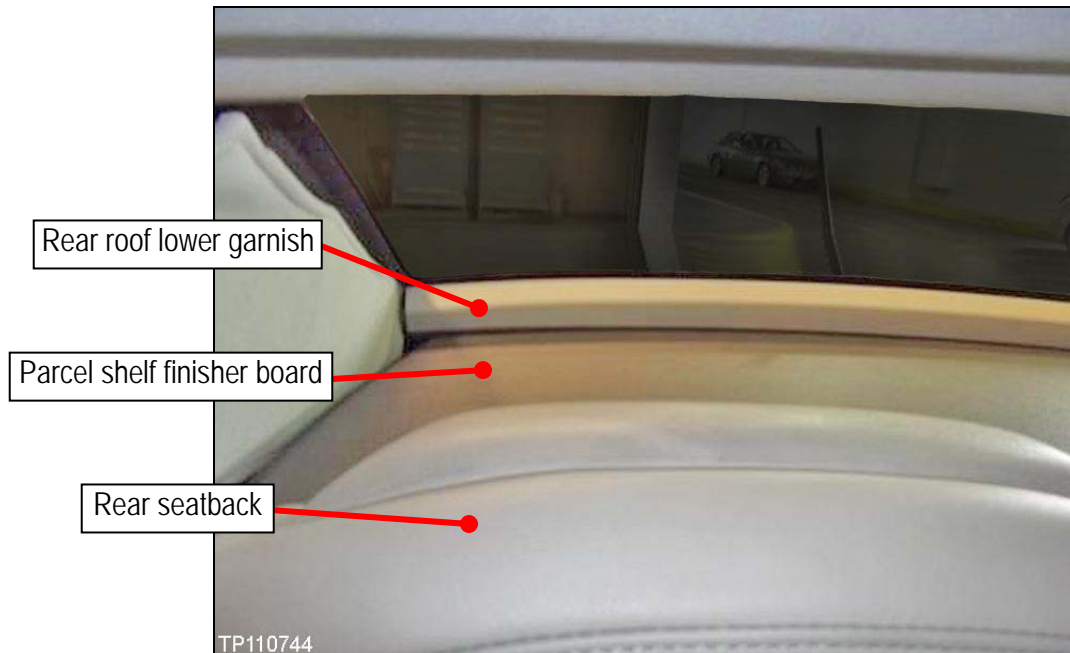
Figure 1

1. Remove the rear roof lower garnish with a suitable pry tool.

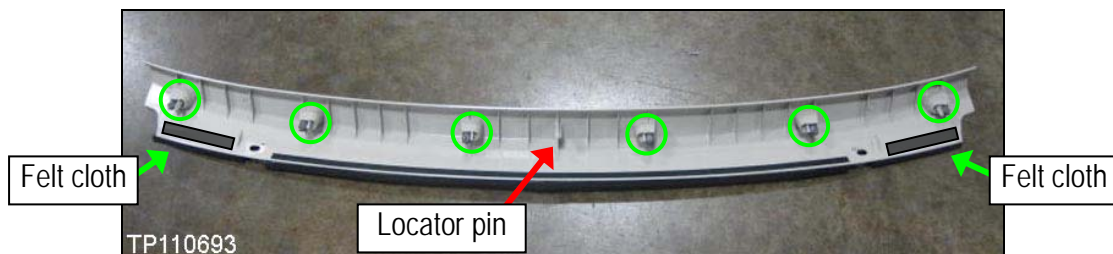
Figure 2

2. Cut two 10 mm x 100 mm pieces from the 1 mm sheet, and then install where shown in Figure 2.
3. Break off the locator pin with suitable pliers (see Figure 2).

4. Cut six 10 x 50 mm pieces from the 1 mm sheet, and apply to the clips as shown in Figure 3, and where circled in Figure 2.

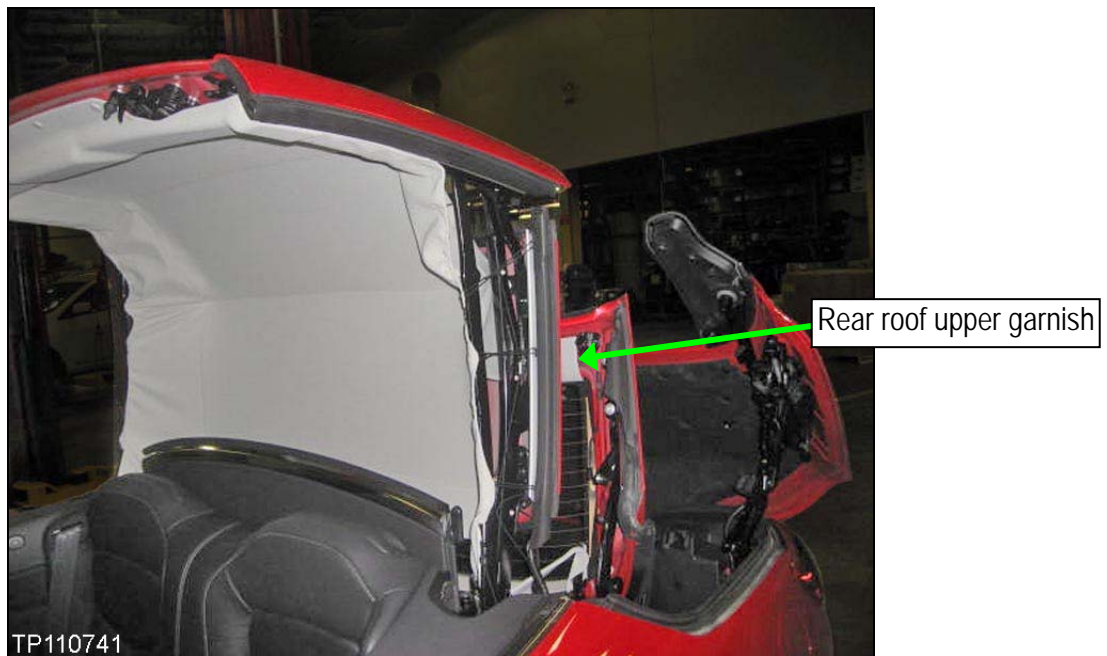
Figure 4

5. Next, position the retractable hard top (or hard top) as shown in Figure 4.  
**CAUTION:** When left in a partially closed position, the hard top could slowly drop which could cause hard top damage.
6. Remove the rear roof upper garnish with a suitable plastic pry tool.

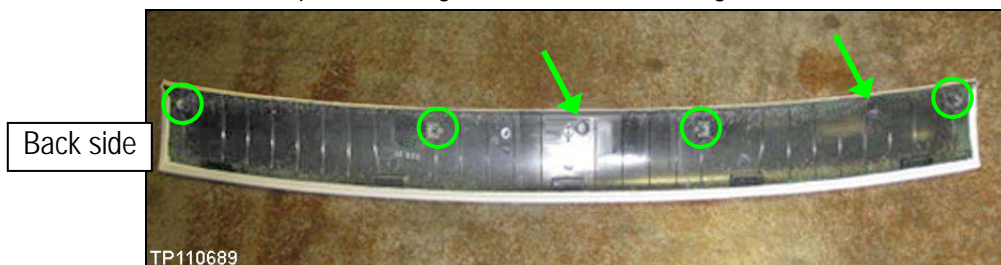
Figure 5

7. Break off flush both locator pins. See Figure 6, and arrows in Figure 5.

8. Remove any existing felt cloth from all clips.
9. Cut four 50 mm pieces from the tape roll, and then apply on the clips. See Figure 6, and circles in Figure 5.

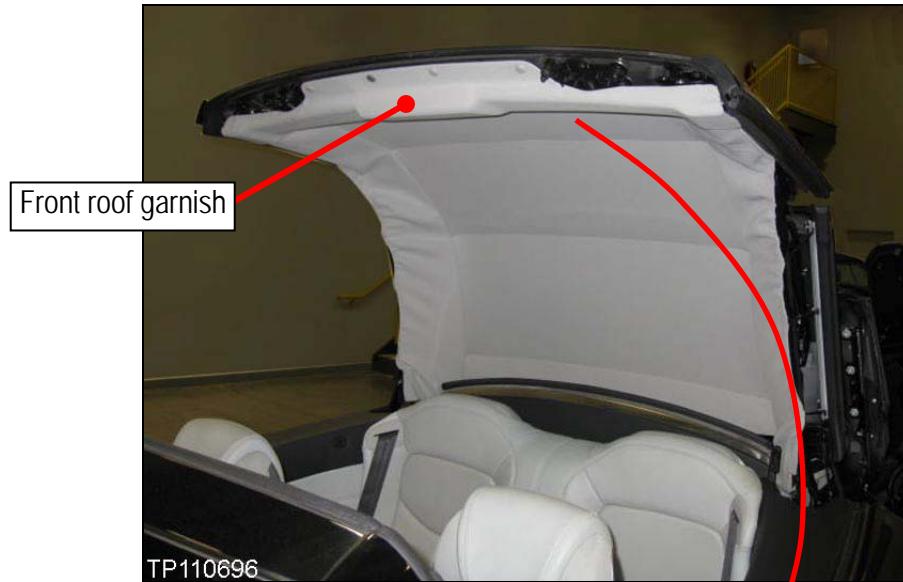
Figure 7

10. Next, remove the front roof garnish with a suitable pry tool.

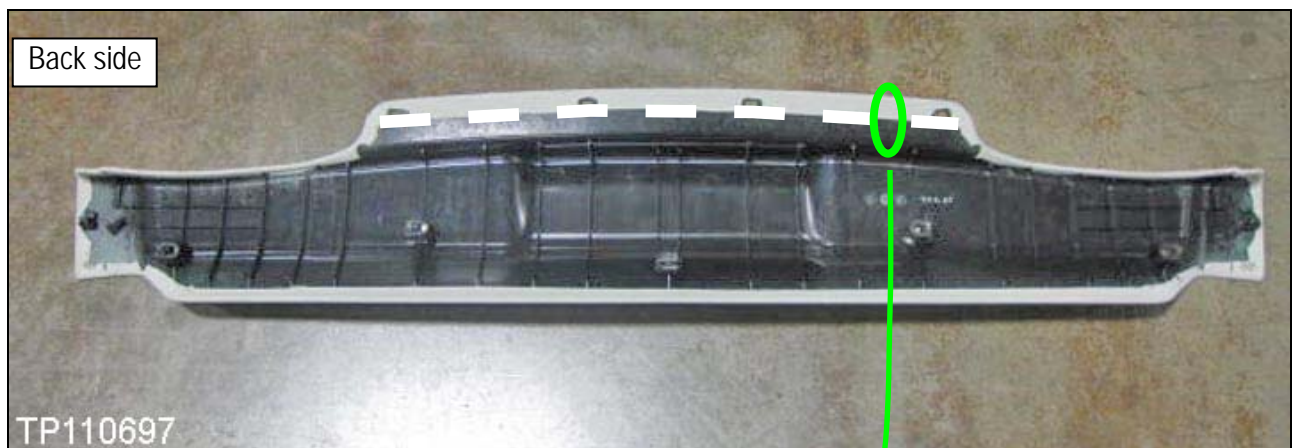
Figure 8

11. Apply felt cloth (from the tape roll) along the dotted line where shown in Figure 8.

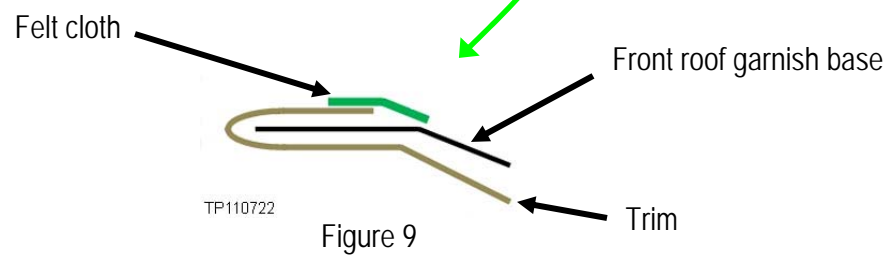
- Figure 9 shows side view (cutaway) of felt cloth position.

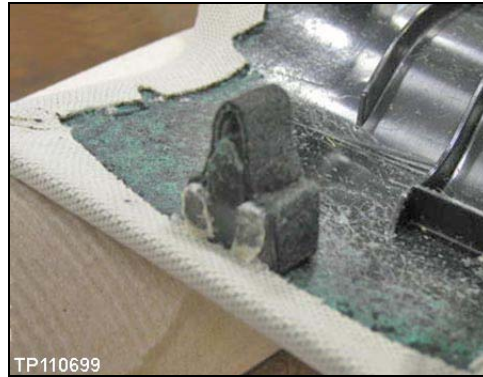
Figure 10

12. If felt cloth is already applied as shown in Figure 10, skip to Step 15.

14. Cut seven 10 mm x 50 mm pieces from the 1 mm sheet, and apply to the clips as shown in Figure 10.

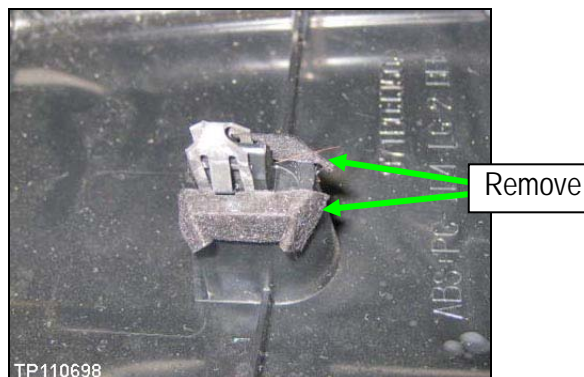
Figure 12

13. Remove any felt cloth found at the sides of the clips (see Figure 12).

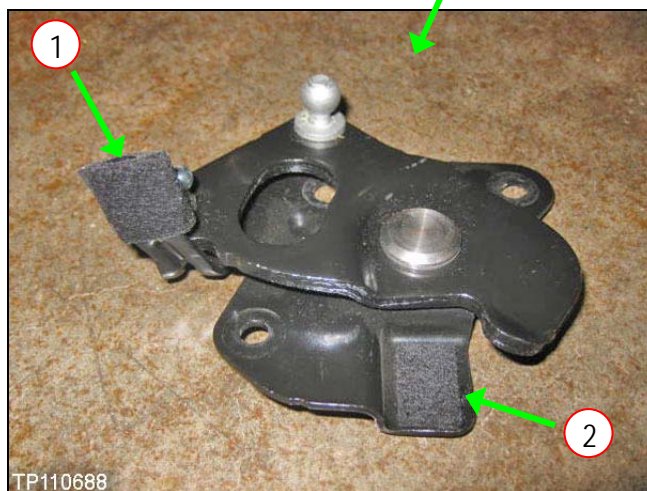
Figure 14

15. Apply felt cloth to both plates where shown in Figure 14.

- Cut two 50 mm long pieces of felt cloth from the tape roll and wrap one at location #1 on each plate
- Cut two 10 mm x 20 mm pieces from the 3 mm felt cloth sheet, and then apply one at location #2 on each plate

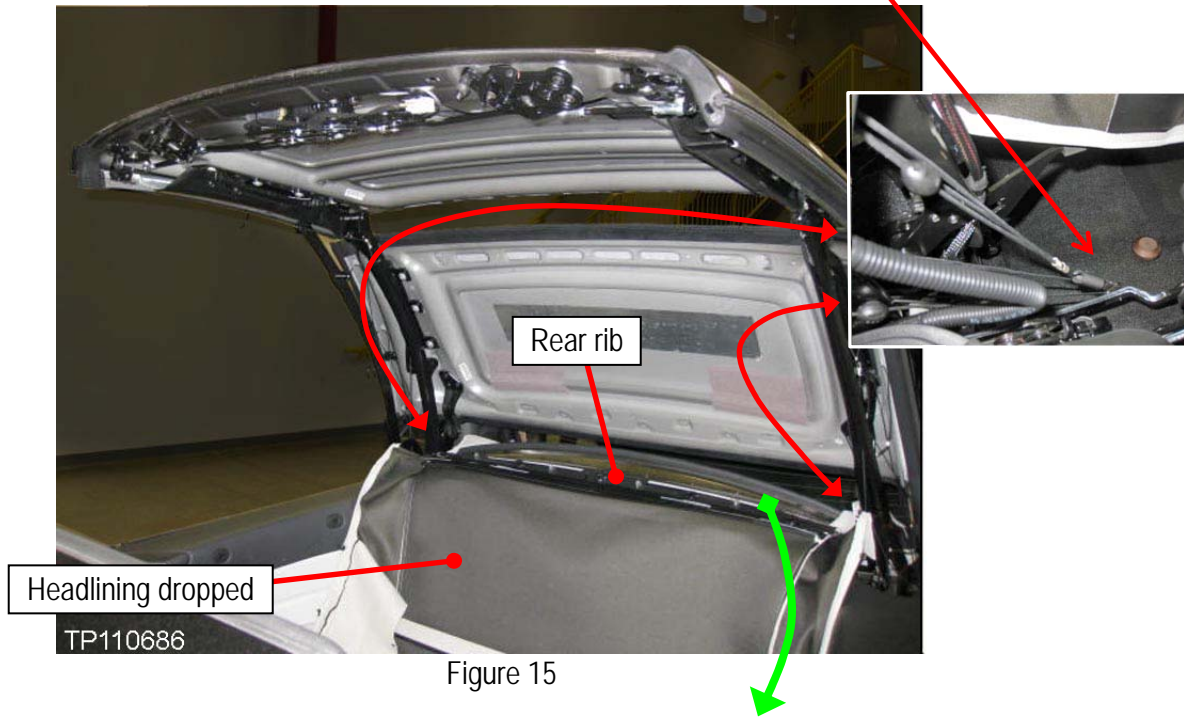
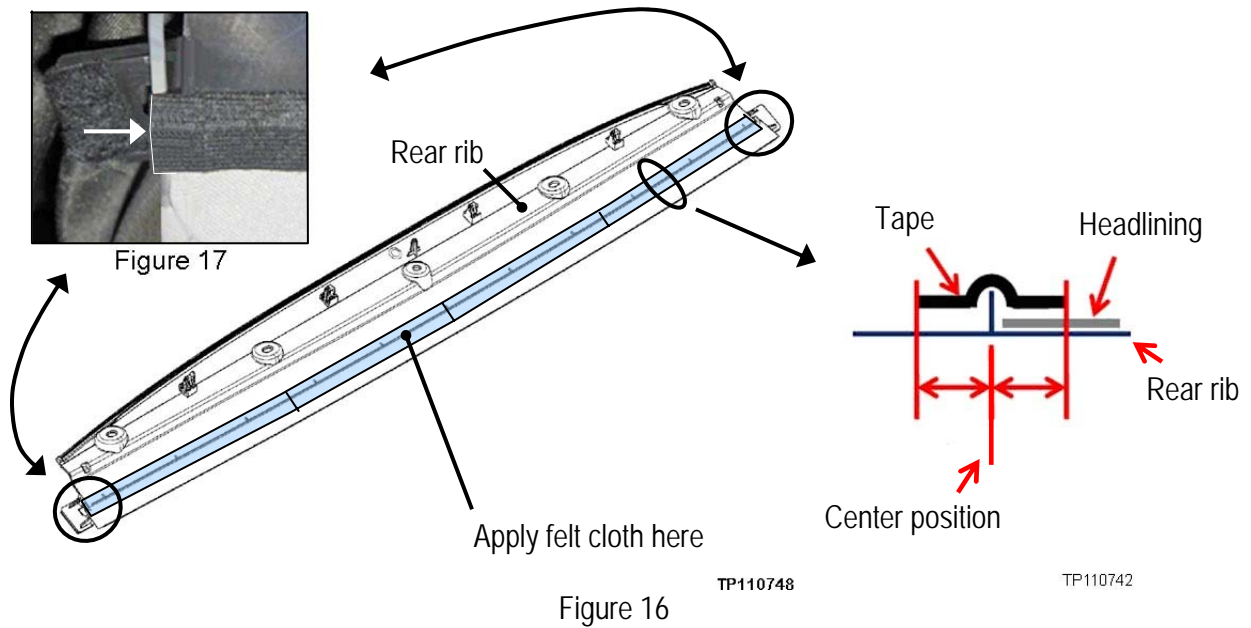
16. Next, drop down the headlining and lay out on the rear back seat to access the rear rib (see Figure 15).

17. Remove any existing pieces of felt cloth where outlined in blue in Figure 16.

19. Apply the cut pieces across the length of the rear rib where outlined in blue in Figure 16.

- Start and finish the application from edge to edge as shown in Figure 17.

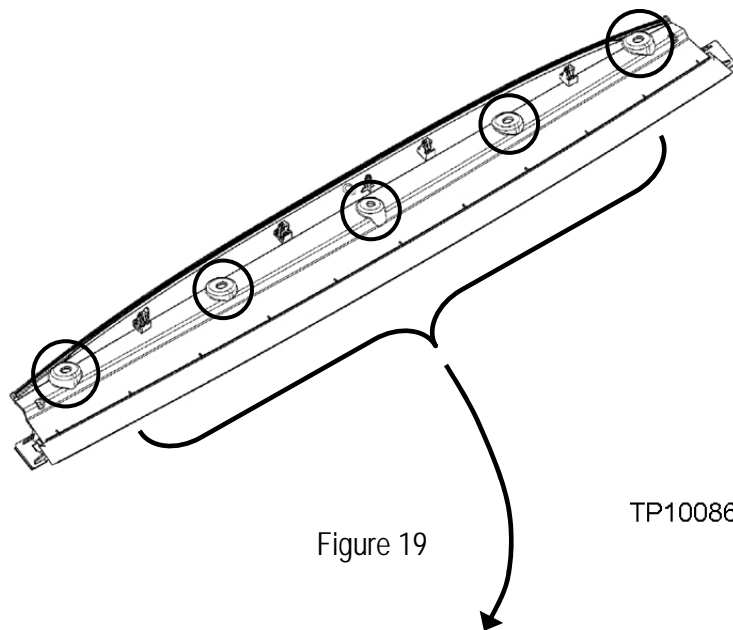
22. Apply these pieces where shown in Figure 19 and 20.

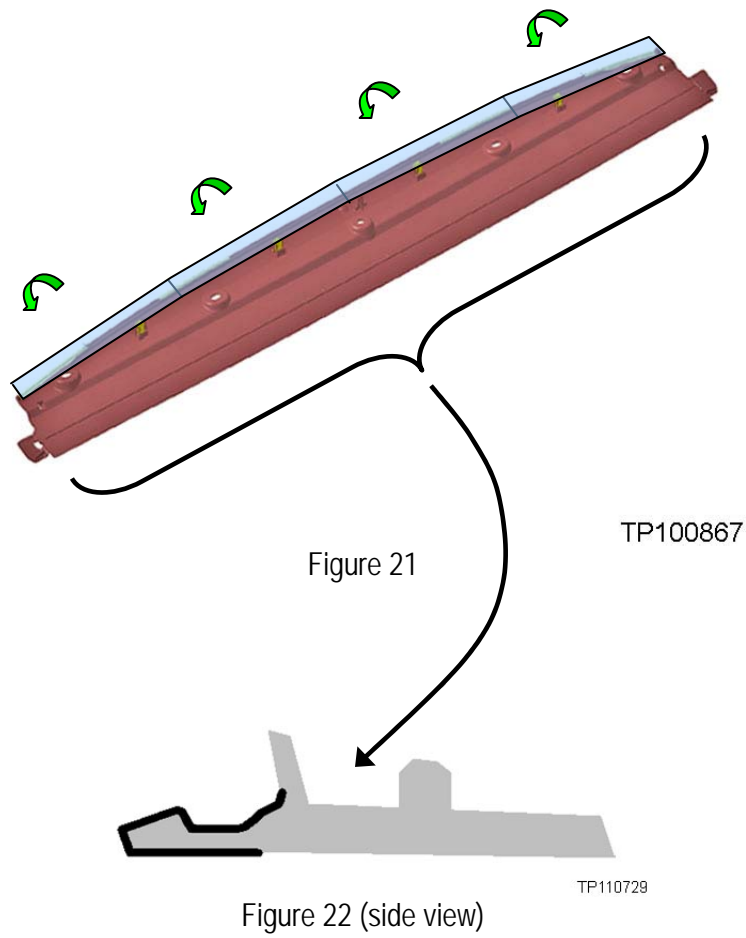
23. Remove any existing pieces of clear tape from the edge of the rear rib (under blue outline). See Figure 21.

24. Cut pieces from the tape roll, and then apply on the edge where outlined in blue and black (see Figure 21 and 22).

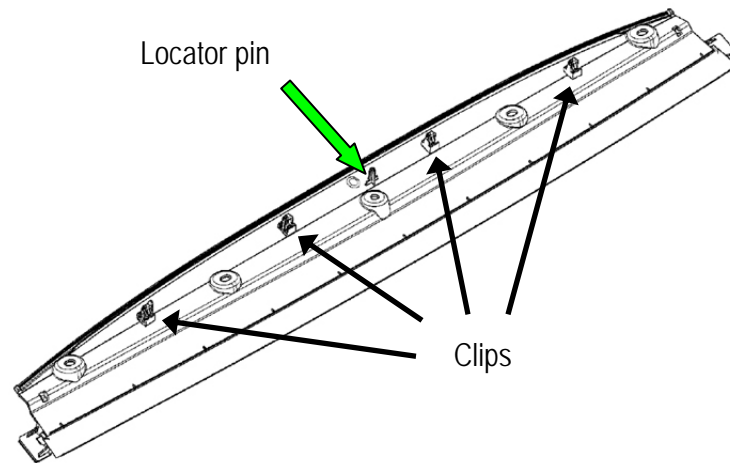
26. Cut four 10 mm x 50 mm pieces from the 1 mm sheet, and then apply one to each clip where shown in Figure 23 and 24.

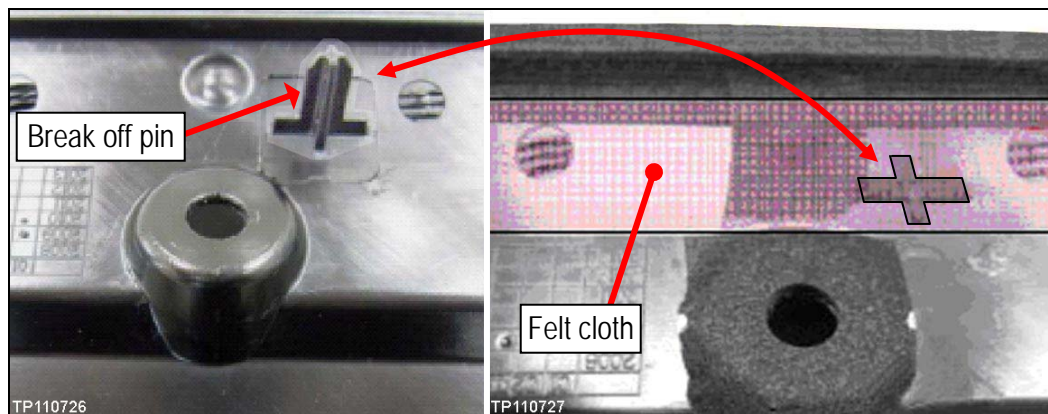
Figure 25

27. Break off flush the locator pin, and then apply a piece of felt cloth tape where broken off (see Figure 25).

- Felt cloth length (cut from the tape roll): 50 mm long

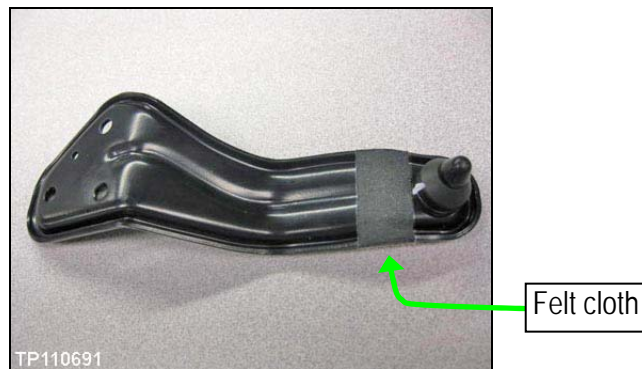
29. Cut two 20 mm x 80 mm pieces from the 2 mm sheet, and then apply one on each center roof panel pin where shown in Figure 27.

**NOTE:** The center roof panel pin in Figure 27 is shown as removed for easier viewing. Neither pin does not need to be removed to apply the felt cloth.

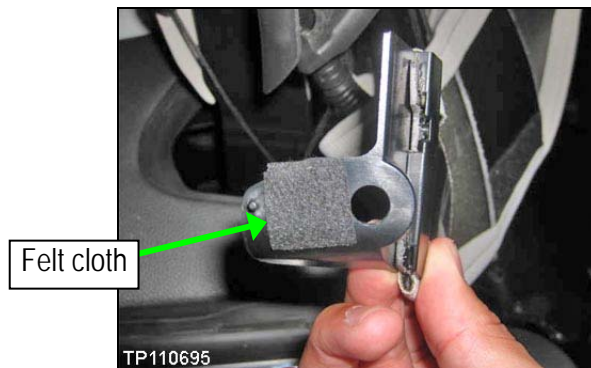
Figure 29

30. Cut two 20 mm x 20 mm pieces from the 2 mm sheet, and then apply one on each part on each side of the vehicle where shown in Figure 29.

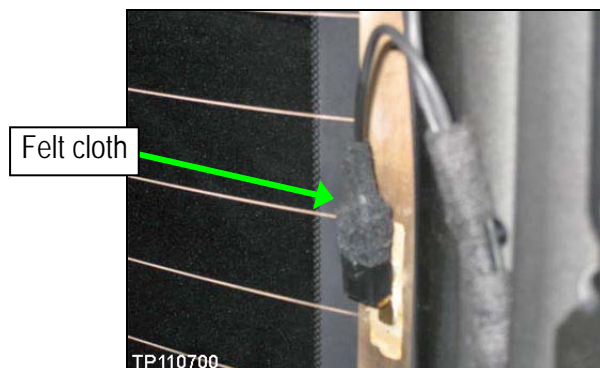
Figure 30

31. Cut two 50 mm pieces from the tape role, and then wrap one on each rear window defogger connector (see Figure 30).

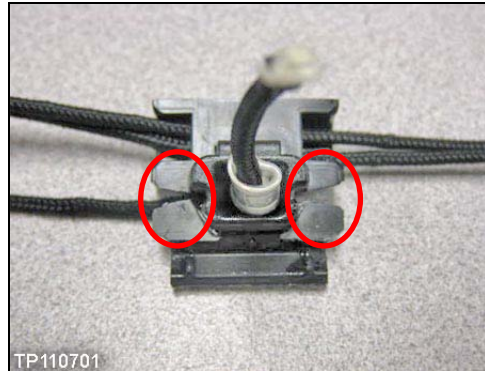
Figure 31

32. Apply "super glue" or equivalent adhesive to ALL tether cord clips where shown in Figure 31.

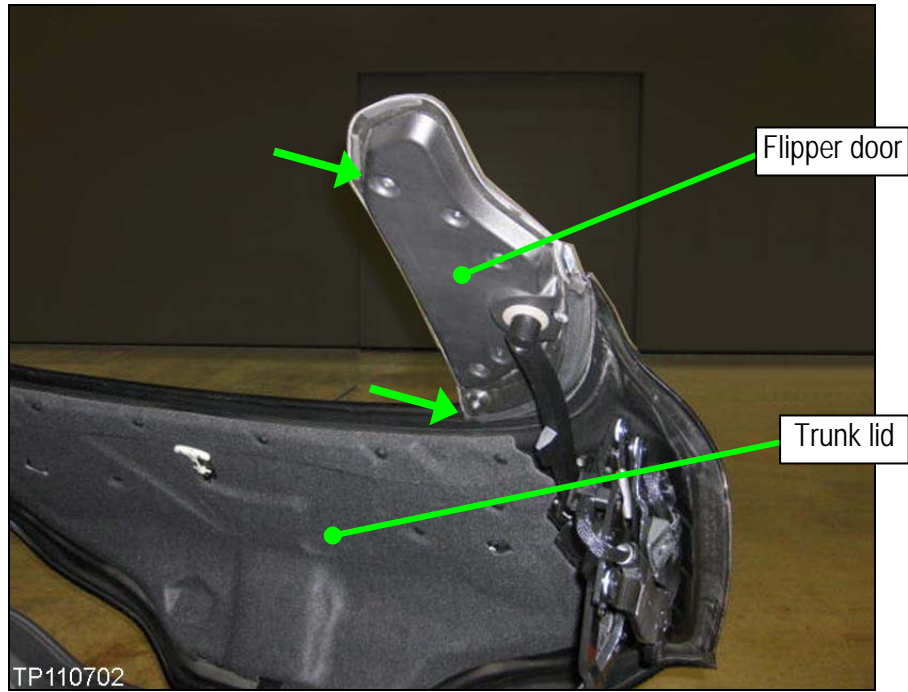
34. Next, fully close the hard top.
35. Proceed to open the hard top until the trunk lid is in the position shown in Figure 32.
36. If felt cloth is found under the flipper door where pointed in Figure 32, skip to Step 38.
  - If none found, go to the next step.

45. Close the trunk lid, and then start opening the hard top until the trunk is opened as shown in Figure 32 on page 17, and 46 below.

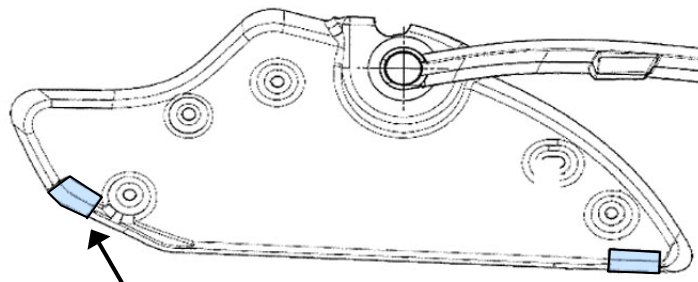
37. Cut six 20 mm x 30 mm pieces from the 3 mm sheet, and then apply under the flipper door as shown in Figure 33 and 34.

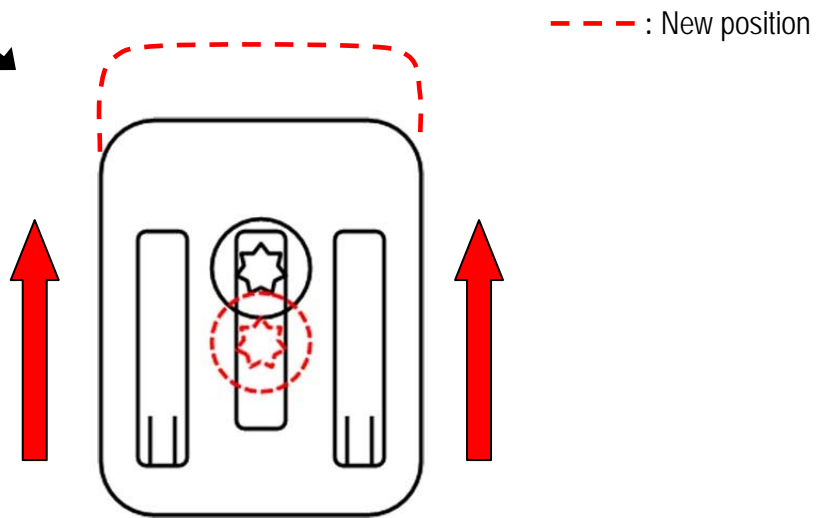
Figure 36

38. Next, adjust the side wedges on each side of the vehicle's trunk as shown in Figure 36.

- T40 Torx bolt torque: 23.5 - 27.5 N•m (2.4 - 2.8 kg-m, 17.3 - 20.3 ft lbs)

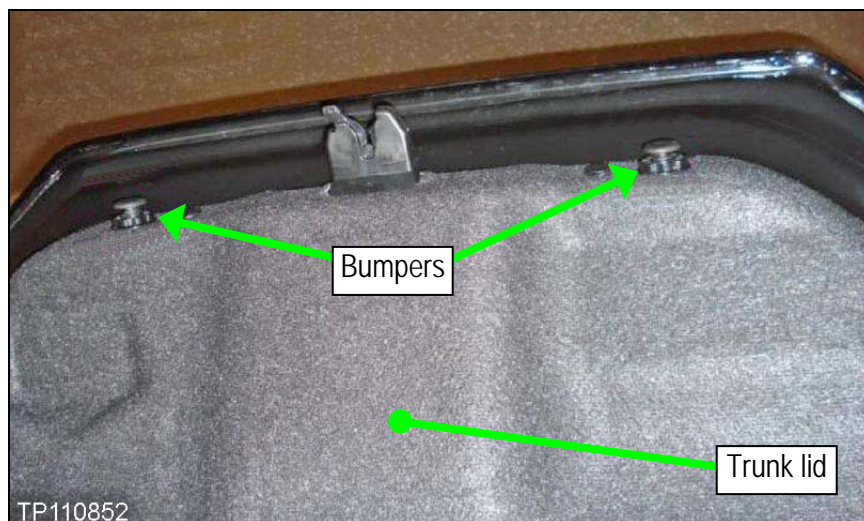
- a. Remove both bumpers, and then extend the rubbers all the way out (see Figure 37 and 38).
  - b. Turn the "flowers" until they bottom out under the rubbers (see Figure 39).
  - c. Reinstall both bumpers, and then carefully slowly close and latch the trunk lid.
  - d. Open the trunk lid, and then turn both "flowers" clockwise until they bottom out (see Figure 40).
- Make this adjustment with the bumpers still installed.
  - Make sure the rubbers do not move during this step.

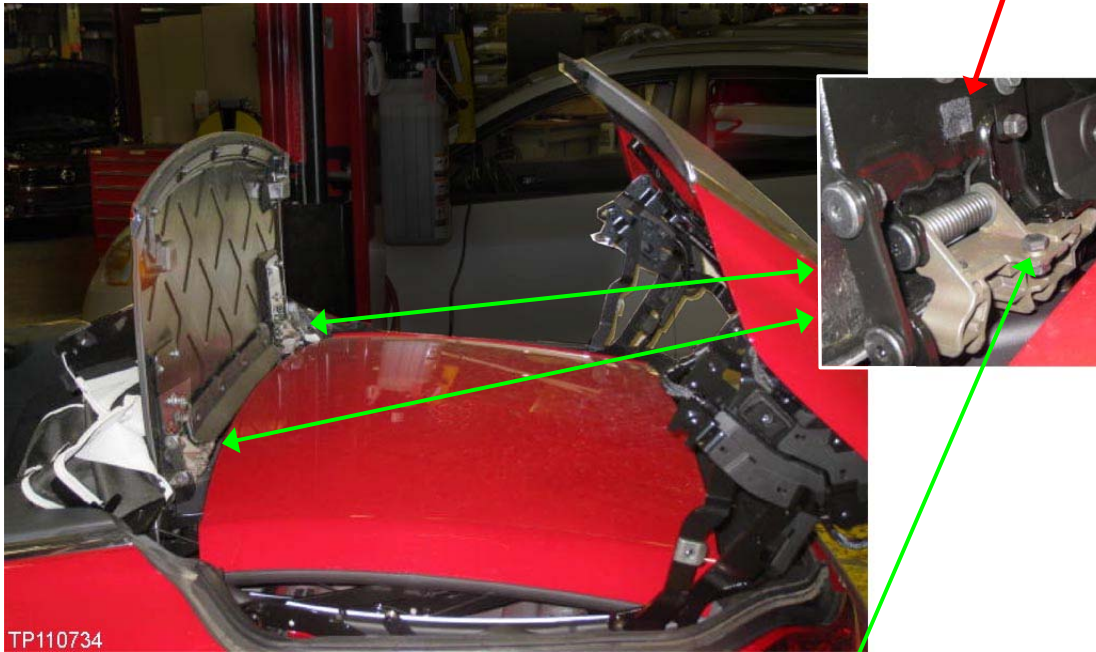
41. Next, close the trunk lid, open the hard top as shown in Figure 41, and then inspect for felt cloth.

- If felt cloth is found, go to the next step.
- If felt cloth is not found, cut two 15 mm x 15 mm pieces from the 3 mm sheet, and then apply on the parcel shelf finisher board where the adjusting bolts come in contact (one on each side). See Figure 41.

42. Locate the two adjusting bolts, and adjust the bolt heads to approximately 5.5 mm (0.20 inches). See Figure 41 and 42.

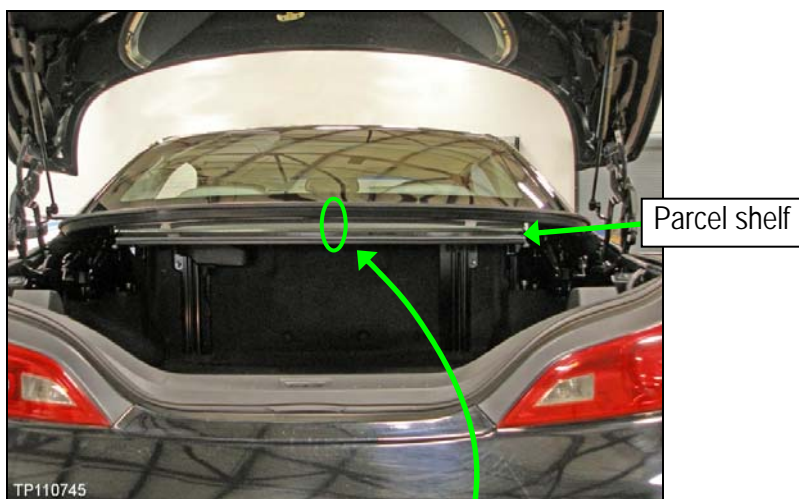
Figure 43

44. Measure the gap between the parcel shelf finisher board and rear roof lower garnish's sponge (it should be approximately 10 mm (0.40 inches)). See Figure 43, 44, and 45.

- If ok, go to the next step.
- If not, access the adjusting bolts and then readjust as needed.

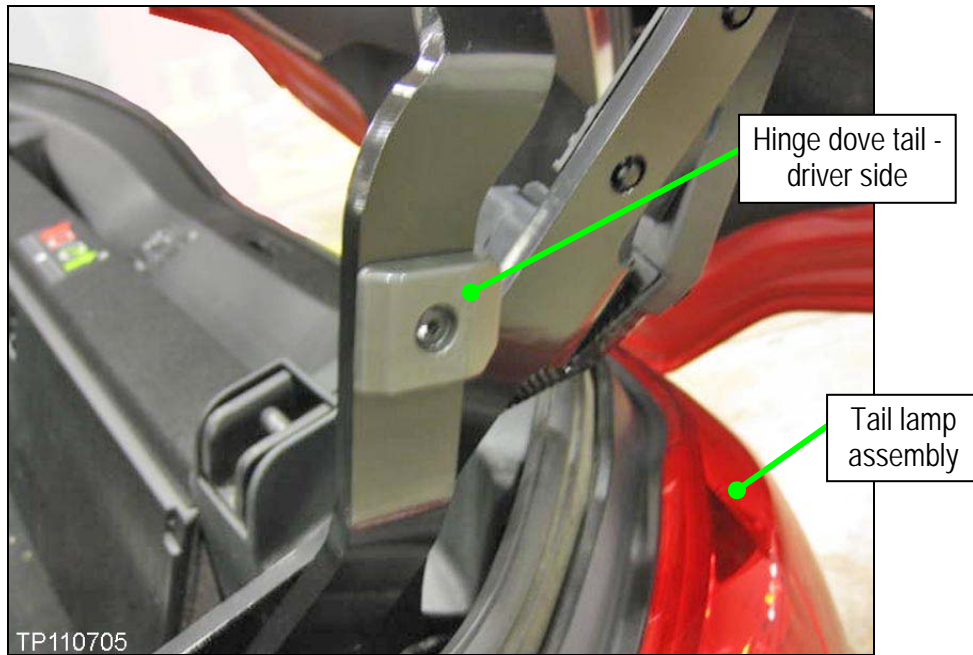
Figure 46

46. Inspect both driver and passenger side hinge dove tails (see Figure 46).

- If either one is found worn, replace both.
  - T20 Torx bolt torque: 3.5 - 4.5 N•m (0.36 - 0.46 kg-m, 31.0 - 39.8 in lbs)
