SERVICE BULLETIN

Classification: HA11-004	Reference: NTB11-048	Date: May 5, 2011
-----------------------------	-------------------------	----------------------

2004 – 2011 TITAN AND ARMADA DRIVER SIDE AIR MIX DOOR MOTOR REPLACEMENT

APPLIED VEHICLE: 2004 – 2011 Titan (A60)
2004 – 2011 Armada (TA60)

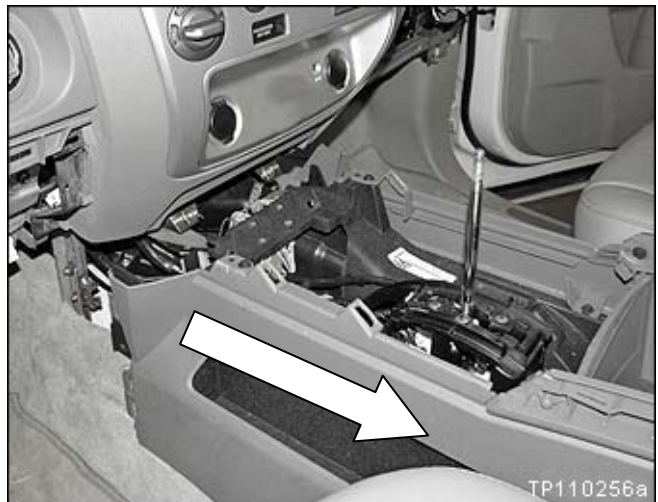
Figure 1

Tip 2. Complete removal of the center console is not needed.

- **Do not** remove the shift selector assembly.
- Remove all mounting screws for the center console and move/slide the console back about 3 inches.

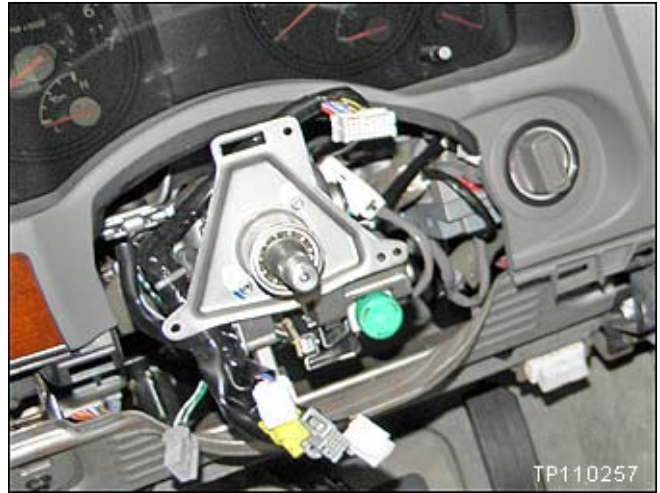
Figure 2

Tip 3. Removal of the steering column assembly is not needed.

- **Do not** remove the steering column mounting bolts.
- **Do not** remove the tilt motor and sensor.
- Remove steering wheel.
- Remove combination switch and spiral cable.

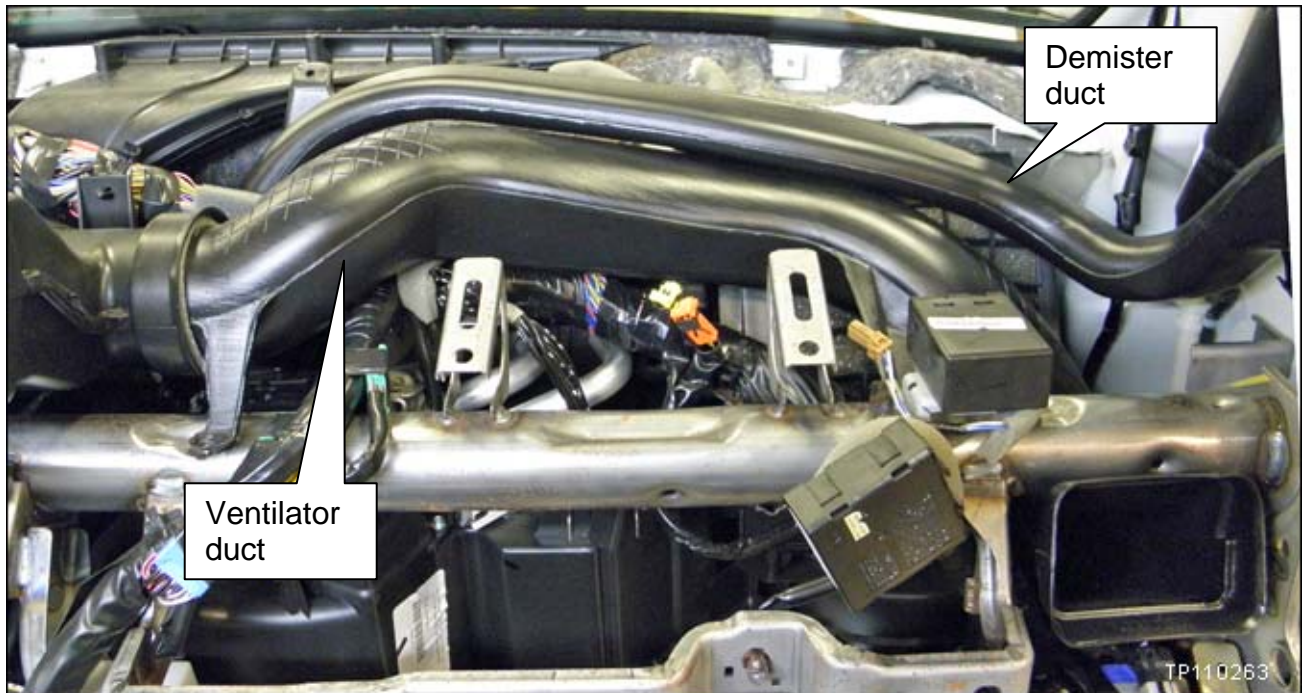
Figure 6

Tip 8. Remove passenger side (right side) demister duct and ventilator duct (see Figure 6).
