## CVT AIR DUCT PARTS INSTALLATION

## CLUTCH SHOE AND HOUSING INSTALLATION

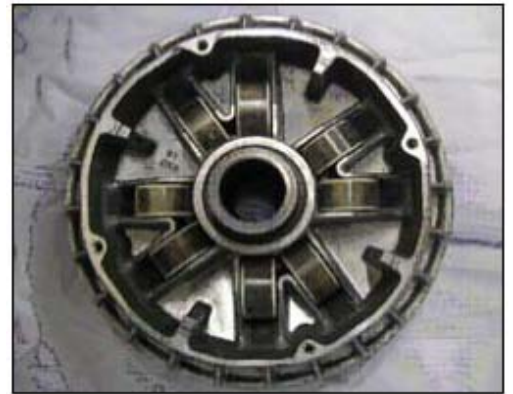
- Using compressed air, clean the inside of the drive pulley including the gaps between the fins.

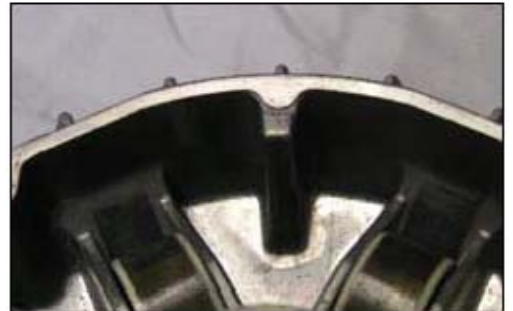
- Apply contact cleaner to a cloth and clean the sliding surfaces of the drive pulley.

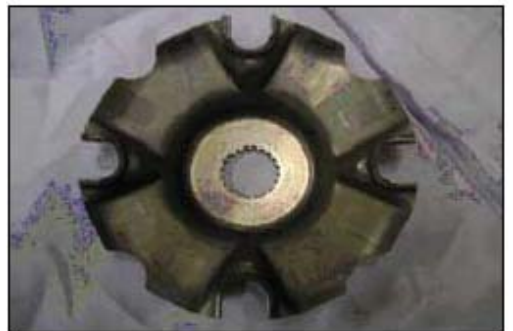
- Clean the plate using compressed air. If necessary clean with contact cleaner.

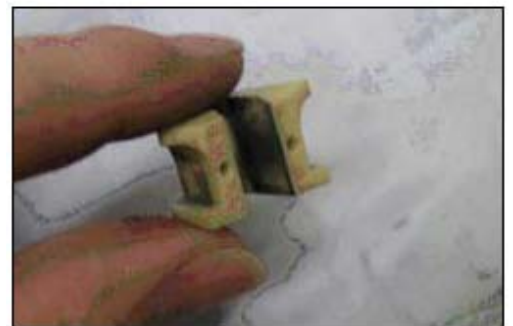
- Clean the dampers with compressed air. If necessary clean with contact cleaner.

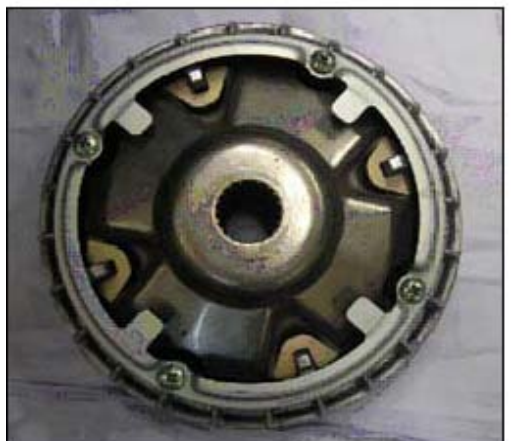
- Reassemble the removable drive assembly according to Service Manual procedure.

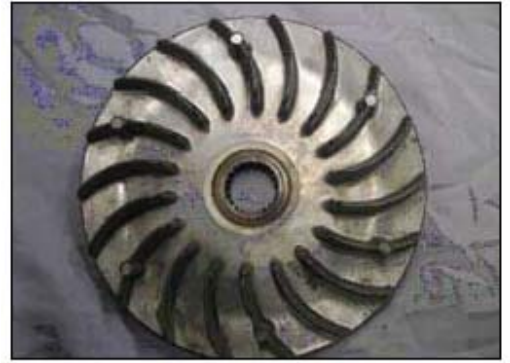
8. Clean the fixed drive pulley using compressed air.

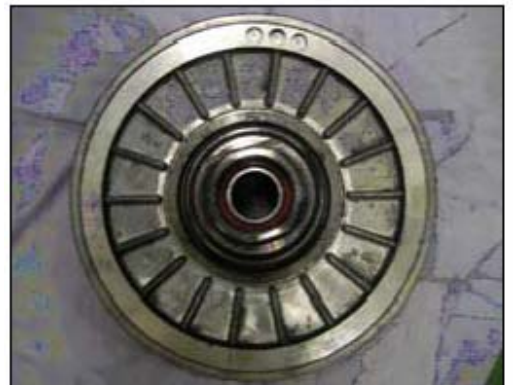
9. Clean the clutch side driven face pulley using compressed air.

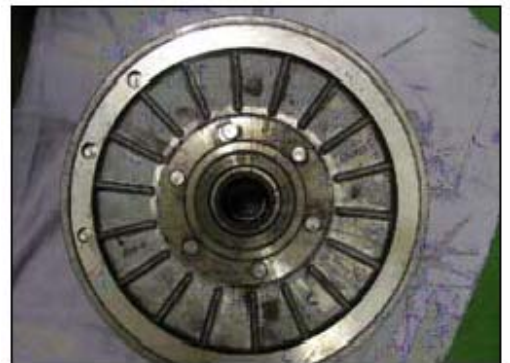
10. Clean the engine side driven face using compressed air.

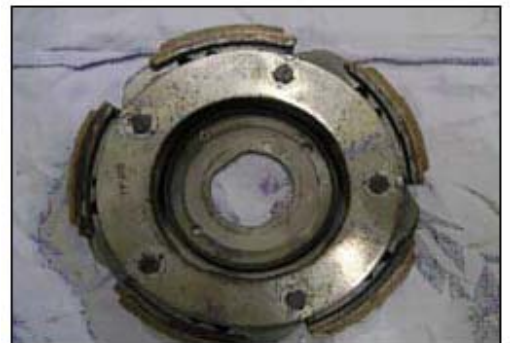
11. Clean the clutch shoe using compressed air. Ensure that the shoe friction material is completely clean.

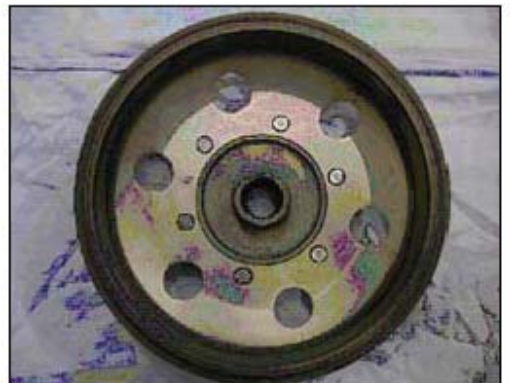
12. Clean the clutch housing with compressed air. If necessary, apply contact cleaner to a cloth and clean the clutch housing.

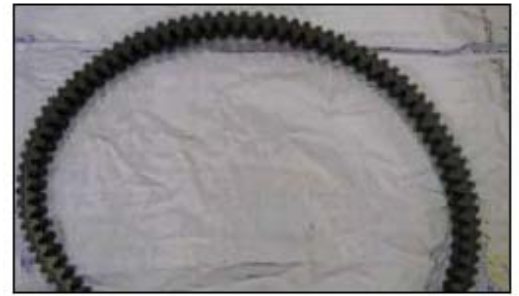
13. Clean all cogs on the belt with compressed air.

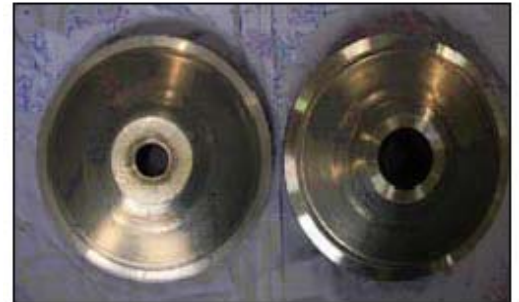
14. Apply contact cleaner to the cloth and clean the drive pulley face.

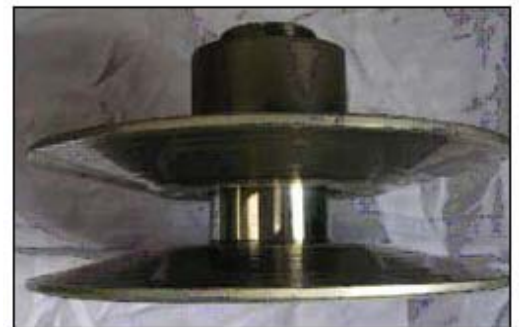
15. Apply contact cleaner to a cloth and clean the driven pulley faces.

Reassemble the CVT according to the procedure described in the 2007- AN400 Service Manual. Refer to section 5A of both the Service Manual and the K9 Supplement on Suzukinet.

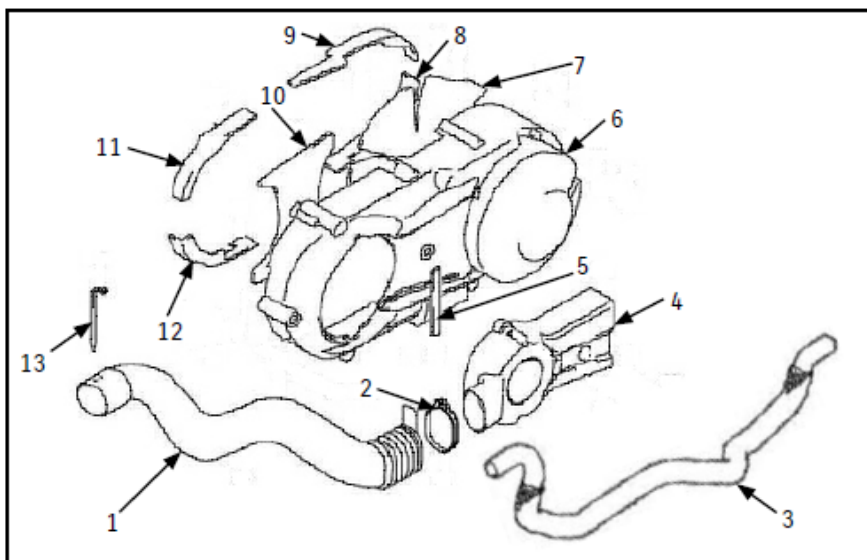
On a customer complaint basis only of clutch judder and/or shoe noise, even after cleaning the dust from the CVT chamber and filter, install one of each of the AN400AK9 type CVT Air Duct parts which are listed below. When installing these parts, follow the procedures described in the 2007- AN400 Service Manual. Refer to section 5A and the 2009 Supplement. If necessary, clean all CVT parts again according to this Service Bulletin.

CVT Air Duct Parts Installation	
Detailed Failure Information	Clutch judder/noise. Install CVT Air Duct Parts per Bulletin 09-06.
Labour Operation	GA9999
Hours	1.4
Causal Part No.	11383-05H40
Qty	1
Complaint Code	26
Defect Code	41
Replaced Parts	Part numbers you replaced

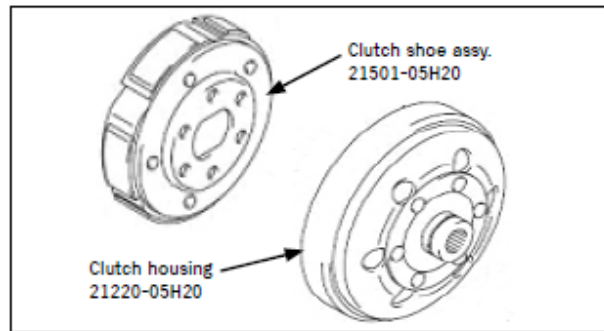
On a customer complaint basis only of clutch judder and/or shoe noise, even after cleaning the dust from the CVT chamber and installing the late type. Air Duct parts, install the AN400AK9 type Clutch Housing (21220-05H20) and Clutch Shoe Assy. (21501-05H20). When installing these parts, follow the procedures Described in the 2007~ AN400 Service Manual. Refer to section 5A. If necessary, clean all CVT parts again according to this Service Bulletin.

Clutch Shoe & Housing Installation	
Detailed Failure Information	Clutch judder/noise. Install Clutch Shoe and Housing per Bulletin 09-06.
Labour Operation	GA9999
Hours	1.0
Causal Part No.	21220-05H20
Qty	1
Complaint Code	26
Defect Code	41
Replaced Parts	21501-05H20
Qty	1
