# Wheel end maintenance

Complete guide to trouble-free handling of bearings, seals, hubcaps, lubricants and more.

# A systems approach to total wheel-end maintenance

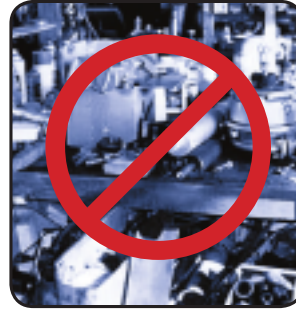
Personal lack of cleanliness in handling components allows particles and dirt to cause bearing and seal damage.

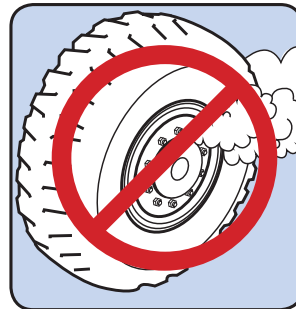
Lack of understanding the important role of lubricants can lead to future problems.

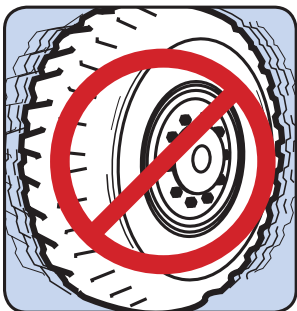
Lack of knowledge about critical end-play adjustment can cause premature or even catastrophic wheel end failure.

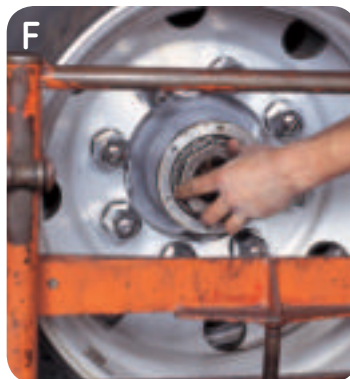
**G** Spindle nut torque adjustment should follow the manufacturer's specification on TMC RP618. End-play adjustment should be verified using a portable dial indicator.

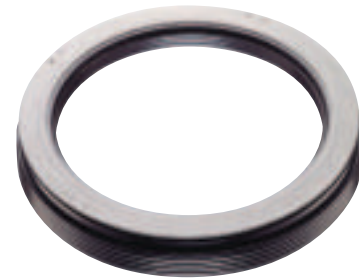
### Scotseal® *Longlife*

Building upon the success of the original Scotseal design, SKF engineers had a great start in their development of a new extended life seal. Computer aided design (CAD) of lip geometry and the addition of an axial dirt excluder lip was combined with a newly formulated material to produce

Scotseal® Longlife—a premium performance seal with the characteristics required by many of today's demanding heavy duty environments.

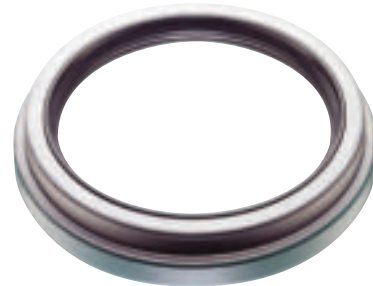
### Scotseal® *Classic*

The original Self Contained Oil Type Seal, Scotseal® Classic became the trucking industry standard—and the best value for more than 30 years. With literally trillions of road miles to its credit, Scotseal Classic has proven to be a solid choice for dependable, long lasting service. Time

and time again, field studies show that when properly installed, using SKF tools and procedures, Scotseal Classic is a reliable performer for meeting the sealing requirements between brake maintenance intervals.

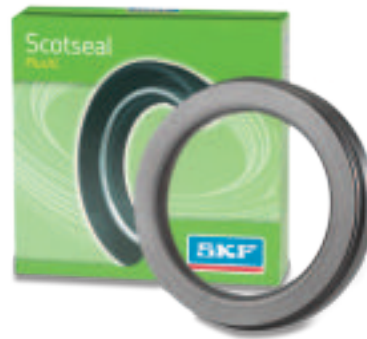
## SKF Scotseal® PlusXL

- The most advanced generation Scotseal, standard in PreSet hub assemblies since 2002
- Hydrogenated Nitrile Butadiene Rubber (HNBR) construction is ideal for frequent braking applications
- Heat resistance up to 300° F; compatible with synthetic lubricants
- Excellent exclusion properties, even in harsh conditions
- Hand-installable design includes a fat footprint ensuring stability on the shaft

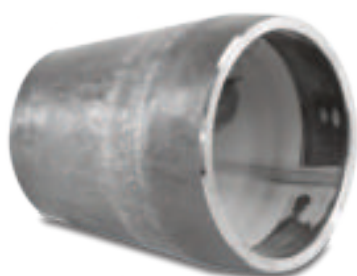
### Precision machined PreSet spacer

- Manufactured of high-strength alloy to precise tolerances
- Eliminates need for manual end play adjustment
- Proprietary machined bearing spacer along with the SKF specifically toleranced bearings provides the most reliable bearing end-play setting, optimizing wheel end life
- Eliminates the need to verify adjustment with a dial indicator

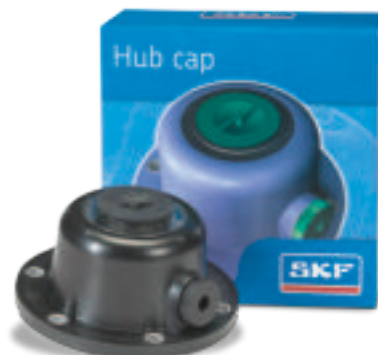
### SKF TF hubcap

- Lightweight DuPont Zytel® material is stronger than aluminum, resisting impact damage, chemicals, UV and ozone
- Embedded, solid aluminum ring distributes an even, leak-proof load against the hub
- Cloud-free window is fusion-bonded to body – no screws to shake loose and no leaking
- Molded pressure ridge on flange bites into sealing gasket to ensure leak-proof fit

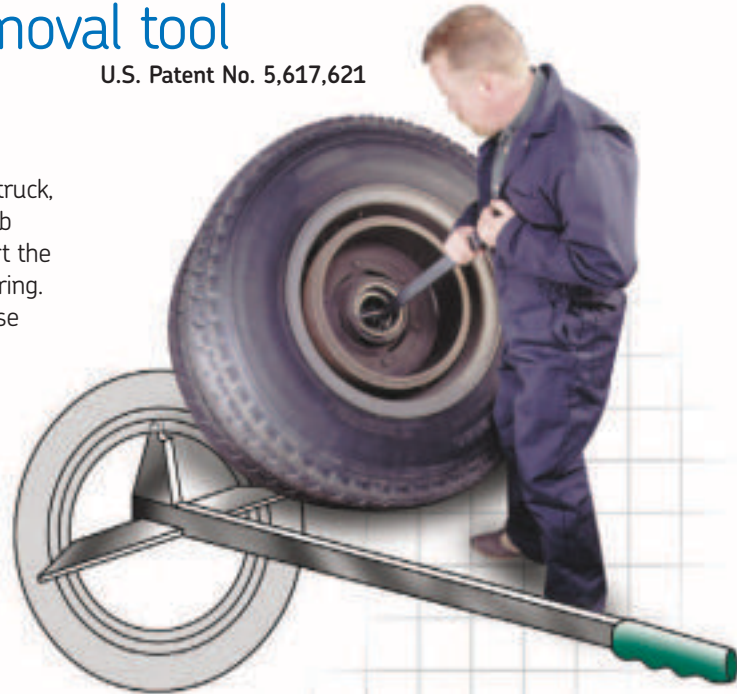
The SKF SRT-1 Seal Removal Tool is recommended for removal of most tractor, truck, dolly or trailer wheel seals. With the wheel hub assembly removed from the axle, simply insert the hook tip of the tool between the seal and bearing. The unique design of the tool allows you to use leverage to easily and safely remove the seal, without damaging the spindle.

Simple design, rugged construction and ergonomic features increase your productivity and eliminate costly bearing damage.

- Saves time — no more laborious prying against bearings or driving out seals.
- Saves bearings — tool grabs seal only and bearings go undamaged.
- Easy to use — wedges and long handle provide exceptional leverage.
- Rubber grip for security in handling.
- Heavy duty construction for long life and dependability.
- Works with steer, drive, and trailer wheel seals.
- Seal is removed intact allowing for proper seal inspection, and failure analysis if required.

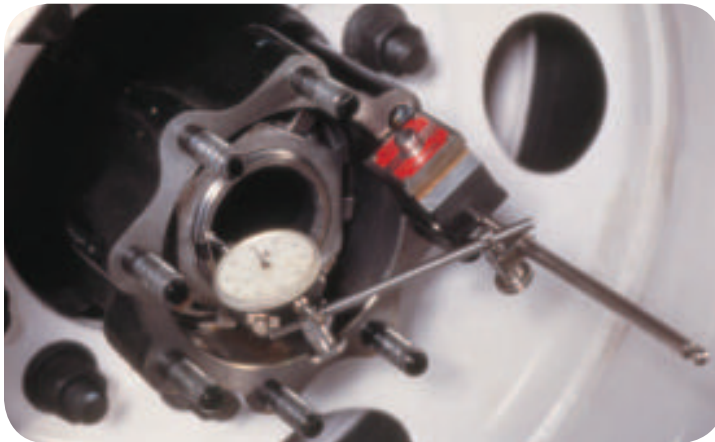
Wheel bearing end play is the free movement of the wheel assembly along the spindle axis. It is recommended, for verification purposes, that wheel bearing end play be measured with a dial indicator. (Example in photo below.)

- Step 5** Grasp the wheel assembly at the 3 o'clock and 9 o'clock positions, while oscillating it to seat the bearings. Read bearing end play as the total indicator movement.

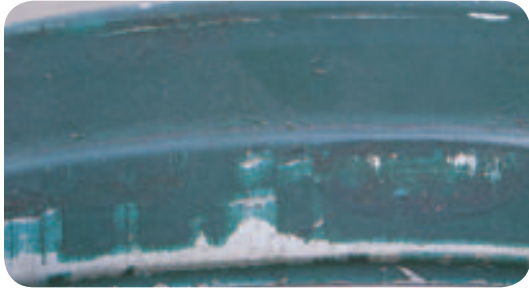
### External inspection – outer diameter

**Normal scuffing:** The surface will show some scraped areas, that's normal. But signs of nicks, scratches metal particles, or any foreign material are warning flags that something else is amiss. Make sure the hub bore is smooth and free of burrs or nicks.

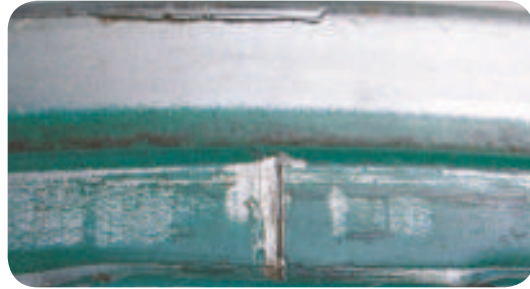
**O.D. radial grooves:** If the Bore-Tite® film has been scored all the way across the width of the seal, you should inspect the hub for burrs or damage. Before installation, the hub should be inspected and cleaned with emery cloth or a fine file.

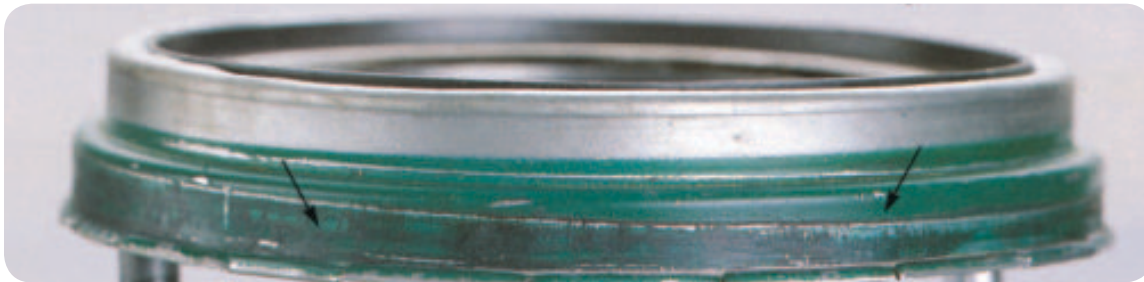
**Lines in the Bore-Tite:** If you see lines around the seal, several things could have happened. If the lines are etched to the metal, the seal could have spun as a result of being the wrong application or, more likely, it was installed crooked or cocked.

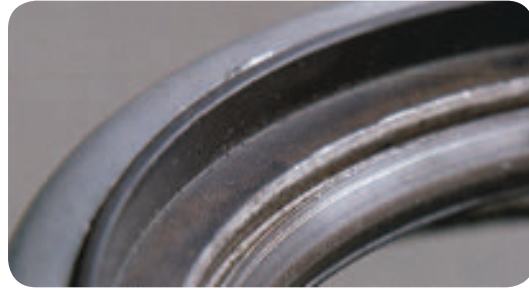
**Installed backwards:** The only way that the packing can be worn shiny, as shown here, is by rubbing against the bearing race. The only way that can happen is by putting the seal in backwards.

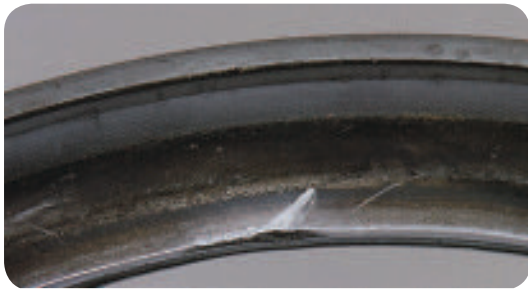
**Severely damaged I.D.:** Scratches or dents in the I.D. are signs that the seal has struck the spindle or axle tube during installation. Rushing the installation and not lining up the wheel dolly is the usual suspect. Or a rough shop floor may be the problem.

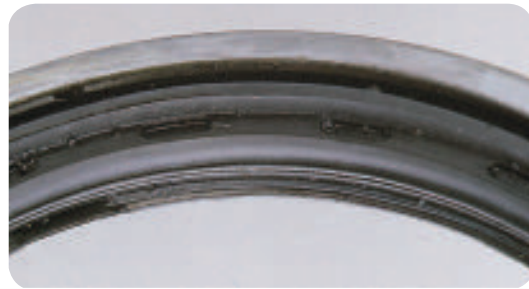
**Distorted packing:** One way to damage the packing of a Scotseal® is to try to install it over a wear ring. The wear ring will deform the inner surface and ruin the seal. Any previously installed wear ring must be removed prior to installing a Scotseal.

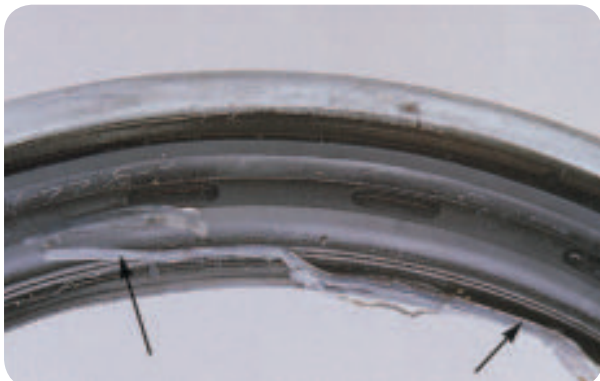
**Foreign matter on I.D.:** Occasionally, you will come across a seal with a shaft leak that has a mysterious, tacky substance on it. Most likely someone added a silicone sealant to “improve” the seal. Old habits die hard.

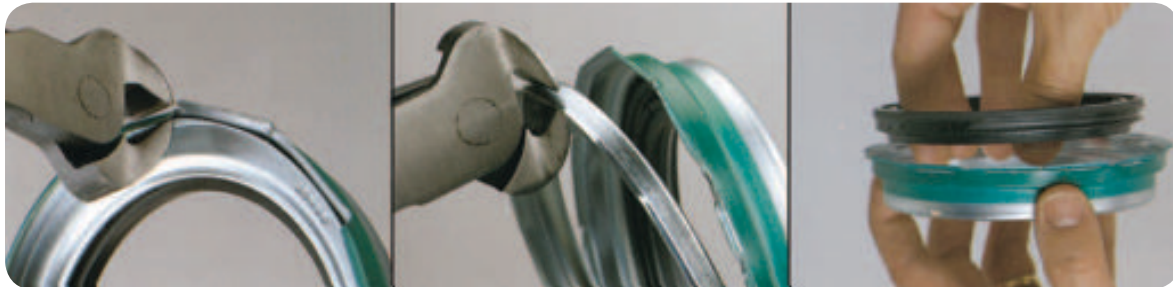
#### Opening a Scotseal

Use pliers or end cutters and work your way all the way around the seal, straightening the outer cup flange.

Remove the inner cup. Be sure to wear gloves or use a shop rag to protect your hands, the open flange edges are sharp.

Remove the packing without disturbing the lip surfaces, as shown.

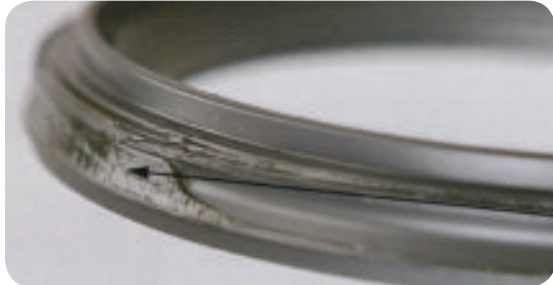
#### Internal inspection – the major clues

Factory  
Applied  
Grease

**Lip grease:** Every **Scotseal®** comes with grease between the primary and dirt lip. If it's not there, it's very likely oil has washed it away. Suspects are excessive end-play, a cocked seal or improper ventilation of the wheel end (dirt, corrosion or paint-plugged vent).

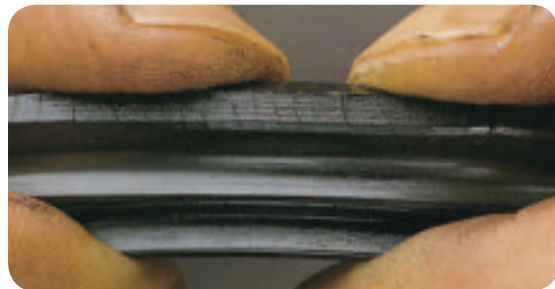
**Brittle primary seal lip:** After cleaning the entire seal, use your fingers to curl the primary seal lip back. Run your finger completely around the circumference. The oil lip should be smooth and pliable. If not, the seal has overheated; lack of lubrication or overtightened bearing adjustment could be the cause. Be sure to inspect bearings carefully.

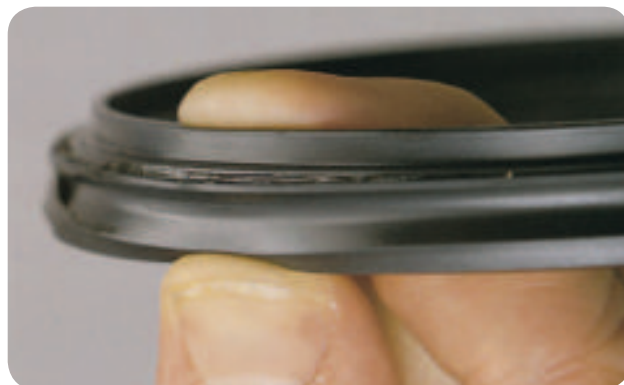
**Broken dirt lip:** Using the same technique, check the dirt lip. If it's dry and brittle, most likely it's been baked. It will probably split away from the seal at some point around the circumference.

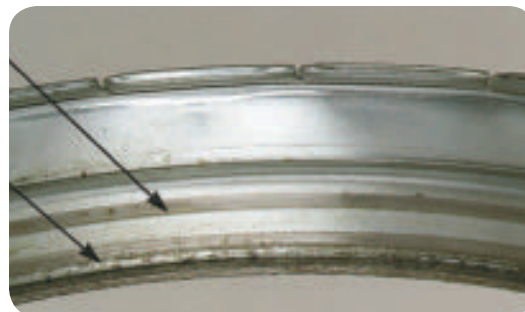
**Wide, wide:** If both lines are wider than pencil lines, it means that the primary lip and dirt lip have been allowed to move in and out on the outer cup. The cause of this is excessive endplay, indicating that the bearing endplay is greater than the recommended range of .001" and .005".

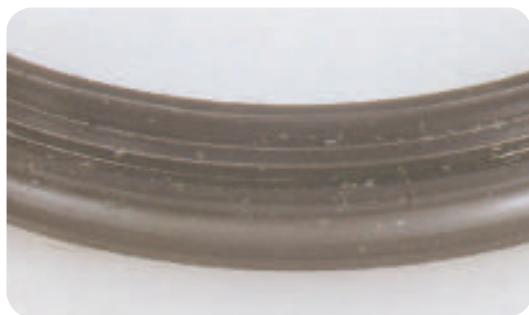
**Metal shavings in lip area:** Before cleaning the seal, inspect the seal area for traces of metal particles. A magnet can attract metal particles. Sharp edges of metal may have cut the seal primary lip causing the seal to leak.

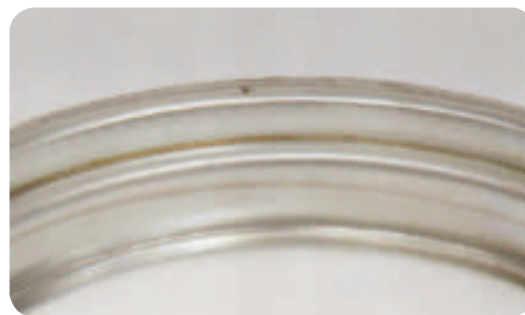
**Cocked seal—inner markings:** Holding the outer cup just below eye level and flat, like a bowl, rotate your wrist through 360°. If the seal has run cocked, the two lines will be parallel to each other, but they appear to move closer and then farther from the outer cup flange.

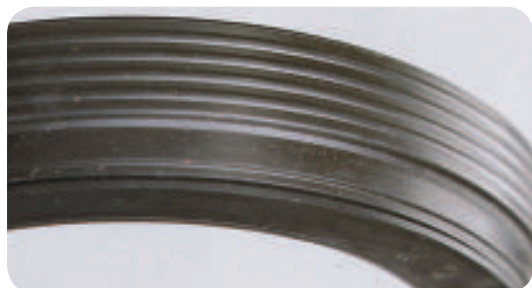
### External inspection – checking the beads

**Normal exterior:** The tough nitrile covering on the **Scotseal® PlusXL** doesn't supply clues as readily as Bore-Tite does. But it can still reveal problems and lead to corrective measures. There should be lubrication in each of the O.D., I.D. beads.

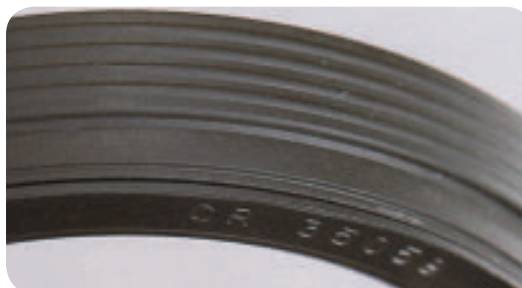
**Dry exterior:** If, in good illumination, you cannot see any residual lubrication between the beads of the outer sleeve, the seal may have been installed dry. A **Scotseal® PlusXL** does not need special tools, but it does need lubrication for proper installation.

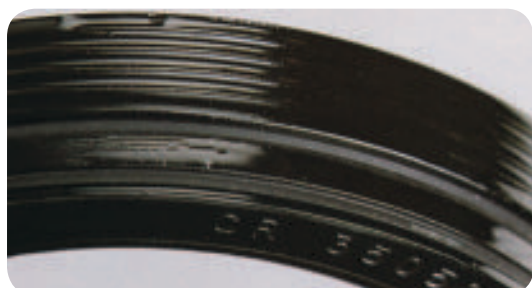
**Damaged O.D. beads:** If the external ridges appear damaged, most likely someone has tried to force the seal in place without proper lubrication. Burrs or dirt in the bore can also cause problems, but they're not as visible with the thick nitrile rubber protection.

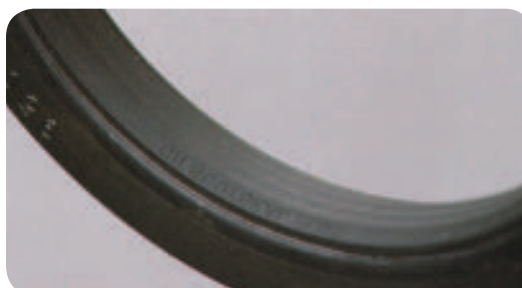
**Worn I.D. beads:** A worn I.D. indicates the seal has been slipping on the spindle. Look for three main causes: a cocked seal, a bent seal section, or poor spindle preparation in changing from another seal to the **Scotseal® PlusXL**.

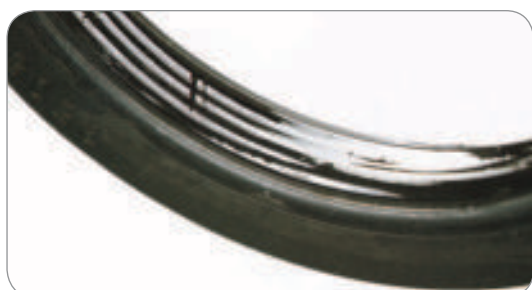
**Damaged I.D. beads:** Cuts or scarring in the I.D. is caused by jamming the seal into the spindle or axle tube. Misaligning the wheel dolly is usually the result of haste, however the work area should be checked to make sure the floor is smooth and free of clutter.

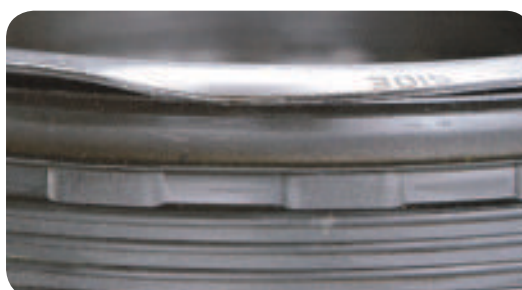
**Dented, scarred sleeve assembly:** A dimpled or dented surface indicates damage caused by a problem during installation. Lack of lubrication would be a prime suspect, but a poorly prepared hub or the use of hard-faced tools or seal driver could be the culprit.

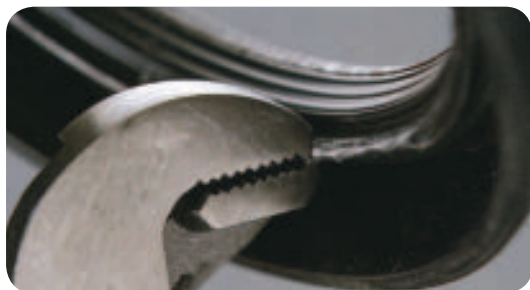
Use pliers to straighten the flange on the sleeve section. Be sure to wear gloves or use a shop rag to protect your hands. The opened flange is extremely sharp.

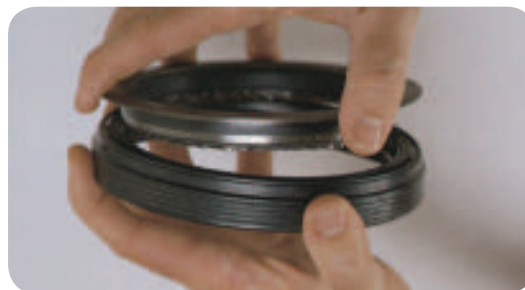
Pull the two components apart. Then set the sleeve assembly aside (the top component shown above). Place it carefully where it is out of the way, but won't be disturbed.

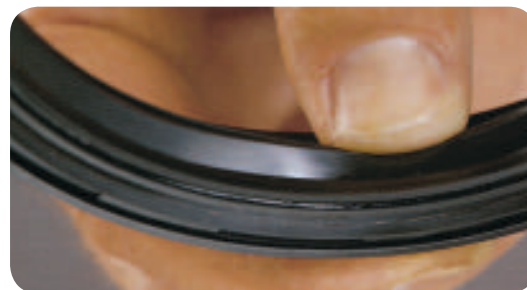
**Normal lip flexibility:** Check the primary sealing lip and dirt lips by pressing downward on them with your thumbs, sliding them around the entire circumference. The rubber should remain soft and flexible in normal use.

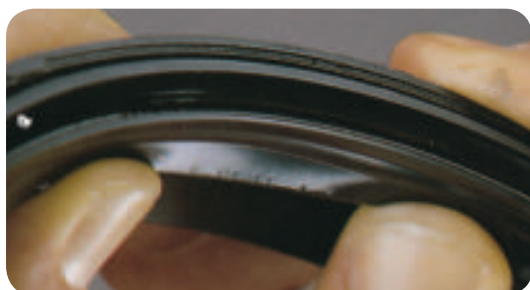
**Cracked lips:** If, when you check the primary and dirt lips the nitrile feels rough and dry, it has probably been subjected to excessive heat. Loss of lubrication and overtightened bearing adjustment are the prime suspects.

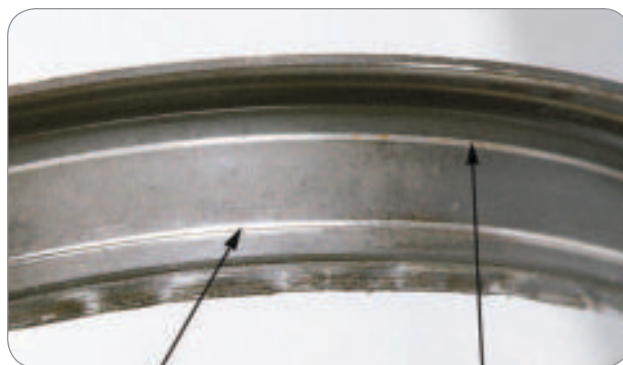
**Good primary lip pattern:** You should see two parallel lines. The primary lip line is slightly wider than the radial lip marking, because it's a SKF Waveseal® design.

Primary  
lip wear  
pattern

Radial  
dirt lip wear  
pattern

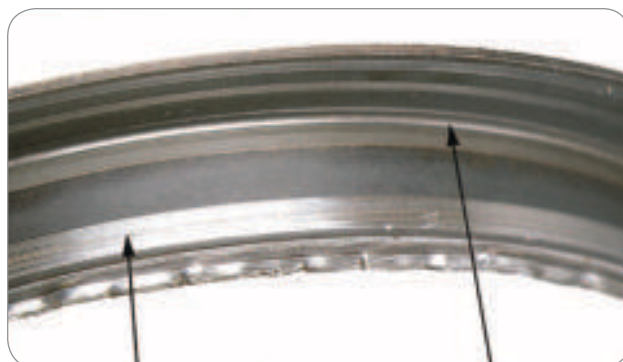
**Wide, thin:** If the primary seal lip line (bottom) is extra wide, while the radial dirt lip line (top) is light, there is excessive pressure on the primary lip. For steer and trailer axles that can be a plugged vent, on drive axles the tube vent may be locked.

Primary  
lip wear  
pattern

Radial  
dirt lip wear  
pattern

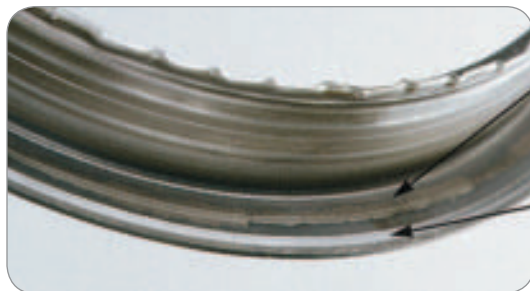
### Internal inspection – Axial dirt lip and bumper lip wear patterns

Axial  
Dirt Lip  
Pattern

Bumper  
Lip Wear  
Pattern

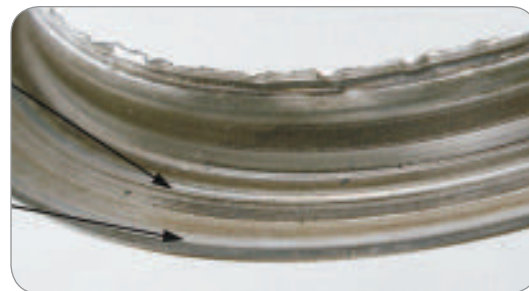
**Wide, shiny:** If both lines are wide or polished clean, then you should suspect that the seal has been compressed. This will happen if the I.D. of the seal isn't lubricated before installation, if the sleeve wasn't sealed fully on the spindle, or if the bearing adjustment is too tight.

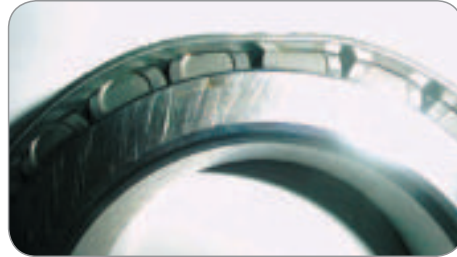
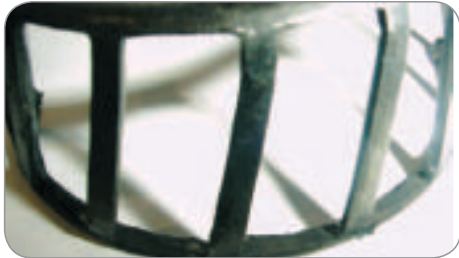
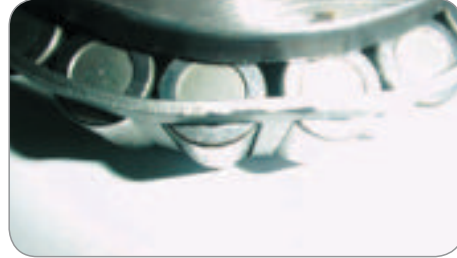
The **bearing cage** is made of either pressed steel or polymer and is therefore subject to various forms of damage.

These cages are deformed due to rough handling (dropping on the floor, being thrown in a box with other hard components, etc.) or poor installation with shock loads caused by hammering during removal or installation.

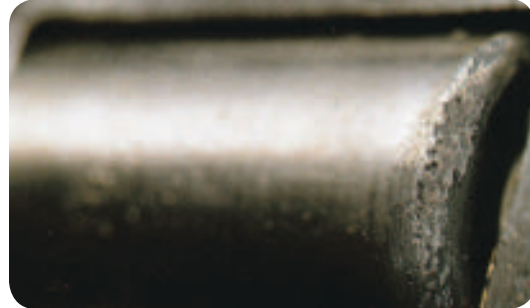
Large end of the roller shows spalling, the result of insufficient lubrication and/or excessive preload.

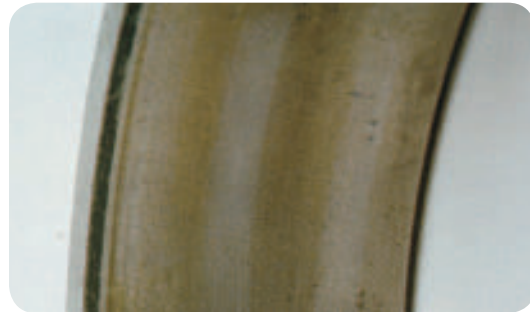
Pitting of the race, as a result of debris in the lube causing surface deformation.

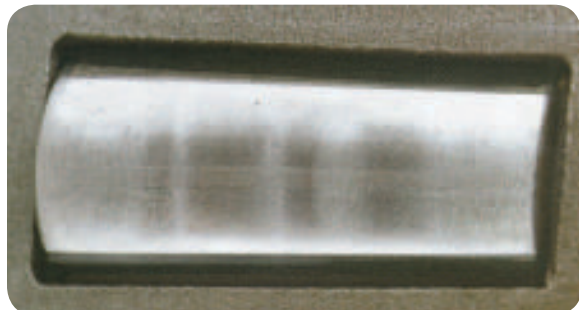
Uneven wear on the roller, the result of improper installation.

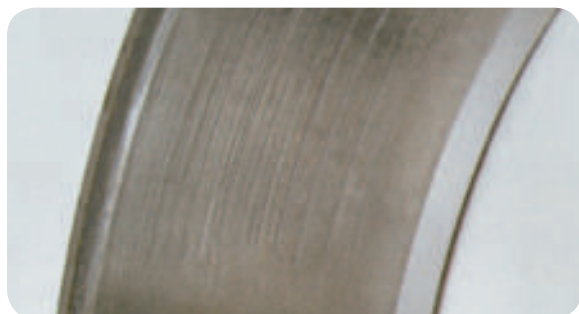
Circular wear in the race, the result of hard particle contamination in the lube.

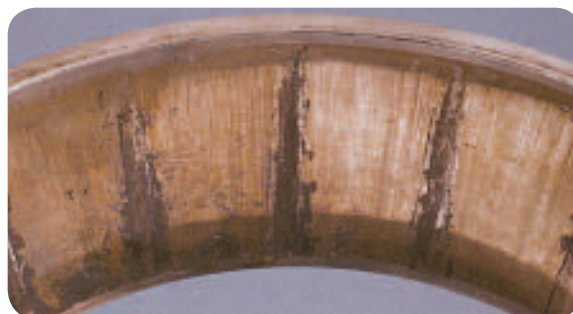
Vertical etching on the race, the result of moisture contamination within the lube.

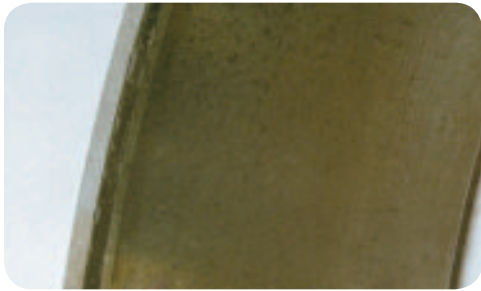
Peeling, the tearing away of metal from the race, the result of the breakdown of lubrication.

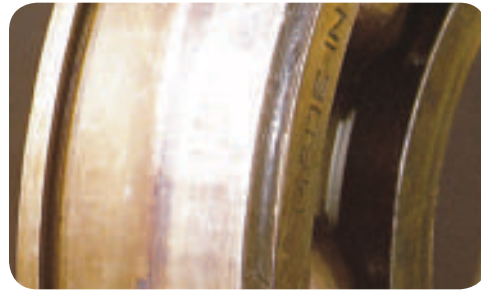
Discoloration indicates high levels of heat, the result of improper lubrication or improper bearing adjustment.

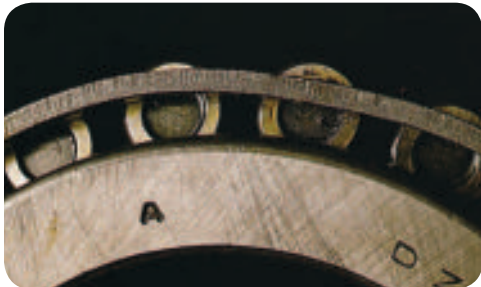
Deformation of the cage, the result of improper installation or mishandling prior to installation.

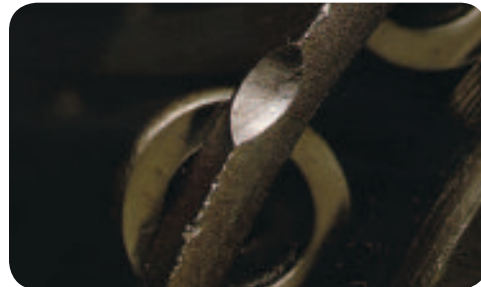
Cage damage, the result of abuse prior to or during installation.

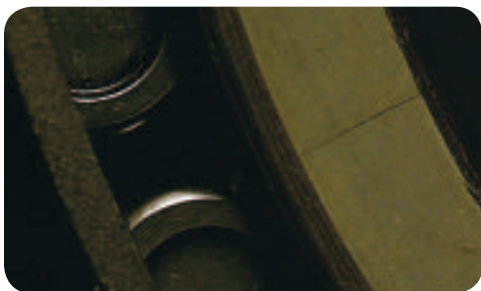
Cracked cone, the result of misapplication or cocking the cone at installation.

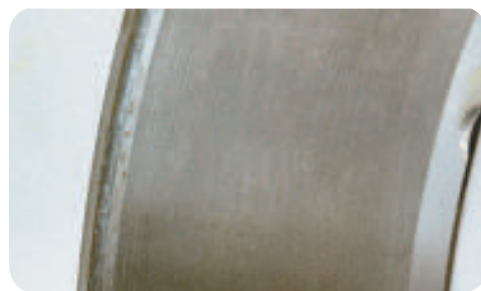
Damage to the cup front face, the result of installation damage through use of a hardened driver.

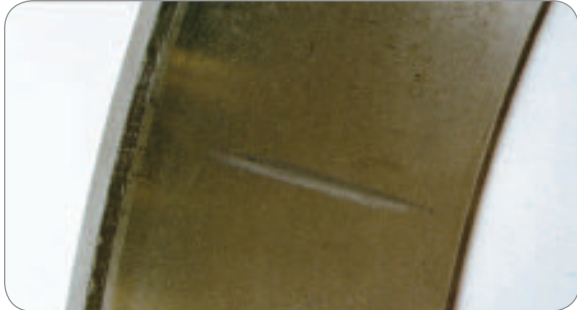
Brinelling, the result of severe impact to the bearing, causing one or more of the roller bodies to deform the surface of the race.

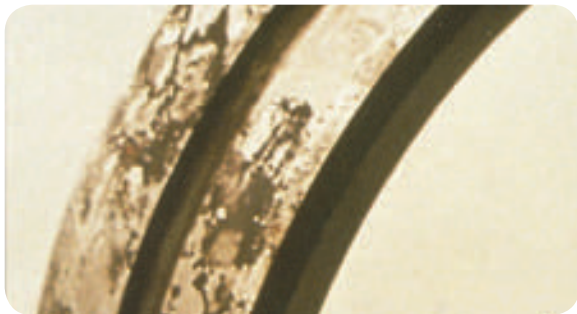
Fretting corrosion of the outer surface is often the result of a worn hub or spindle.

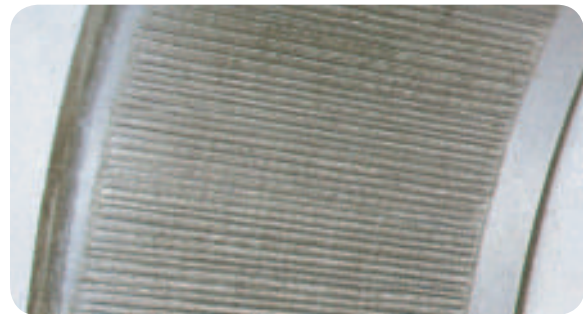
Light pitting can be caused by electrical arcing. The probable cause is electrical welding grounded through the shaft.

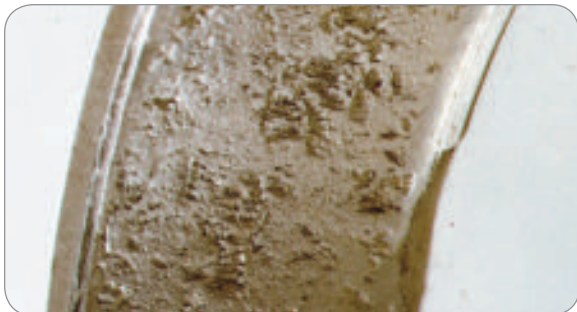
Spalling, the wearing away of metal from the bearing surface, the result of contamination, brinelling, improper installation, improper lubrication, or the normal end of bearing life.

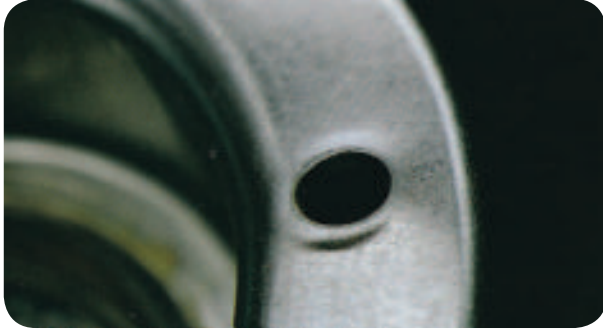
**Distorted bolt hole:** Bolt hole, or flange distortion, may be the result of excessive bolt torque during installation. The use of an impact wrench may damage the flange at the bolt hole area during assembly.

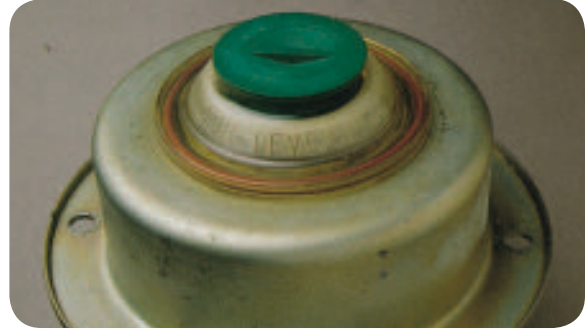
**Milky window:** The view window in the hub cap will become nearly opaque white when subject to heat. The heat comes from inside and spells trouble. You'll want to pull the wheel and check the bearing adjustment, check for low lube or a change to an incompatible lubricant.

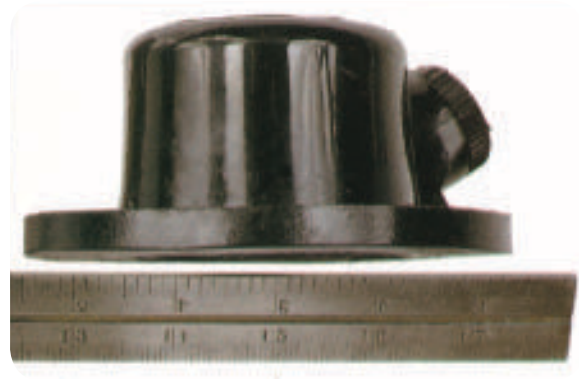
**Warped Flange:** Place hubcap on a flat surface. When flange is distorted it will not hold contact all the way around. Proper torque specifications may not have been followed.
