Foothills Antique Tractor and Engine Club

TECH TIPS

POLARIZING YOUR GENERATOR

Appendix 14, page 1 of 6
Engine Lubrication System

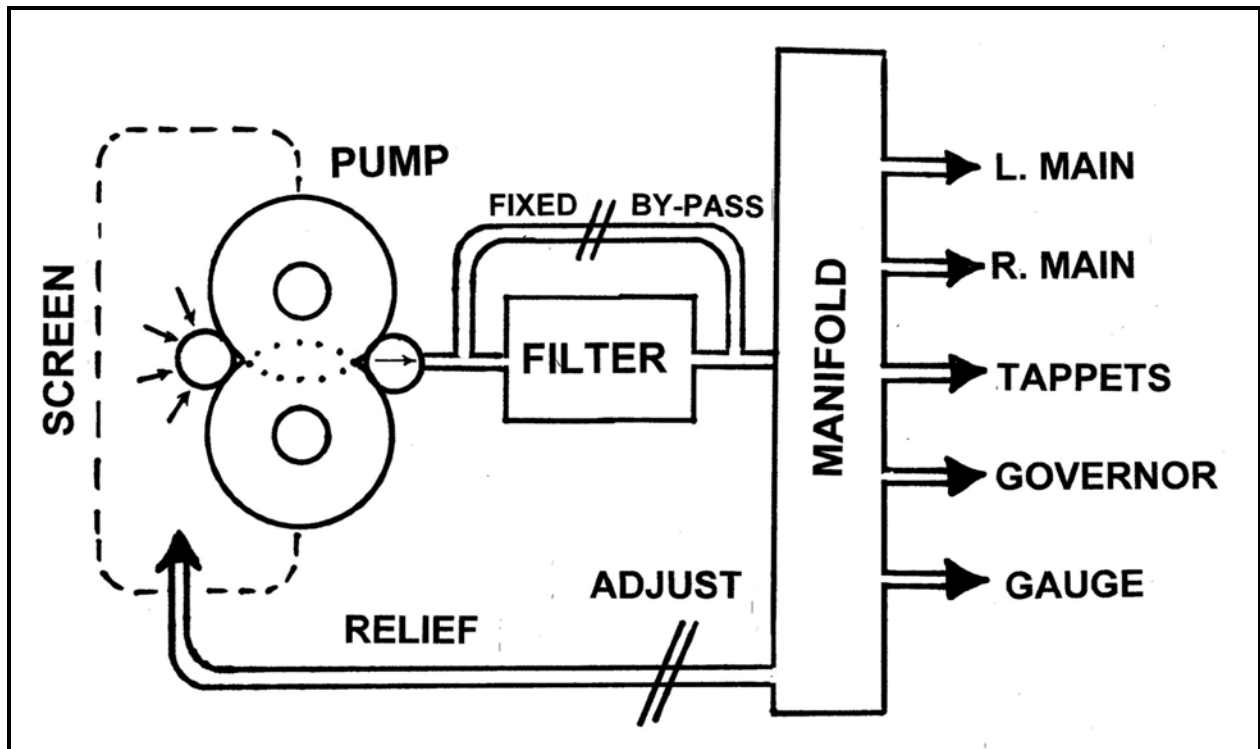
Figure 14-1, Schematic Diagram of Engine Oiling

John Deere two-cylinder tractors will employ a system similar to the schematic. The pump consists of a gear pair that simply and positively "grabs oil" in the gear teeth traveling around the perimeter of the gears and forces that oil through the filter and on to various destinations. Above we have the Model "H" schematic, others will be similar in principle, differing in design (leaf springs, spring-loaded plungers, etc.). Oil pressure is user-adjustable, the adjustment method varies among models, but the concept is the same. Without regulation, the amount of oil being pumped will vary with temperature and oil viscosity. At initial start-up when more oil is being pumped, excess oil is returned to the pump inlet section (Relief). This regulating scheme is a function of a relief spring held against a port of the manifold (Adjustment) under tension of another spring and adjustment screw. The end result is to be an oil pressure reading within a well-defined range of from 10 to 15 PSI (between M and H on the gauge). The pump is situated at the bottom of the crankcase. Oil drawn into the pump is screened, and oil pumped out to distant points of the engine returns to the crankcase. Note also an avenue for oil to bypass the filter. There is found another spring-tensioned gate, a "safety" in event the oil filter becomes totally blocked – allowing unfiltered oil to be pumped throughout the engine.

A System of Interacting Pressures -- Looking back at the schematic on page 1 for a moment, many factors come into play when setting oil pressure. Each of the manifold outputs is designed for certain volume, and the individual calculated circuit resistances come into play to determine overall resistance to oil flow. This is much like having four or five hoses connected to one hose bib on the side of the house – if one bursts, all will lose pressure. If one is plugged up, the pressure increases for the rest. This system is much the same. So if an output is clogged, like the governor line on a “B” tractor for instance, pressure will rise. If your tractor has worn out main bearings allowing much of the oil to slide back into the crankcase prematurely, pressure will be lower. The bottom line here is that any rather sudden rise or fall in oil pressure should be taken as a signal that your engine’s oiling system needs attention.

Fixed By-Pass for the Oil Filter -- As visualized in figure 14-1, and briefly stated in the paragraph below figure 14-1, The oil filter head contains a “spring-tensioned gate” relief valve. Figure 14-5A illustrates the spring contained in the cap section. In figure 14-5B, we see the leaf spring with its pilot; the valve port being just below the pilot. This valve operates under a fixed tension, and is designed to permit the system to continue to oil the engine long after the oil filter has become clogged. When this happens, of course, unfiltered oil is lubricating the engine.

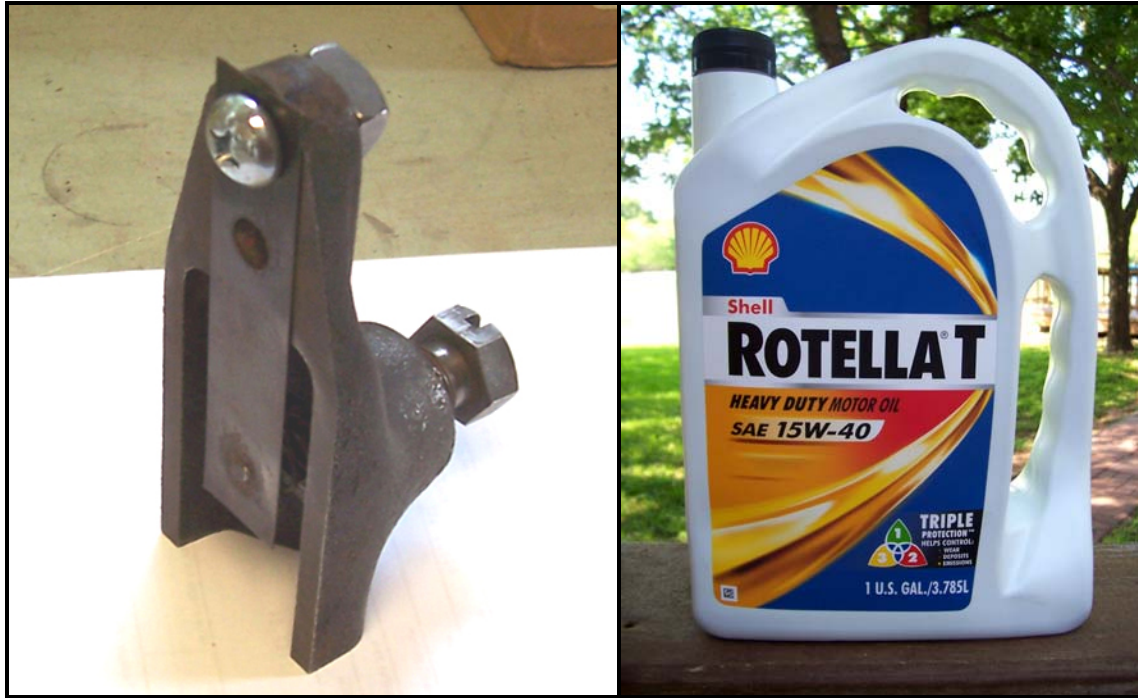
Figure 14-3 (A&B). John Deere “H” Oil Pressure Regulator Unit (left), and on the right is the “Author’s Choice” of oil for Two-Cylinders Tractors

Pressure Regulation – Figure 14-3A illustrates the regulating part of the engine lubricating system. The adjust screw, when turned INWARD (CW) will exert pressure on the thin-looking relief spring by means of (unseen) a small coil spring – to increase oil pressure. The relief spring is pressed up against the sixth port of the manifold. Only when pressure exceeds a preset amount will the relief spring be pushed back to allow Relief oil (Fig 14-1) to return to the pump’s input side.

Engine Oil – Many ask what oil is best suited for the John Deere Model “H” and similar vintage two-cylinder tractors. At this writing, Figure 14-3B represents the “author’s choice” once the “break-in” period is concluded.

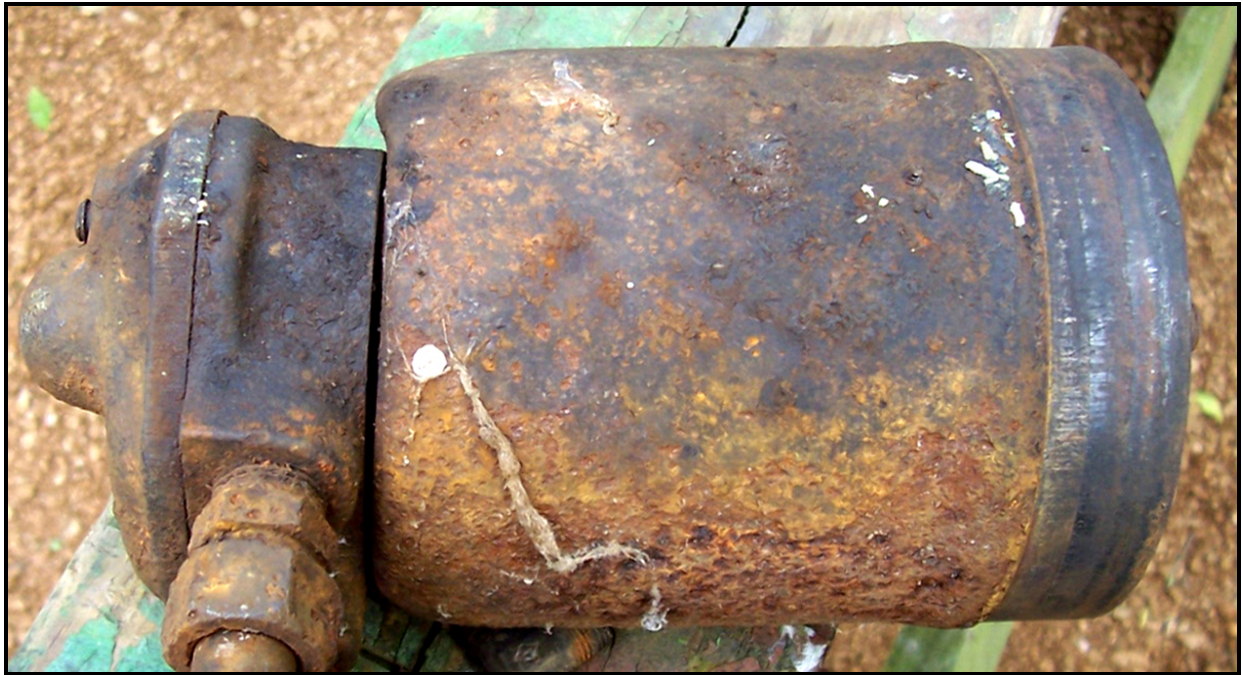
Fig 14-6. This oil filter body was removed from H-47511.

Crushed Filter Body – Figure 14-6 -- Note the cave-in of the canister at the canister/filter head interface. This distortion, the drawing of the filter head too tightly into the filter body, was the result of applying excessive torque to the oil filter cap screw. Why? Men will apply added torque in attempts to stop oil leaking around the cap. The issue, however, is usually a hardened A519R filter cover gasket.

This tractor lost all oil pressure – because pumped oil escaped back into the crankcase without reaching the manifold, leaking out between filter body and filter head! The one single remedy is to renew the oil filter body (the canister); no easy task and special tooling is required! Consult your tractor’s Service Manual. The lesson to be learned here is to renew the A519R oil filter cover gasket at least once per season. The most sound practice would be to renew this gasket with each oil filter change.
