## Service Solutions

### Service Manual Correction on Genesis Control System

### Control Box Leaking Water on Front Filter Refrigerators

### Moisture Forming on the Inner Oven Door Glass

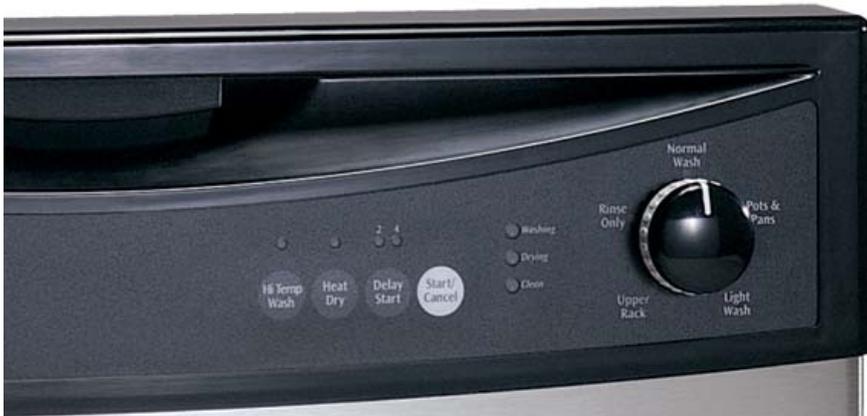
# Frigidaire Precision Select Dishwasher

- New, slimmer console with updated styling
- High quality, heavy Frigidaire knob with Easy-Grip outer ring
- 5-Level Precision Wash System
- 4 Pad/5 Cycles/4 Options
- 7 Status Lights
- 2-4 Hr Delay Start
- 100% Filtered Water
- Stainless Steel Food Disposer
- Self Cleaning Filter
- Premium Upper Racks
- Premium Lower Racks
- Deluxe Silverware Basket
- UltraQuiet™ II Sound Package

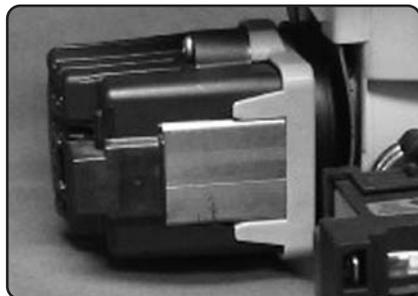
Askoll wash motor 154523501

**Solution:** The pictures below are to distinguish between the two different styles of wash motors.

Only on the above listed models in the serial number range from TH451 through TH515, changing the wash motor to a part number 154523501 (see picture above) will solve this cleaning problem in the upper rack.

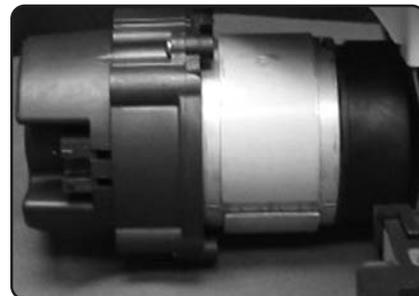
Johnson wash motor 154536101

**Cause:** Only the above models in the listed serial number range, that have passed the preceding checks could have a 154536101 wash motor. The 154536101 motor may not pause long enough to allow the check ball in the sump to change its position and spray from the center arm.

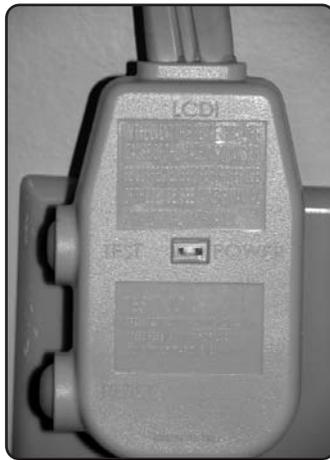
LCDI power cord

- Models:** All models produced for the 2005 Season.
- Problem:** Air conditioner will not start on new installed unit.
- Cause:** Room air conditioners made for the 2005 sale season will be equipped with a new type of power cord that senses current leakage from a damaged cord and also has a trip/reset button similar to what most hair dryers have in their plug heads. The LCDI cords are used throughout the 2005 United States, AC product range. These products are only mandated for the U.S. market. All products produced for Sears Canada and Danby come with original style power cords
- Solution:** Air conditioners with an inoperative start situation will need the LCDI on the power cord reset. A service call should not be needed, just advise customer to reset the LCDI.

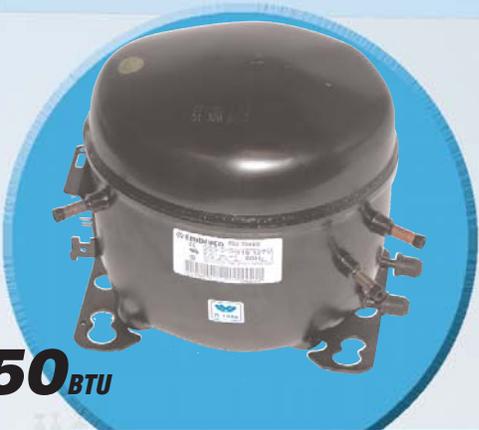
**P/N 5304442311**

**750<sup>BTU</sup>**

- R134A
- -35°C to -10°C (-31°F to +14°F)
- Static Cooling
- Low Back Pressure
- Low Starting Torque
- Resistive Start – Capacitive Run
- Precharged with ISO10 Ester Oil
- 115V

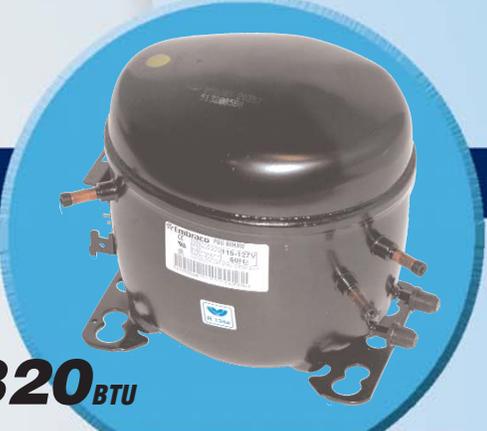
**P/N 5304443725**

**820<sup>BTU</sup>**

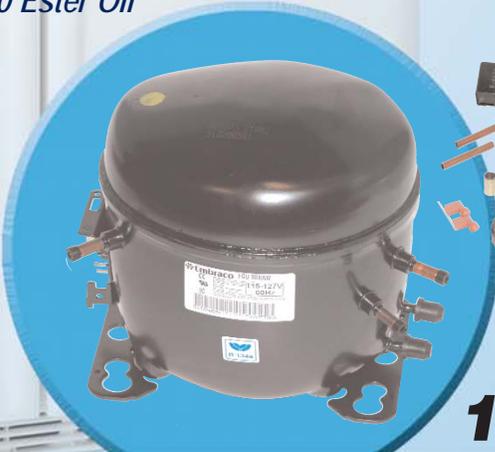
**P/N 5304429237**

**1,065<sup>BTU</sup>**
