Propeller Technical Manual

Propeller Model C000242-D60P38
Propeller Model C000242-D60P42
Propeller Model C000242-D60P44
Propeller Model 4A401A0D
Propeller Model 4A401B0D
Propeller Model 4A401C0D

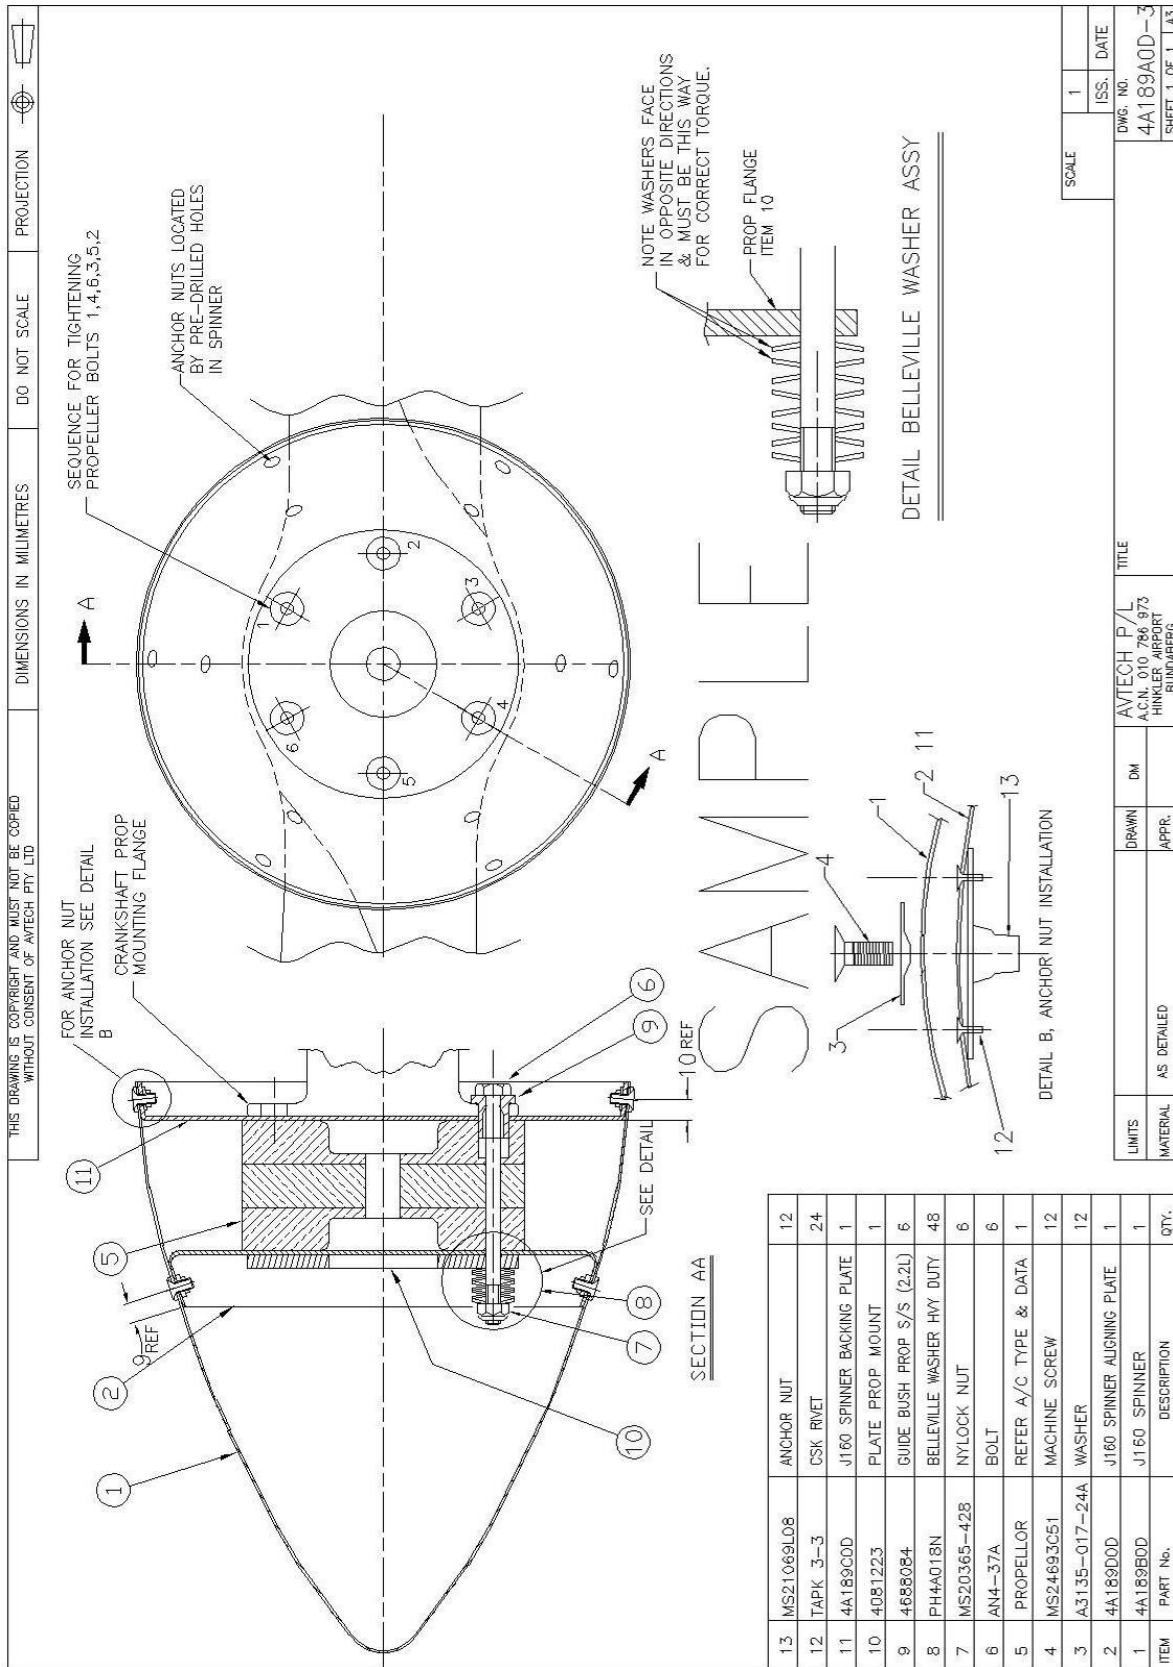
Figure 1 – Typical Propeller Installation

5. Fit front spinner backing plate to front of propeller. Fit Aluminium Propeller Flange, Belleville Washers - 42 off: (8 per Bolt: assembled in pairs as shown)

6. Progressively tighten bolts ensuring equal distribution of load and in a normal criss-cross torque sequence.
7. Using Torque Wrench, tighten Bolts to 6lb.ft (72 inch/lbs).

8. Check tracking of Propeller by locating a fixed object on a flat floor so that it just clears the Propeller tips when rotating the Propeller by hand. Check that each blade clears the object by the same amount. If the Propeller is outside the approved tolerance, refer to JABIRU Aircraft Pty Ltd or a JABIRU Approved Service Centre.
Maximum Tracking Error Tolerance is +/- 2mm.

9. Locate Spinner on Spinner Flange and fix with Machine Screws through tinnerman Washers.
10. Check Spinner tracking by locating a fixed object on a flat floor to just clear the lower edge of the front dome of the Spinner. Rotate the propeller by hand and check that the Spinner runs true.

11. Correct any run-out by loosening machine screws, realigning spinner then retightening machine screws.
12. Leading edge tape can be applied between the inner edge of the urethane leading edge and the spinner. This optional tape protects the propeller and reduces the chances of moisture ingress.

13. After the first flight following the propeller installation the spinner must be removed and the propeller bolts checked for correct tension.

Figure 3 below shows an older propeller hub. Several small cracks are visible extending along the blade from the hub bolts. This type of damage is typically caused by over-torquing the propeller bolts (or not using Belleville washers on the installation as shown in Figure 1).

- Ensure the propeller is installed as detailed in Figure 1.
- Check the fit of the propeller drive bushes in the sockets is not loose.
- Measure the length of the cracks & compared to the limits shown below.

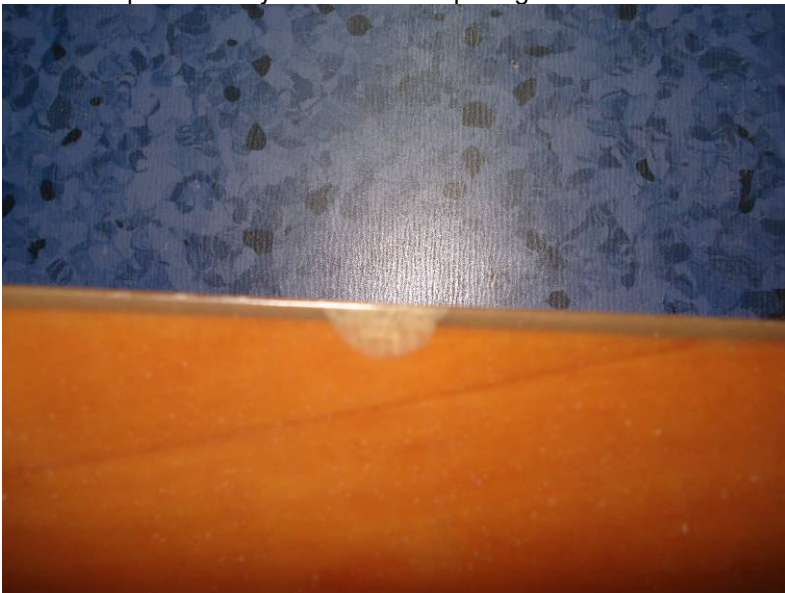
Figure 2 – Trailing Edge Chip

Figure 2 below shows a minor trailing edge chip, approximately 13mm (0.5") long. This type of damage is normally caused in the hangar or while the propeller is in storage or being shipped.

- In general, whitening is a sign that the resin matrix surrounding the fibreglass has been damaged. This type of damage can allow moisture to enter and act as a starting point from which de-laminations can grow.
- If the fibreglass has been chipped or frayed apply a thin type of superglue to the fibres. Capillary action will draw the glue into the glass and the colour will change from white to translucent.
- If the line of the trailing edge has been notched by a small amount (up to 2mm) the notch can be sanded away to leave a smooth trailing edge. This must be done AFTER the glass weave has been stabilised with superglue.
- Maximum size to repair by the method above: 13mm along the blade and extending up to 10mm towards the blade leading edge.
- After repair: visually monitor the chip for growth.

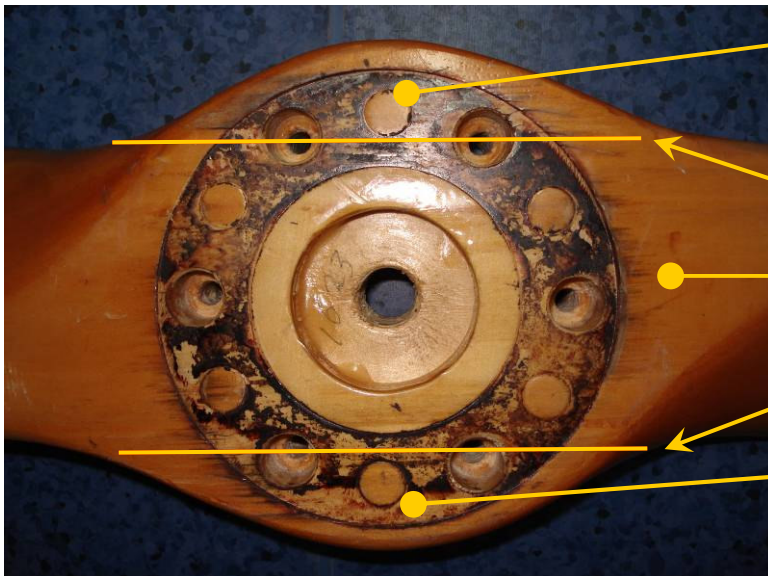
Figure 3 – Hub Aging

Maximum crack length outside central zone (beyond lines) 50mm (2") or up to the edge of the propeller. If the crack touches the side of the prop it must be visible down the side of the hob for no more than 10mm. (0.39")

Line through centres of outer bolt holes.

Maximum crack length within central zone (between lines) 25mm (1")

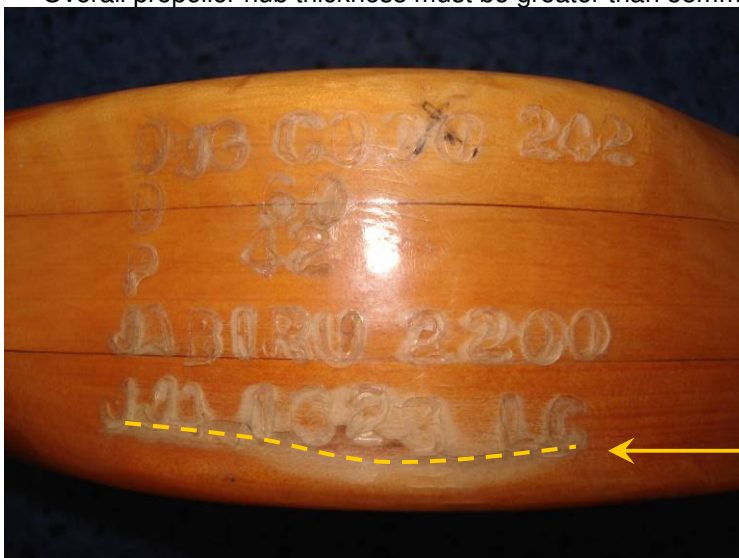
Figure 4 – Hub Compression Cracking

Figure 4 below shows the side of an older propeller hub. A crack running along the grain is visible. This type of damage is typically caused by over-torquing the propeller bolts (or not using Belleville washers on the installation as shown in Figure 1).

Crack

- Check the propeller installation & verify bolt tensions.
- Where the crack has exposed the wood, seal it using a thin type superglue to prevent moisture ingress.
- Overall propeller hub thickness must be greater than 58mm.

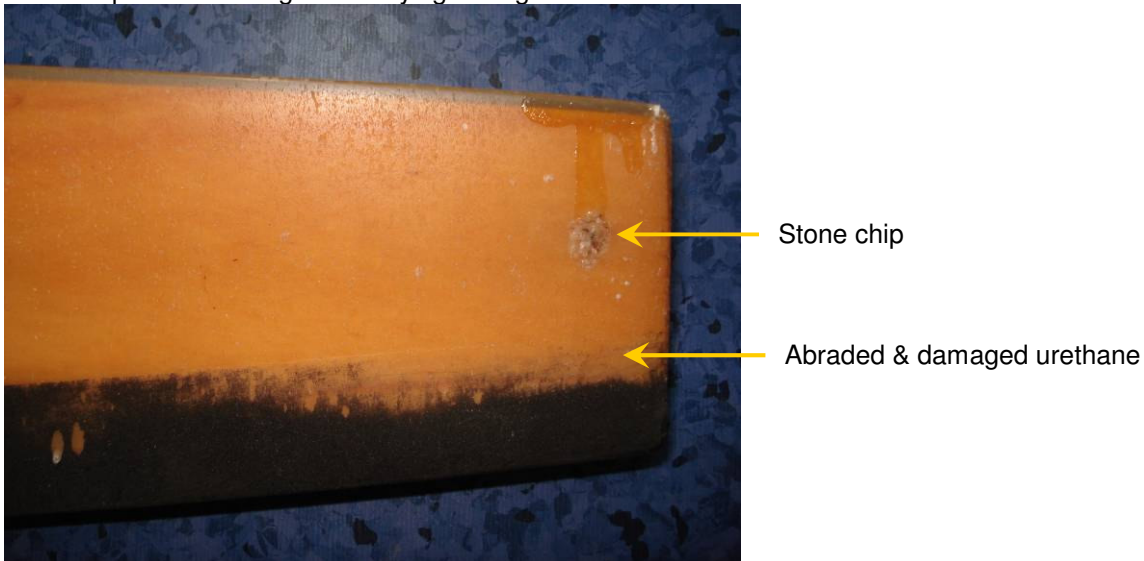
Figure 5 – Stone Chip & Urethane Abrasion

Figure 5 below shows a stone chip and urethane abrasion near the tip of a propeller blade. In this case some superglue has been applied to the stone chip. This sort of damage is generally caused by operations from gravel runways and flying through rain.

- Stone chips like the one shown below are not generally dangerous, however they should be visually monitored during normal daily inspections as it is possible for glass de-laminations to start from them. Using a thin type of superglue to seal the chip is recommended to seal the damage & stabilise the chip.
- The urethane damage shown below is minor. The edge of the fibreglass is not exposed and there are no loose sections of urethane. Note: due to the abrasion of the urethane this propeller tip will be much more susceptible to damage when flying through rain than it would be if the urethane was in as-new condition.

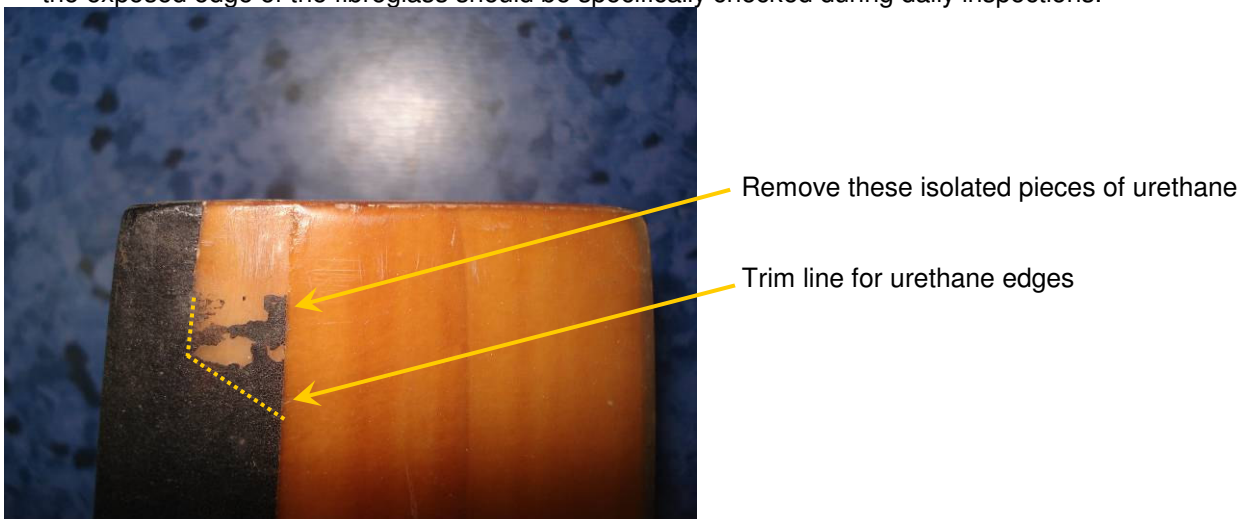
Figure 6 – Urethane Abrasion

Figure 6 below shows more severe damage to the urethane. This type of damage is generally caused by flying through rain or taxiing through long grass.

- Urethane loss such as shown below is low-medium level damage. The leading edge of the fibreglass has been exposed and while the edges of the urethane appear stable they are irregularly shaped and may begin peeling. A propeller tip in this condition is safe in normal use, however it will be damaged much more rapidly by rain. The irregular ends of the urethane can be carefully removed with a sharp knife and the exposed edge of the fibreglass should be specifically checked during daily inspections.

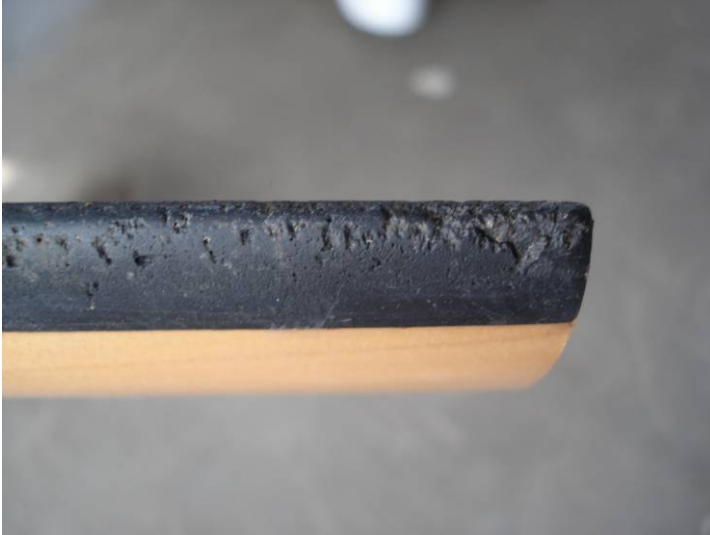
Figure 7 – Urethane Pitting

Figure 7 below shows urethane which has been pitted by flying through rain.

- Minor damage can be sanded slightly to improve the smoothness of the leading edge. The pits shown would be treated this way.
- Major damage must be repaired by replacing the urethane leading edge protection.

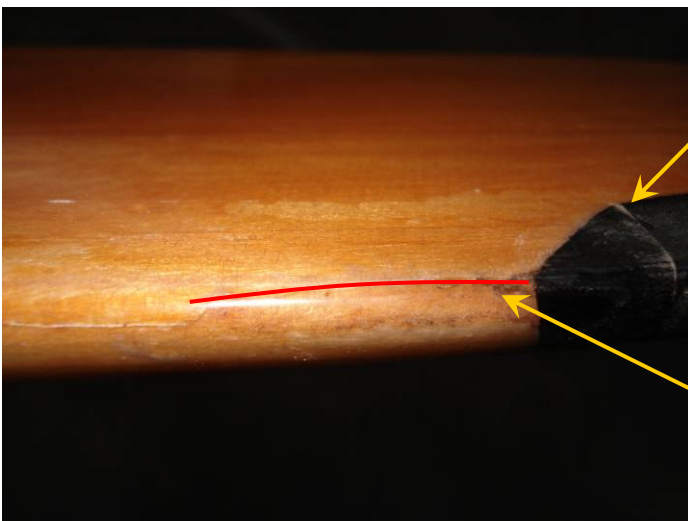
Figure 8 – Moisture Ingress – Leading Edge at Root.

Figure 8 below shows cracking in the resin shell of the propeller at the leading edge between the inboard end of the urethane and the start of the spinner. The example shown is also fitted with leading edge prop tape. This damage is usually caused by moisture ingress into the blade causing the wood to swell and crack the resin coating. The moisture can enter whenever the blade is exposed to water: flying through rain, covered by dew overnight etc.

Prop tape runs from the inboard end of the urethane through to the spinner.

Cracking visible in the resin at the leading edge

- The damage shown below is a minor example of it's type. At this stage it should be covered with prop tape and monitored.
- If the cracking progresses any open cracks should be sealed with a thin type of superglue. Maintaining a seal over the wood is the best way to prevent this type of damage from spreading.

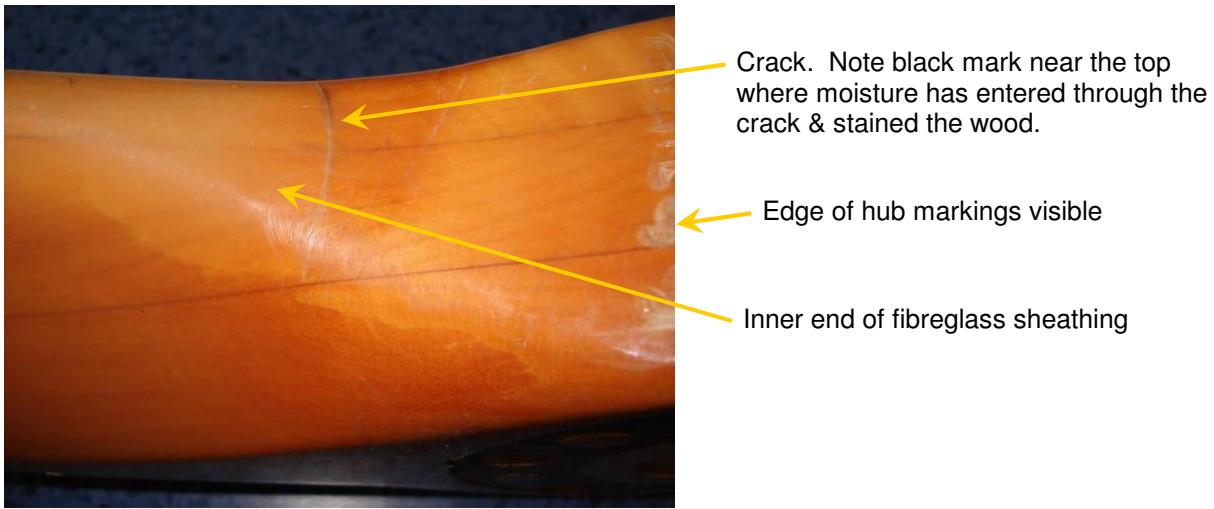
Figure 9 – Resin Crack

Figure 9 below shows cracking in the resin shell of the propeller near the hub. Cracks of this type can occur in older propellers where there is only resin (and no fibreglass) covering the wood.

- The inner end of the fibreglass can be seen as the colour of the composite covering the wood changes from a relatively opaque covering to a clearer coating. Fibreglass/resin composite is more opaque than resin alone. The fibreglass coverings of the propellers covered by this manual run from the tip of the blade to a point approximately 100mm (4") from the centre of the propeller.
- Cracks such as this one are not a structural issue provided that they are no more than 110mm from the prop centre and are no longer than 50mm (2").
- Where a crack has opened slightly it must be sealed with superglue to prevent moisture entering. The black marking of the upper part of the crack shown below is due to moisture staining the wood.

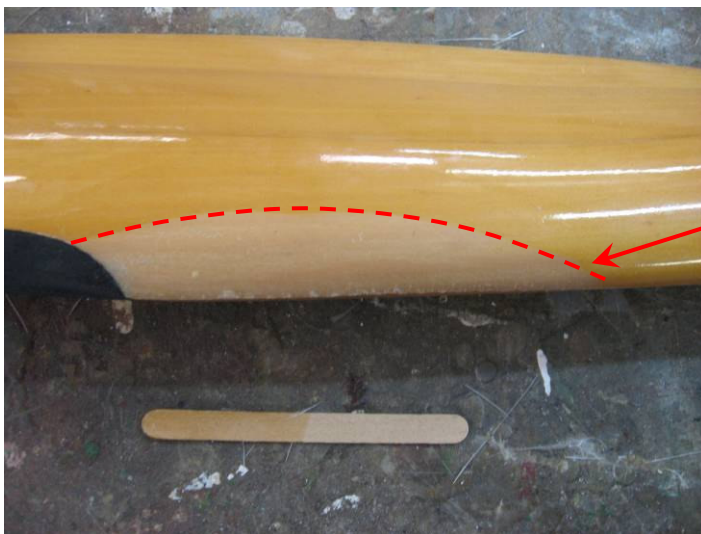
Figure 10 – Fibreglass De-lamination

Figure 10 and Figure 11 below show an extreme example of the same type of damage shown in Figure 8. In this case the initial minor cracking was not sealed. Over a period of several months more water entered and a small de-lamination began; the aircraft continued to be flown. The result is that the fiberglass has delaminated from the wood over a large area.

Edge of delaminated area

- **IT IS NOT SAFE TO FLY WITH ANY AMOUNT OF DE-LAMINATION.** Whenever de-lamination is found the propeller must be removed from service and repaired.
- It is unusual for a de-lamination to reach this size. Normally air pressure acting on a smaller de-lamination would rip the fibreglass off the entire blade. Happening in flight this leads to an extremely out of balance propeller – normally the engine must be shut down immediately and an emergency landing carried out.

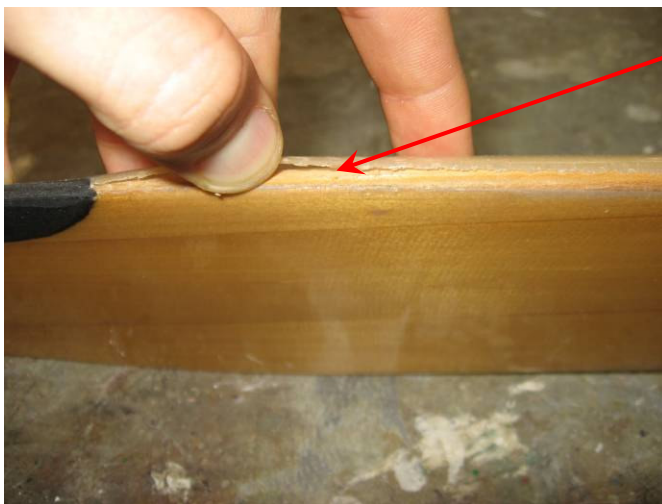
Figure 11 – Fibreglass De-lamination

Wood exposed at leading edge.
Fiberglass no longer bonded to wood.
