Tech Tips

APRIL 2012 | PARK BRAKE LEVER LUBRICATION

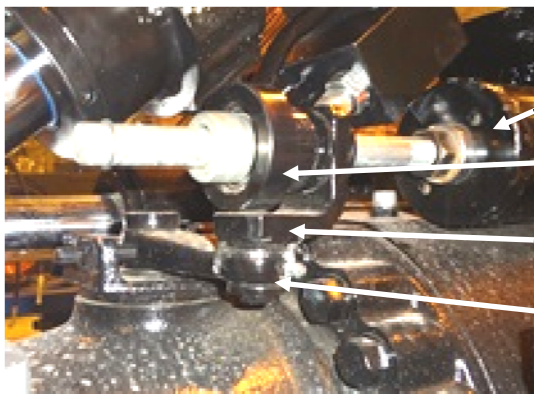
Figure 1

The Skyjack boomlift models 40/45T, 61/66T, 46/51AJ, and telehandler models VR642, VR843, ZB6042, and ZB8044 use drive axles with spring applied-hydraulically released parking brakes. The parking brakes are actuated by a cylinder and dual lever mechanism on the top of the axle housing. (Figures 1 & 2)

Park Brake Cylinder
(Rod end)

Quick release
mechanism

Support

Park Brake Lever arm
with grease fitting

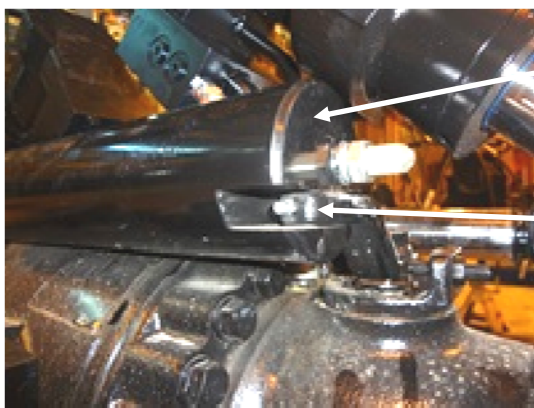
Figure 2

Park Brake Cylinder
(Barrel End)

Park Brake Lever arm
with grease fitting

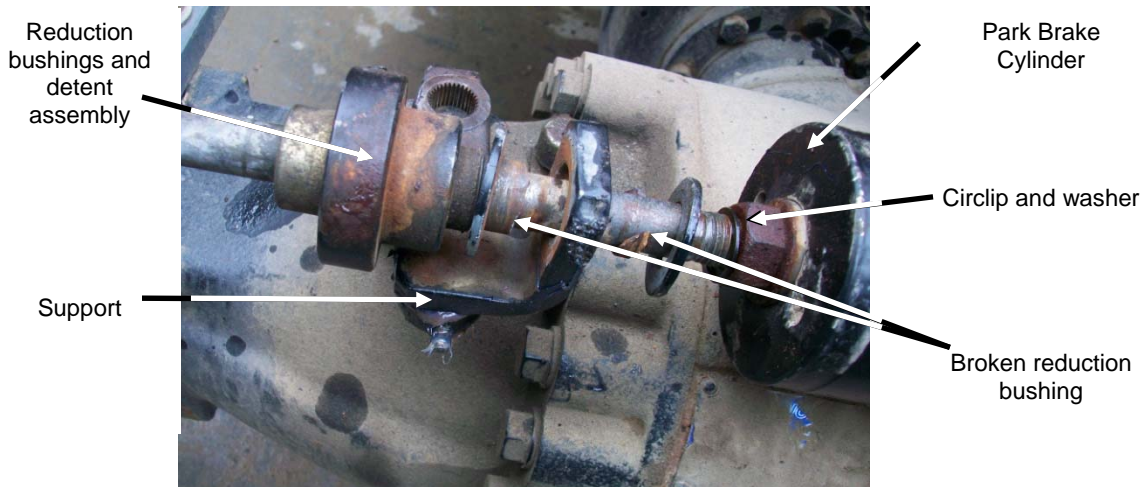
The park brake lever is equipped with a grease fitting and if not properly and regularly lubricated, the lever can bind up on the support pivot, breaking apart the quick release mechanism, causing the park brake to stay released.

Figure 3 shows the park brake cylinder quick release mechanism damaged because of a seized brake lever support pivot.

The pivot on the support seized and the pressure from the park brake cylinder pushed the circlip off the brake actuator rod and cracked the reduction bushing. This broke the connection to the park brake lever resulting in no parking brakes. It is very important to lubricate ***all*** of the grease points on your equipment regularly and properly to avoid costly damage and equipment downtime.
