Trays 2, 3, and 4

Trays 2, 3, and 4 component locator

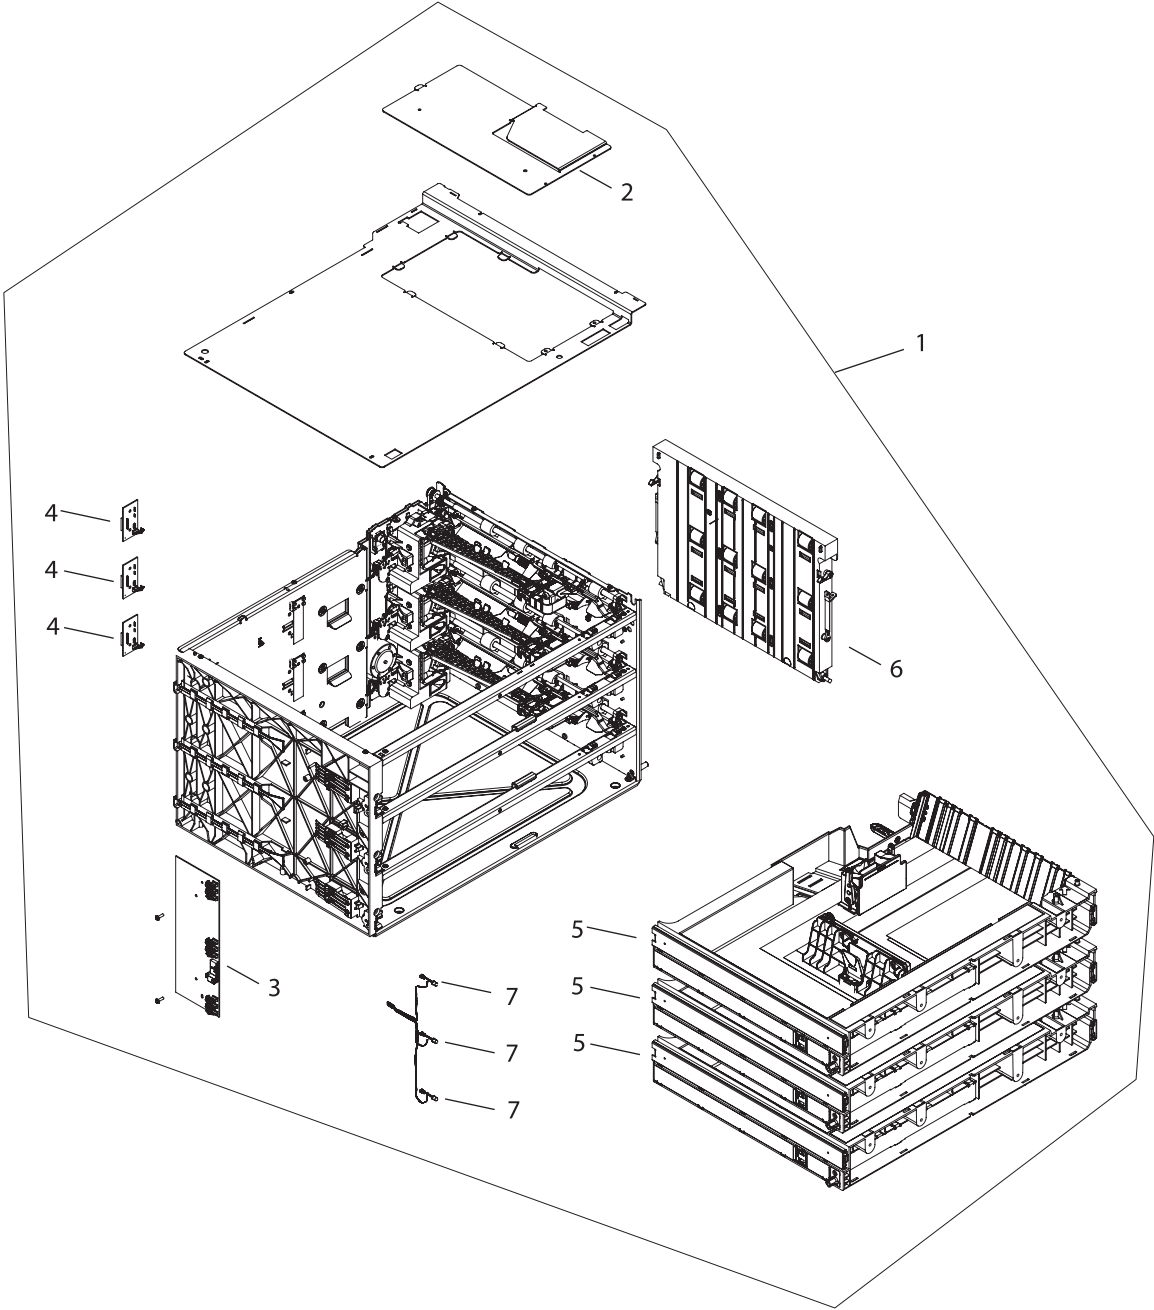
Figure 10-131 Trays 2, 3, and 4 main assembly parts diagram

Ref	Description	Part number	Qty
1	Tray 2, 3, and 4 assembly (SVC ASSY-MEDIA TRAYS)	C5956-67724	
2	Tray 2, 3, and 4 assembly cover plate (SVC COVER, PLATE, TOP)	C5956-67400	
3	Trays 2, 3, and 4 Controller PCA (A23) (SVC-PCA, CONTROLLER, CONDOR, INPUT)	C5956-67416	
4	A33/A33/A33 (SVC-PCA, DISTRIBUTIONBOARD)	C5956-67417	
5	Paper tray assembly (SVC ASSY-DRAWER)	C5956-67422	
6	Right-side lower panel (SVC ASSY-PAPER, PATH)	C5956-67389	
7	Tray 2 LED (LED15)/Tray 3 LED (LED16)/Tray 4 LED (LED17) (SVC-HOLDER LED)	C5956-67406

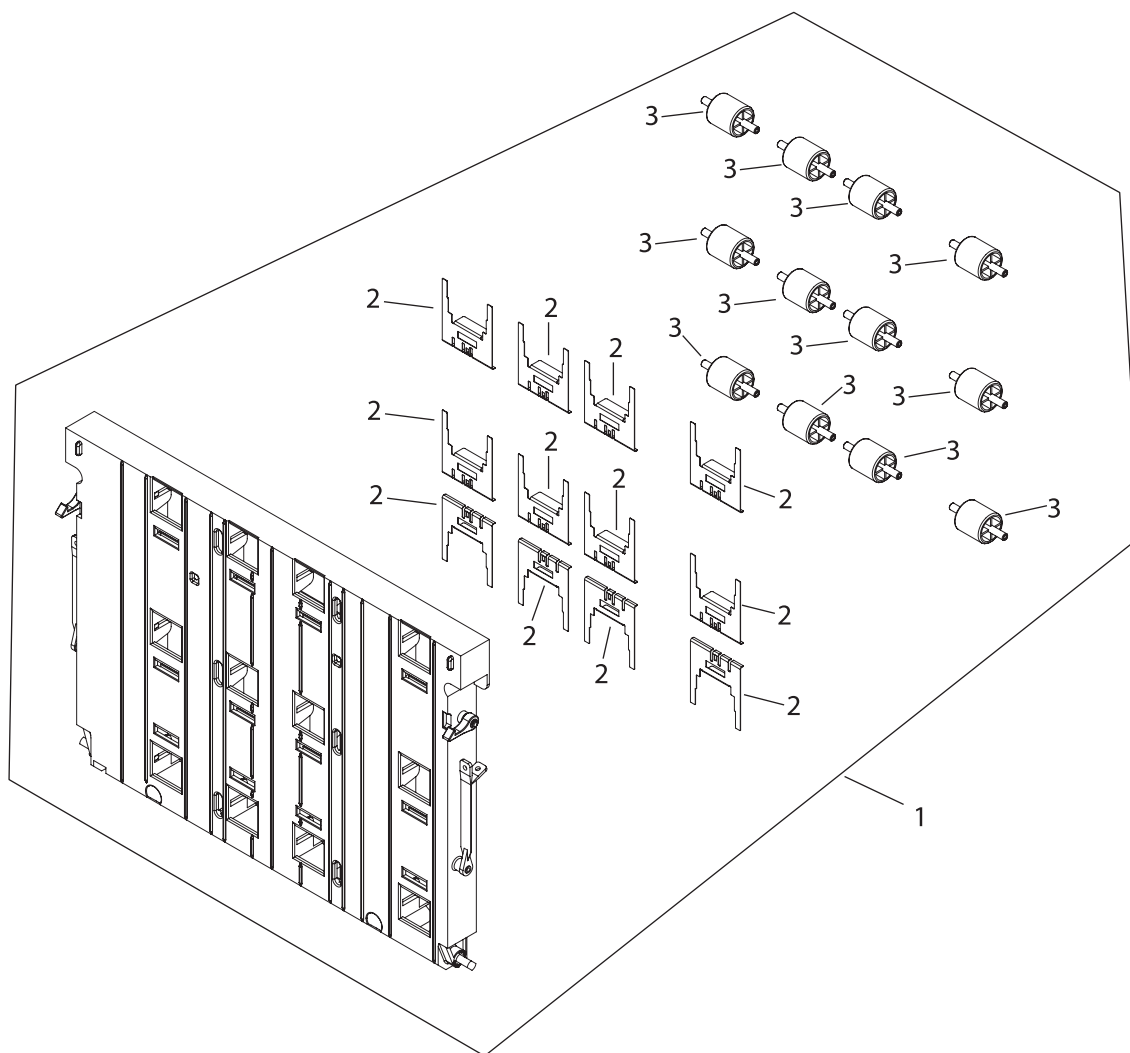
Figure 10-132 Trays 2, 3, and 4 paper path parts diagram

Ref	Description	Part number	Qty
1	Right-side lower panel assembly (SVC ASSY-PAPER, PATH)	C5956-67389	
2	Roller pressure spring (SVC-PRESSURE, SPRING, ROLLER)	C5956-67398	
3	Paper roller (SVC-ROLL)	C5956-67388

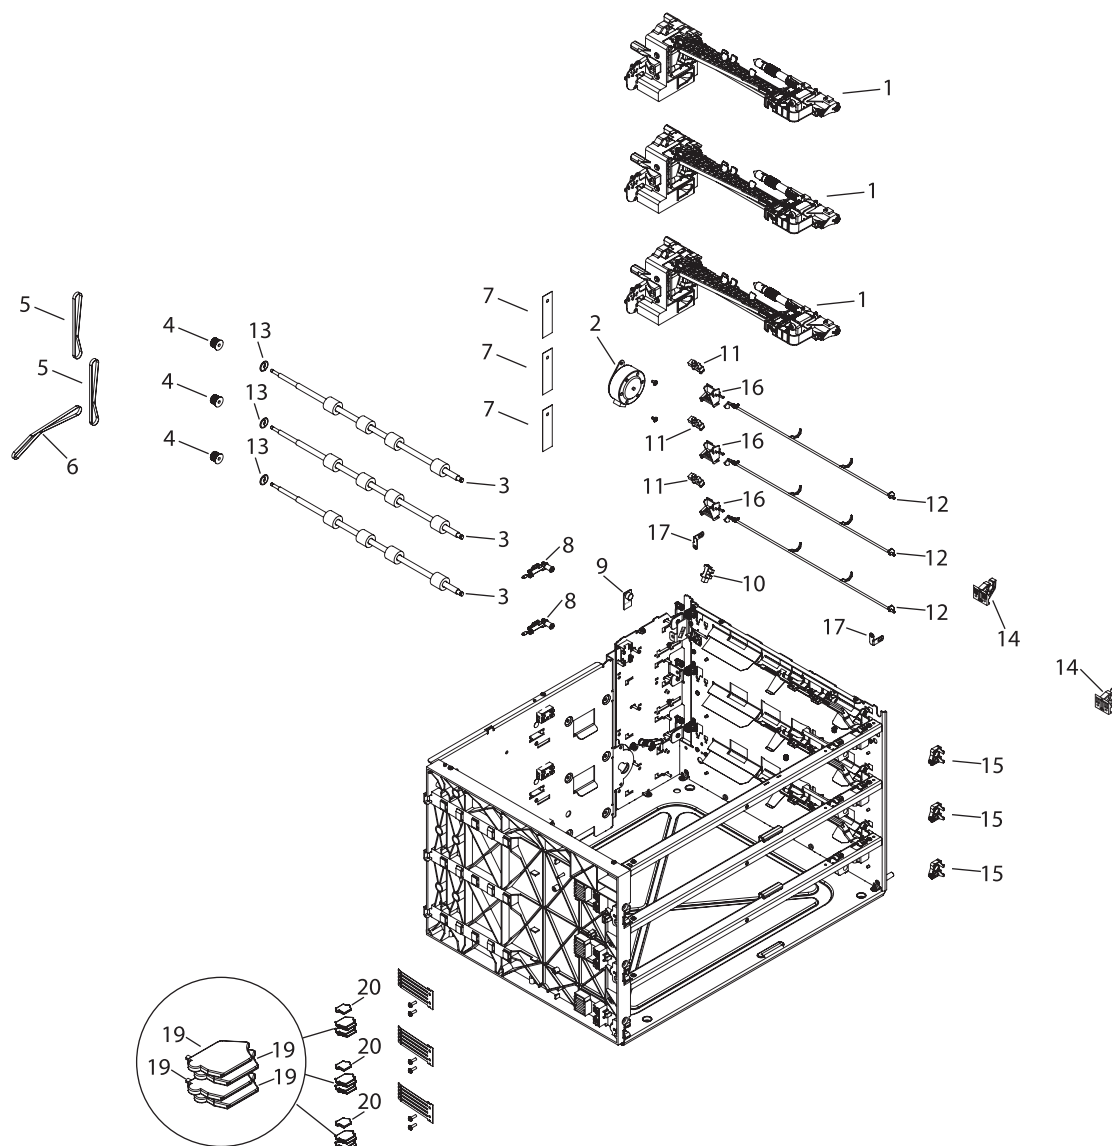
Figure 10-133 Trays 2, 3, and 4 drive parts diagram

Ref	Description	Part number	Qty
1	Pick arm assembly (SVC-SEPARATION, UNIT)	C5956-67419	
2	Trays 2, 3, and 4 Transport motor (M18) (SVC-MOTOR, STEPPER, CPL.)	C5956-67414	
3	Tray exit roller shaft (SVC-SHAFT, EXIT, CPL)	C5956-67384	
4	Tray exit roller shaft clutch (SVC ASSY-MEDIA TRAY CLUTCH)	C5956-67436	
5	Tray exit roller belt (SVC-BELT, SYNCHRONOUS, T=2.032)	C5956-67407	
6	Motor belt (SVC-BELT, SYNCHRONOUS, MOTOR, T=2.032)	C5956-67408	
7	Tray closed sensor actuator foil (SVC ASSY-MEDIA TRAY ACTUATOR FOIL)	C5956-67434	
8	Tray exit roller belt tensioner (SVC ASSY-MEDIA TRAY BELT TENSION)	C5956-67435	
9	Tray 2, 3, and 4 Humidity sensor (SN42) and Tray 2, 3, and 4 Ambient Temperature sensor (SN41) unit (SVC-PCA, SENSOR, HUMIREL)	C5956-67418	
10	Right-side Lower Panel Open sensor (SN43) (SVC ASSY-MEDIA TRAY PAPER PATH SENSOR)	C5956-67437	
11	Tray 2 Exit sensor (SN47)/Tray 3 Exit sensor (SN51)/Tray 4 Exit sensor (SN55) (SVC-PHOTOINTERRUPTER WITH CONNECTOR)	C5956-67770

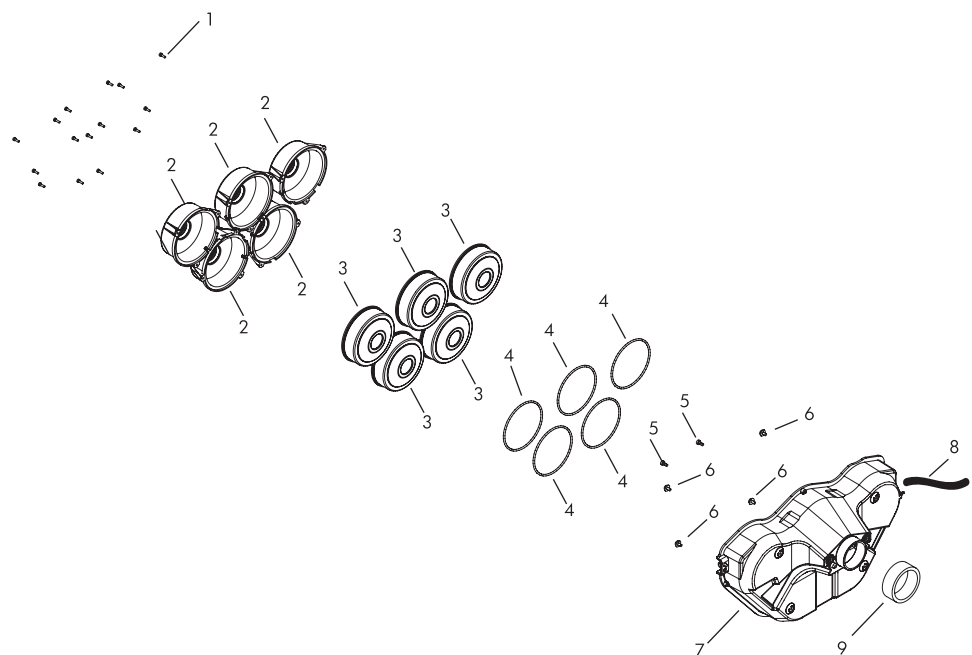
Figure 10-137 Vacuum supply assembly parts diagram

Ref	Description	Part number	Qty
1	Screw (SVC-SCR-MACH M3X0.5 10MM-LG PAN HD ROHS)	C5956-67004	
2	Vacuum blower muffler (SVC ASSY-MUFFLER, VACUUM BLOWER)	C5956-67322	
3	Vacuum blower (SVC-BLOWER-VACUUM)	C5956-67666	
4	O-ring (SVC-ORING-VACUUM SUPPLY)	C5956-67814	
5	Screw (SVC-SCREW-MACH M4 X 0.7 9.5MM-LG ROHS)	C5956-67011	
6	Screw (SVC-SCREW-TPG M4X0.7 8MM-LG PAN HD ROHS)	C5956-67003	
7	Vacuum supply housing (SVC ASSY-VACUUM SUPPLY HOUSING)	C5956-67272	
8	Vacuum housing tube (SVC-TUBE-RUBBER-VACUUM SENSE SHORT)	C5956-67205	
9	Vacuum housing gasket (SVC-GASKET-VACUUM DUCT-MOLDED)	C5956-67241

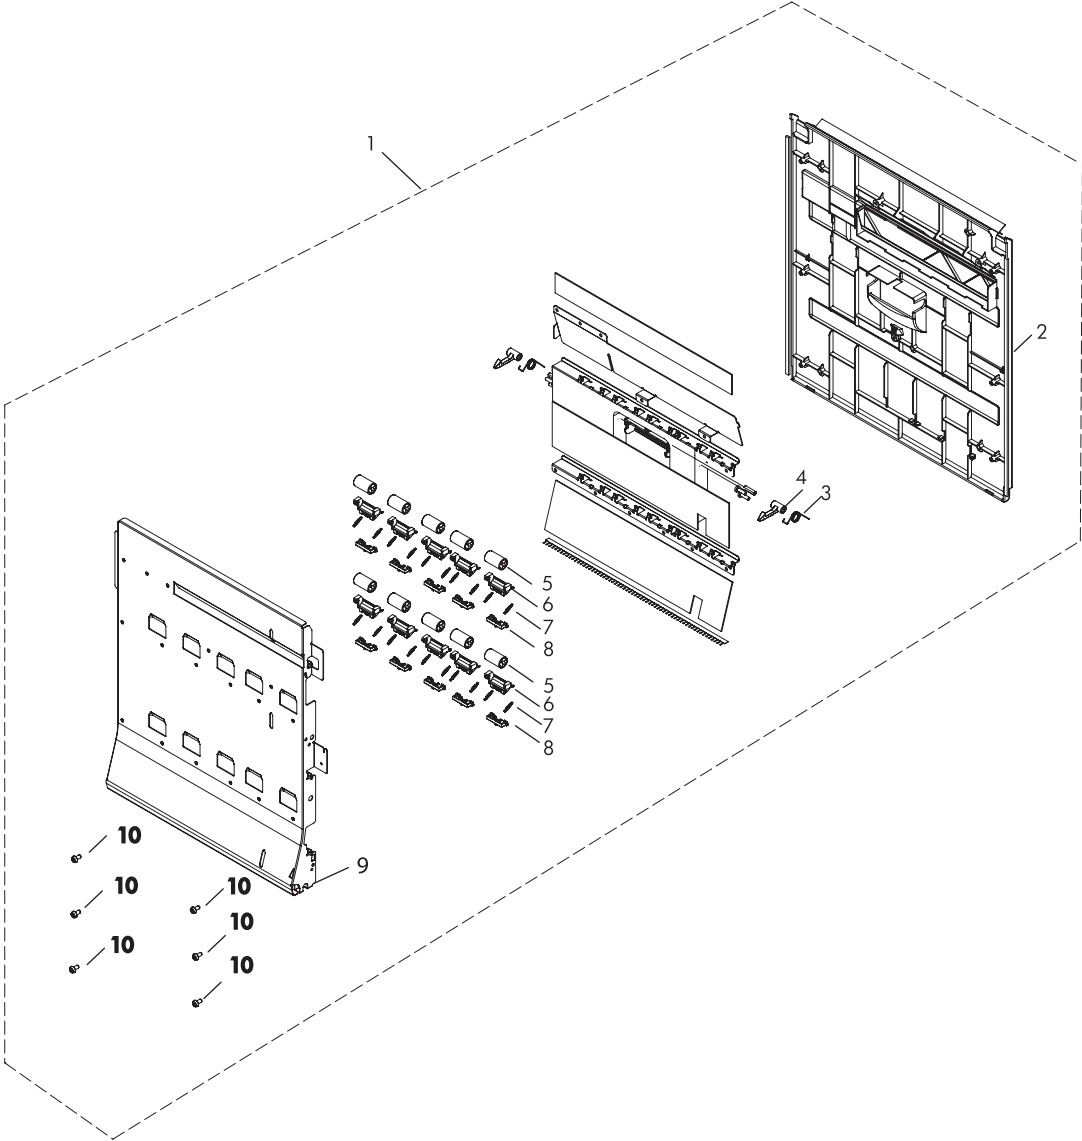
Figure 10-139 Vertical outer guide parts diagram

Ref	Description	Part number	Qty
1	Vertical outer guide (SVC ASSY-GUIDE VERTICAL OUTER)	C5956-67448	
2	Vertical path door (SVC ASSY-VERTICAL PATH DOOR)	C5956-67453	
3	Tensioner spring (SVC-SPRING-TENSIONER)	C5956-67113	
4	Latch (SVC-LATCH-VERTICAL DOOR)	C5956-67109	
5	Pinch roller (SVC-ROLLER-PINCH)	C5956-67257	
6	Pinch roller holder (SVC-HOLDER-PINCH ROLLER-SMALL)	C5956-67258	
7	Pinch roller spring (SVC-SPRING-EXTENSION-PINCH ROLLER-SMALL)	C5956-67086	
8	Pinch roller datum (SVC-DATUM-PINCH ROLLER-SMALL)	C5956-67087	
9	Vertical outer guide (SVC ASSY-GUIDE OUTER VERTICAL)	C5956-67461	
10	Screw (SVC-SCREW-TPG 4-20X7.94MM 10IP ROHS)	C5956-67012

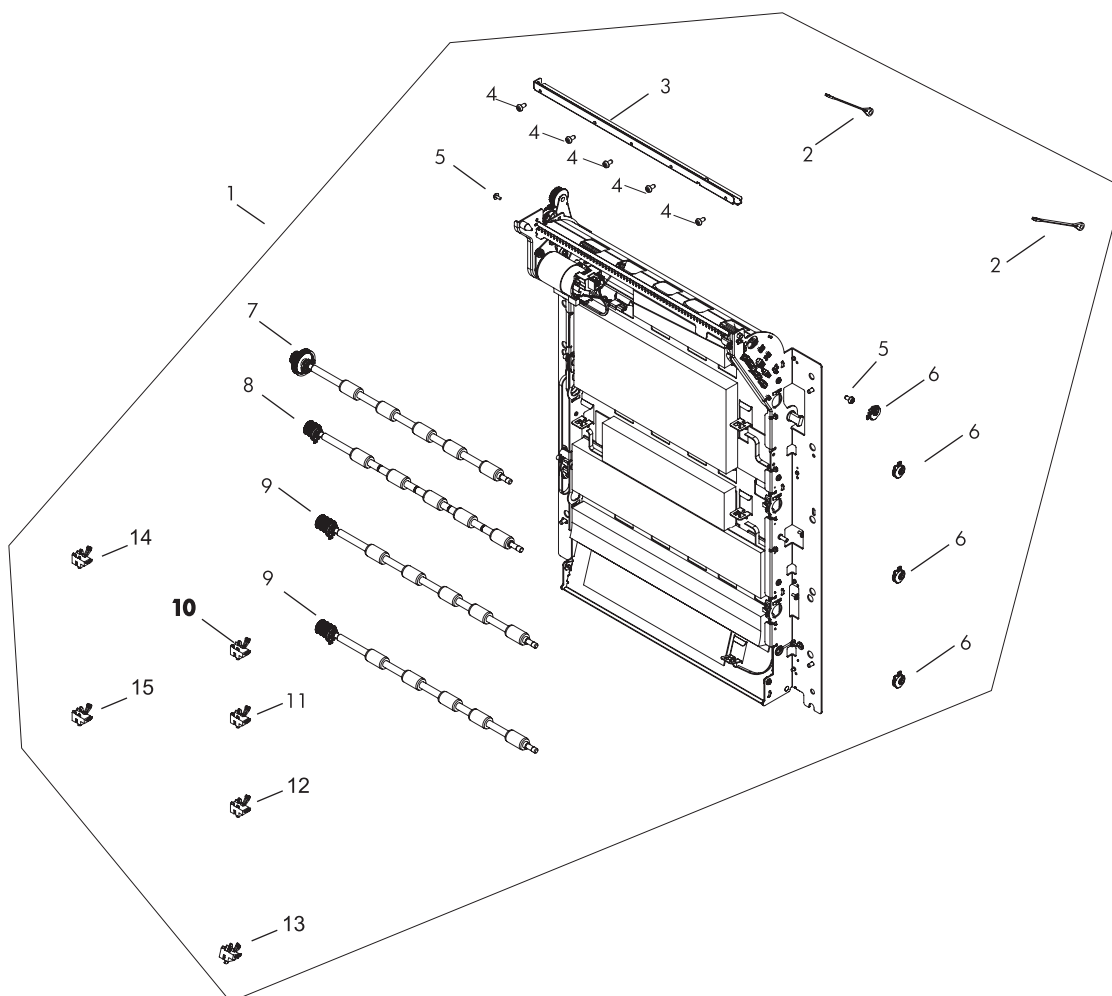
Figure 10-140 Vertical inner guide parts diagram

Ref	Description	Part number	Qty
1	Vertical inner guide (SVC ASSY-VERTICAL PATH INNER)	C5956-67789	
2	Door open limit strap (SVC-STRAP-DOOR OPEN LIMIT)	C5956-67084	
3	Bypass upper guide (SVC ASSY-GUIDE BYPASS UPPER)	C5956-67332	
4	Screw (SVC-SCREW-TPG M3X0.5 6MM-LG PAN HD ROHS)	C5956-67001	
5	Screw (SVC-SCREW-MACH M3X0.5 6MM-LG PAN HD ROHS)	C5956-67005	
6	Bearing yoke (SVC ASSY-BEARING YOKE LARGE)	C5956-67329	
7	Driver roller (SVC ASSY-DRIVE ROLLER CLUSTER BYPASS)	C5956-67323	
8	Drive roller (SVC ASSY-DRIVE ROLLER PULLEY IDO DBL)	C5956-67287	
9	Drive roller (SVC ASSY-DRV RLLR PULLEY VERTICAL TRIPLE)	C5956-67338	
10	Vertical Transport 3 sensor (SN25) (SVC-SENSOR, MEDIA PRESENCE)	C5956-67255	
11	Vertical transport 4 sensor (SN26) (SVC-SENSOR, MEDIA PRESENCE)	C5956-67255	
12	Vertical Transport 2 sensor (SN28) (SVC-SENSOR, MEDIA PRESENCE)	C5956-67255	
13	Vertical Transport 1 sensor (SN35) (SVC-SENSOR, MEDIA PRESENCE)	C5956-67255

14	Tray 1 Door Open sensor (SN30) (SVC-SENSOR, MEDIA PRESENCE)	C5956-67255	
15	Right-side Middle Panel sensor (SN23) (SVC-SENSOR, MEDIA PRESENCE)	C5956-67255

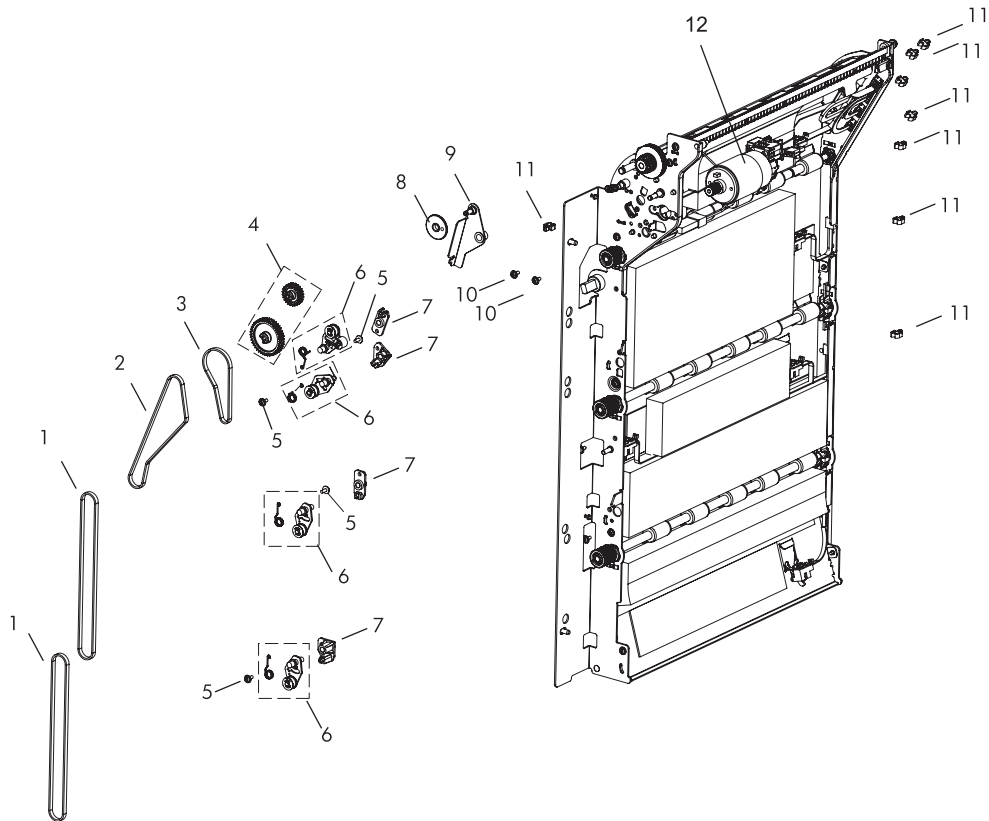
Figure 10-141 Vertical transmission parts diagram

Ref	Description	Part number	Qty
1	Belt (SVC-BELT-GT2-177T, 2MM PITCH X 4MM)	C5956-67657	
2	Belt (SVC-BELT-DRIVE, 144T, GT2, 2X4)	C5956-67661	
3	Belt (SVC-BELT-GT2-2MM PITCH X 4MM, 85T)	C5956-67656	
4	Gear bypass idlers (SVC KIT-GEAR-BYPASS)	C5956-67672	
5	Screw (SVC-SCREW-TPG M3X0.5 6MM-LG PAN HD ROHS)	C5956-67001	
6	Tensioner (SVC ASSY-MEDIAPATH TENSIONER)	C5956-67297	
7	Tensioner standoff (SVC KIT-STANDOFFS, TENSIONER)	C5956-67711	
8	Pitch bypass wheel (SVC-WHEEL-PITCH BYPASS)	C5956-67114	
9	Bypass drive swingarm (SVC-SWINGARM-BYPASS DRIVE)	C5956-67295	
10	Screw (SVC-SCREW-TPG M3X0.5 6MM-LG PAN HD ROHS)	C5956-67001	
11	Wire saddles (SVC KIT-WIRE MANAGEMENT 2)	C5956-67649	
12	Motor (SVC-MOTOR, MEDIAPATH)	C5956-67742

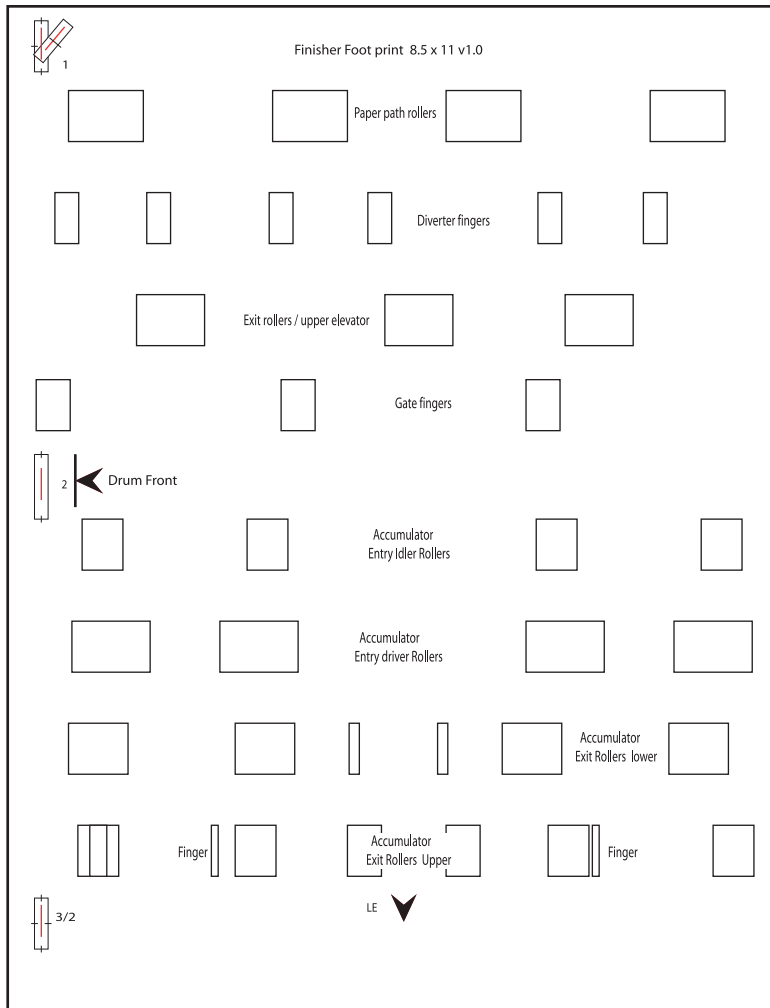
Use the Finisher Footprint test page to determine whether rollers or diverter fingers in the finisher paper path are marking, damaging, or contaminating the prints. This test page shows where the finisher rollers make contact with the paper. Check the roller that corresponds to the area of the test page that was damaged or contaminated. Look for smudges, damage, roller tracking marks, nicks, or dents where the diverter fingers contact the page.

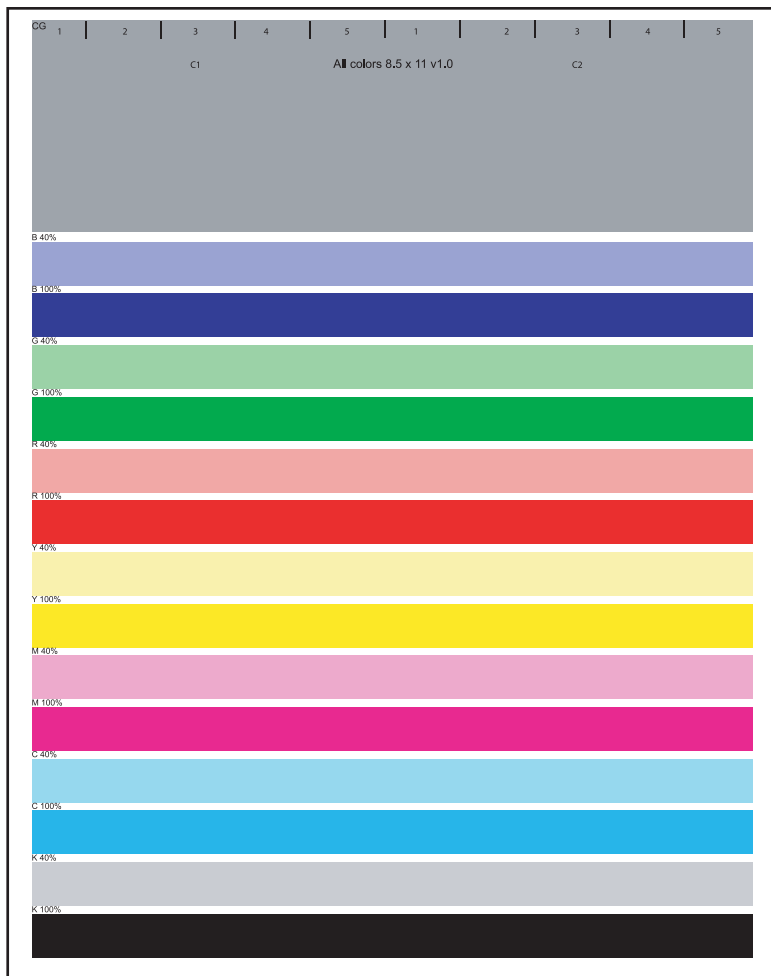
The All Colors test page shows the following color schemes:

- Primary colors (CMYK) and primary composite colors (RGB) at 100 percent and 40 percent
- Composite gray (at the top of the page) at 40 percent

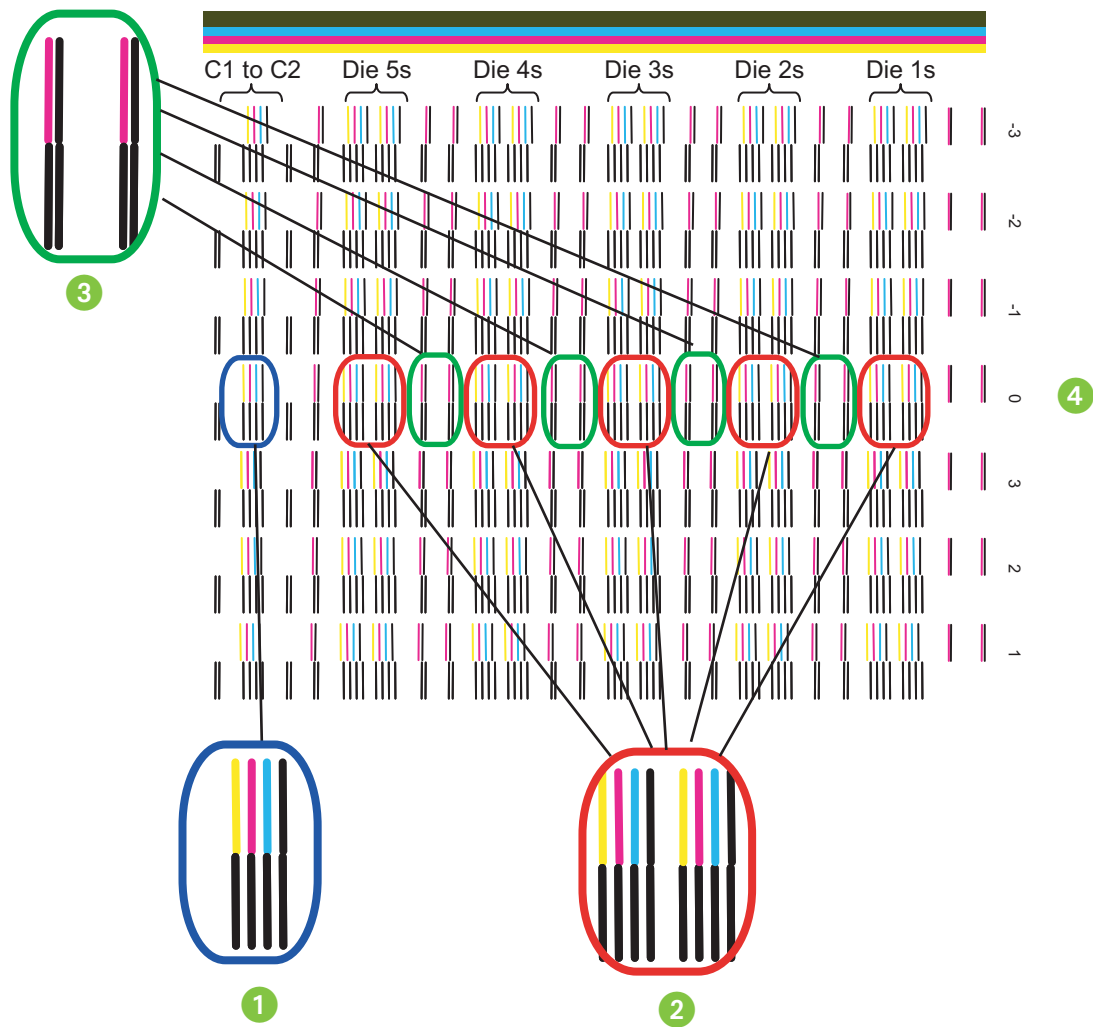
Carriages 1 and 2 and carriage-to-carriage vertical alignment

- Carriage-to-carriage vertical alignment: Verify that the CMYK marks are aligned to black on the left most column.
- Pen-to-pen vertical: Verify that the CMYK marks in each of the five groupings are aligned to black along the zero zone of the page. The marks on the left correspond to Carriage 2. The marks on the right correspond to Carriage 1.
- Die-to-die vertical: Verify that the MK marks in each of the four groupings are aligned to black along the zero zone of the page. The marks on the left correspond to Carriage 2. The marks on the right correspond to Carriage 1.

1	Carriage-to-carriage vertical alignment
2	Pen-to-pen vertical alignment.
3	Die-to-die vertical alignment
4	Zero zone

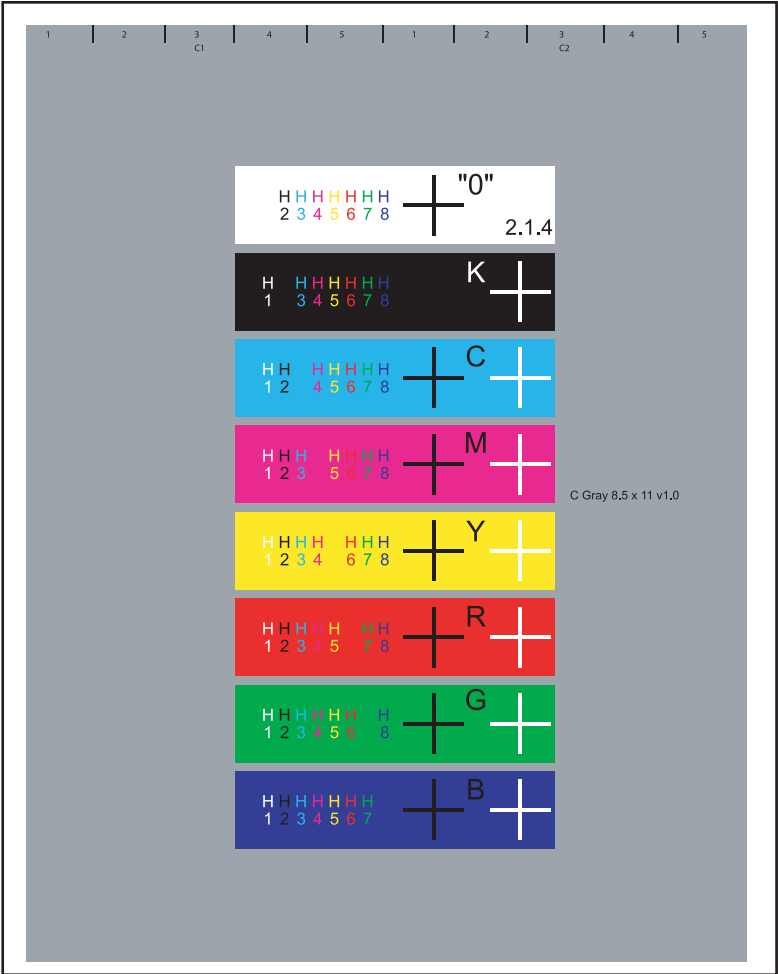
Composite Gray test page

The Composite Gray page has a composite gray area with primary colors blocks at 100 percent density down the middle of the page. Each of the primary color blocks contains color text. Use this page to diagnose print-quality problems, such as: vertical banding, graininess, bleed, and color misregistratation.

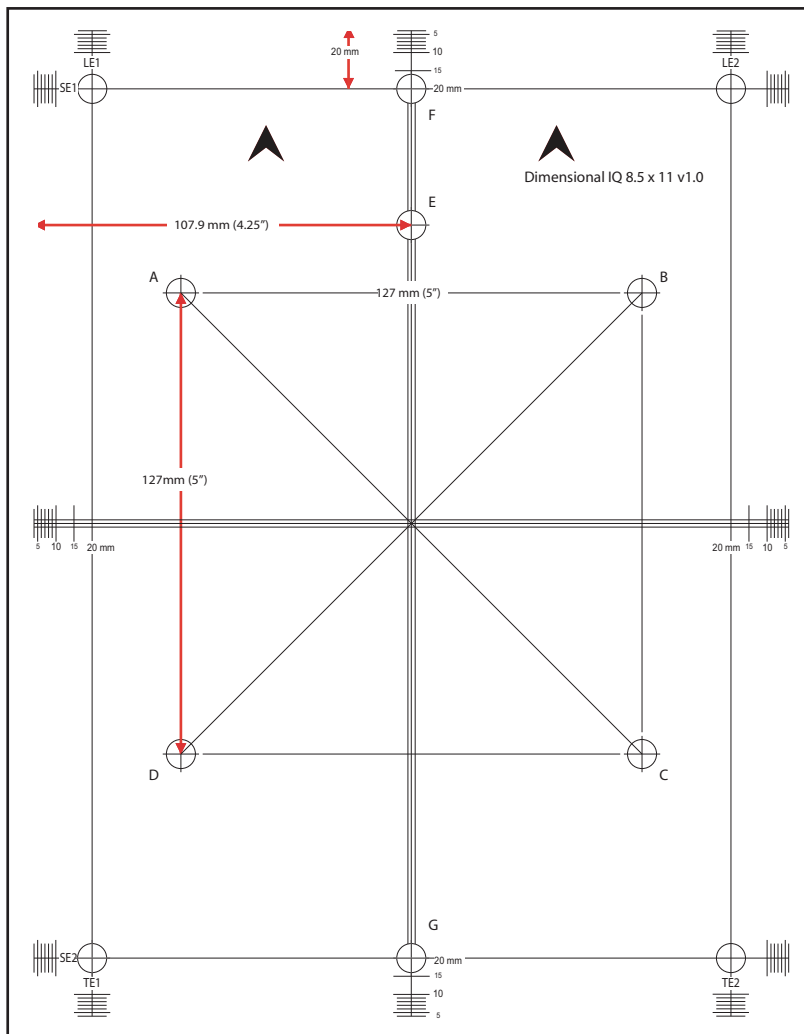
The Dimensional IQ test page is available in the following paper sizes:

- 8.5 x 11 in
- A4
- 11 x 17 in
- A3

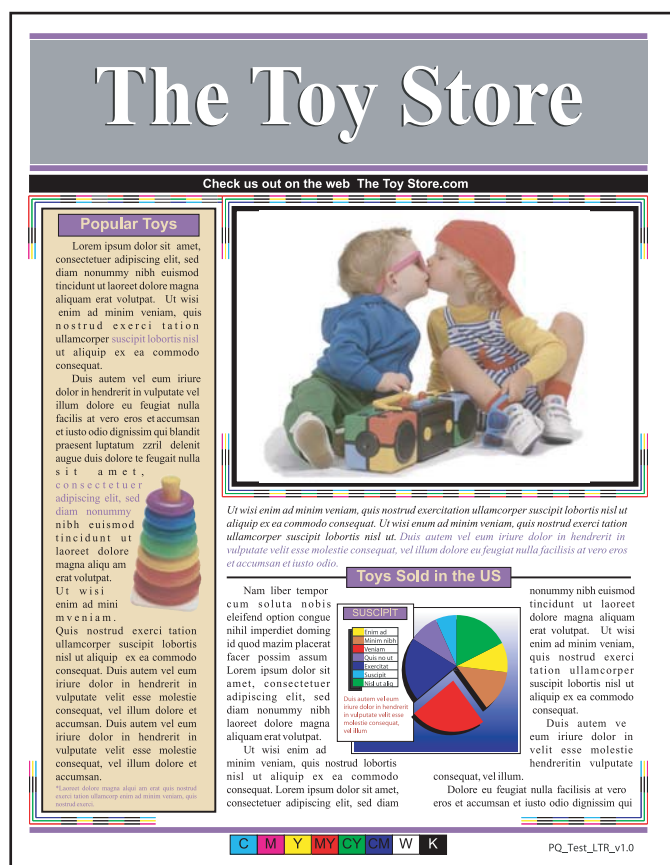
Use the PQ test page d to evaluate overall print quality. The page contains composite gray areas, color registration marks, skin tones, black and colored text, and solid color areas. Use this page as a validation page to check for text and graphics quality, color registration, color reproduction, and color balance.

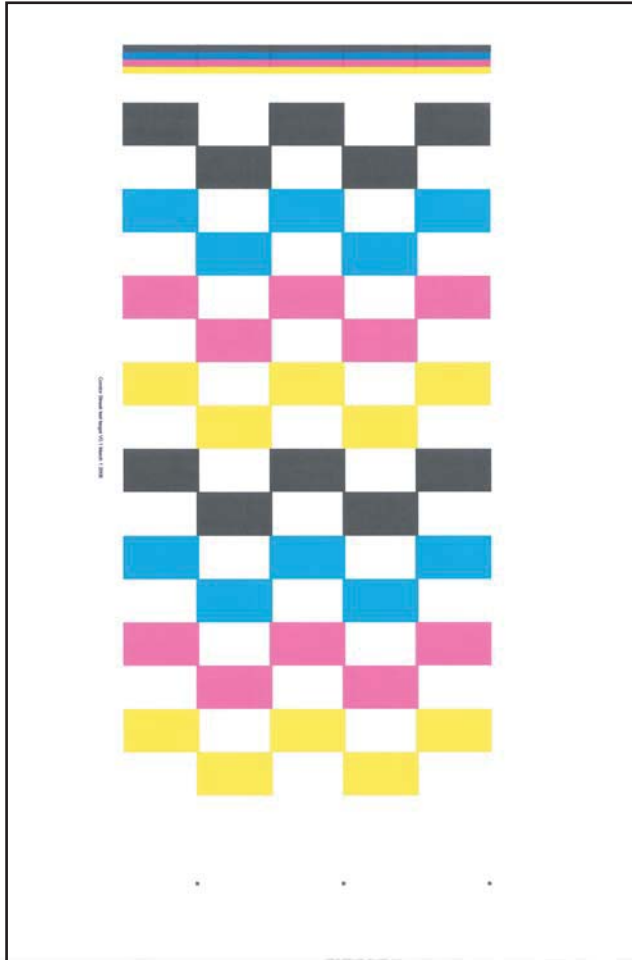
The Streaks test page is one of the three direct drive pages, so the source tray, output tray, and quantity is predefined. This page is a single pass print. Each block is printed with all the nozzles in one die slot. There are 1056 nozzles per die slot. The overlap between the die slots is equivalent to 64 nozzles. Use this page for the streaks test in the Scan and Analyze routine to troubleshoot streaks and vertical banding.

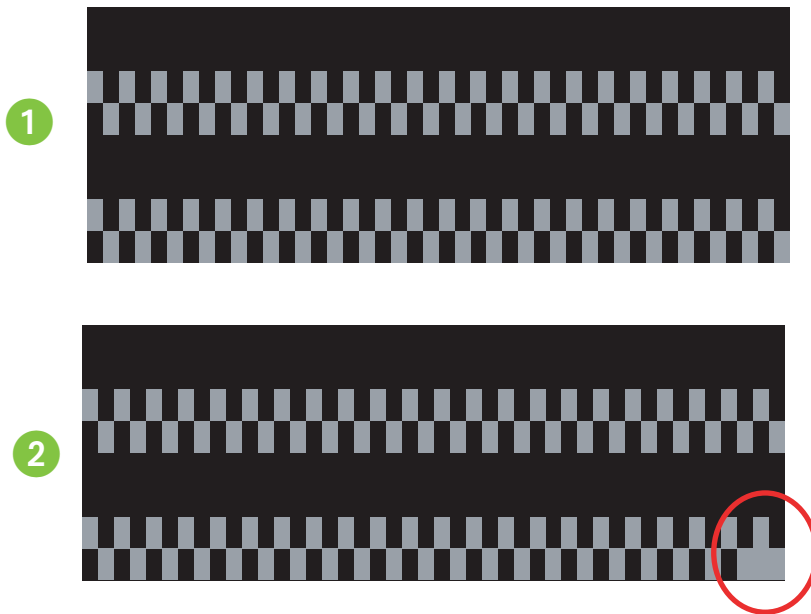
Figure D-3 Die

1	Checkered pattern that indicates healthy Bonding Agent pens.
2	Incomplete checkered pattern that indicates unhealthy Bonding Agent pens.

CAUTION: The Bonding Agent health is not indicated correctly if the Nozzle Health plot is printed on ColorLok media.

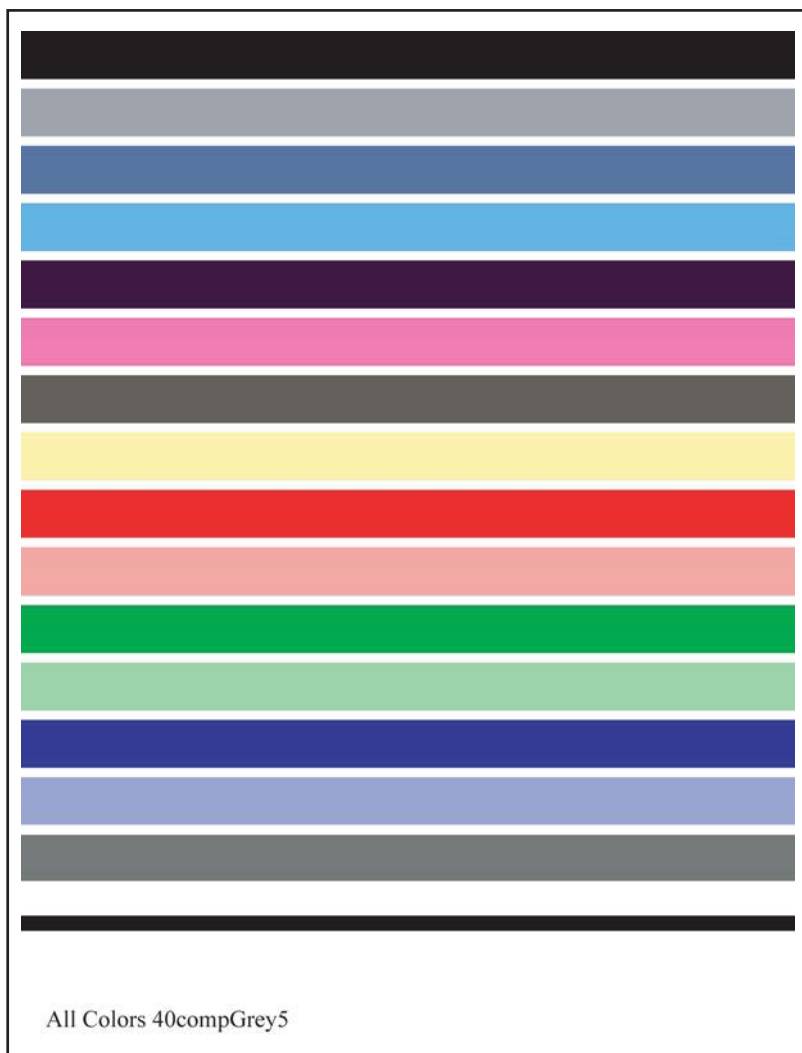
Vertical Banding test page

The vertical banding test page shows the following colors:

- Colored bands of primary colors CMYK
- Composite primary colors RGB
- Additional colors
