18-10-2014; picking up the ReVox

Overhauling report ReVox-A77-MKIV-2 track serie nr. G243567

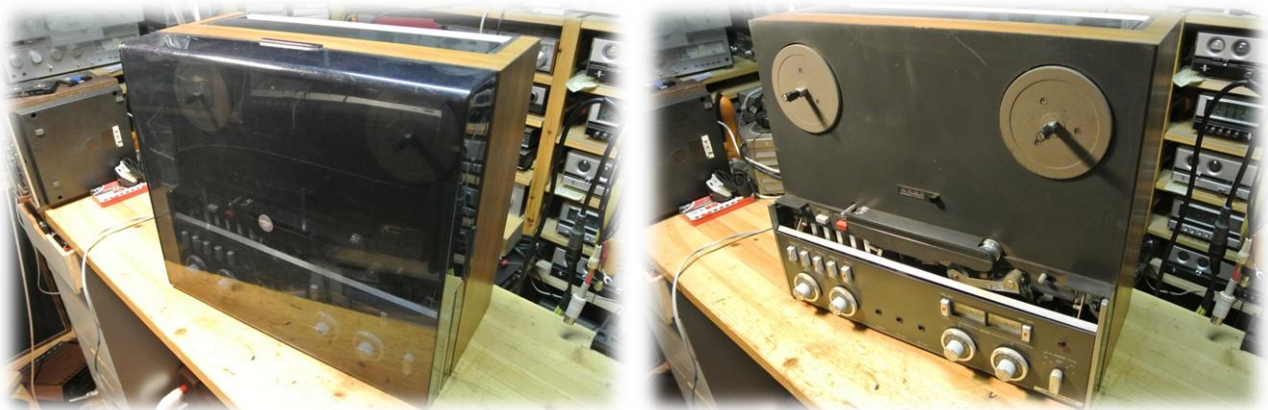
27-10-2014; the ReVox on my working bench

The recorder had to wait about one and a half week before it could on the workbench, there still was a Philips N4512 on the workbench with a broken print. The first findings of the A-77 were not disappointing: heads are neat, complete, lettering is still intact, no major damages. A small damage to the woodwork on a corner, an advertising sticker on the front, the plastic supports under the Cabinet are missing so on the bottom some light scratches, too bad but we will find an alternative for that. For the rest the recorder looks nice and dusty as usual.

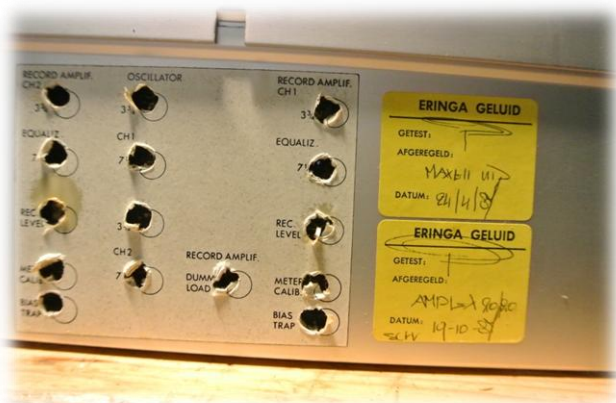
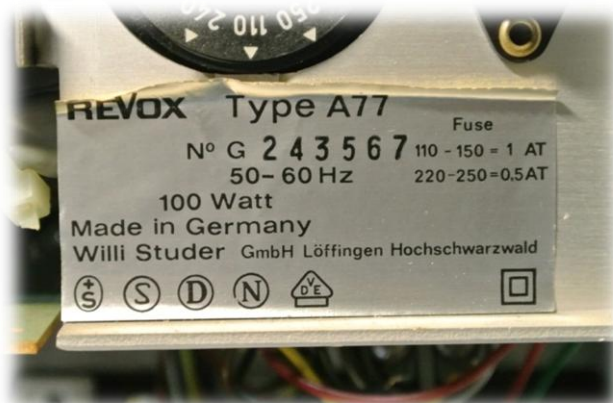
Unfortunately no amplifier prints, that is disappointing, I hoped that they were there. For the rest the recorder looks perfect on the inside, a little to no dust, no nicotine tarnish, everything seems original which is generally a good sign. The counter belts need to be replaced. According to the sticker on the bottom the recorder has been adjusted in 1987 by "Edmund sound", which is already 27 years ago so a fresh service job seems to be in place.

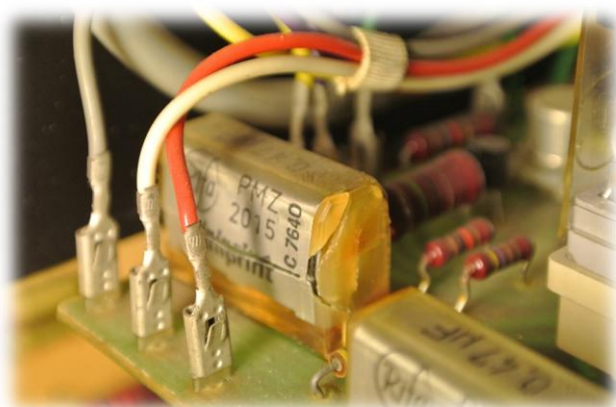
Important is when starting up an old ReVoX A77 you have to keep an eye on the RiFa metalized paper capacitors. It turned out that this is often the cause of failures. There are several known cases they can explode as a result of drought of the material, which in that case can cause short circuiting. That is also the case with this A77, the RiFa's swelled already pretty bad and started to show cracks. Immediately I switch off the power and the first thing is to replace all of the RiFa's.

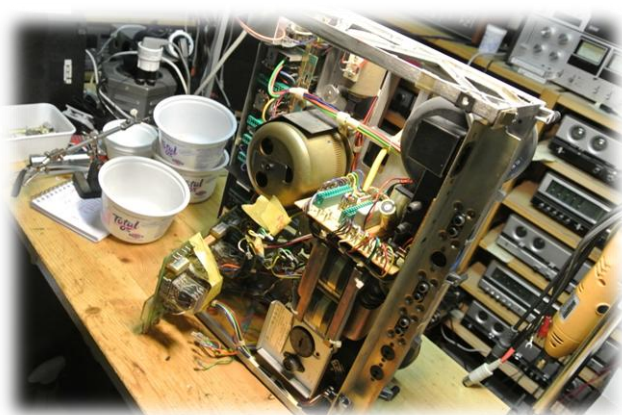
31-10-2014; preparing the overhauling

In the mean time I start the preparation for the overhauling: I removed all plug-in PCB's (Printed Circuit Board), I numbered the PCB's and I also noted these numbers on the recorder itself so later on I know where they belong, this saves up time by replacing them. All fixed PCB's will be disassembled if necessary. Wire connections are disconnected, I always make a lot of pictures and also make drawings of the wire connections. When the PCB's have replaced I can check the wire connections. I don't trust the Service Manual on that.

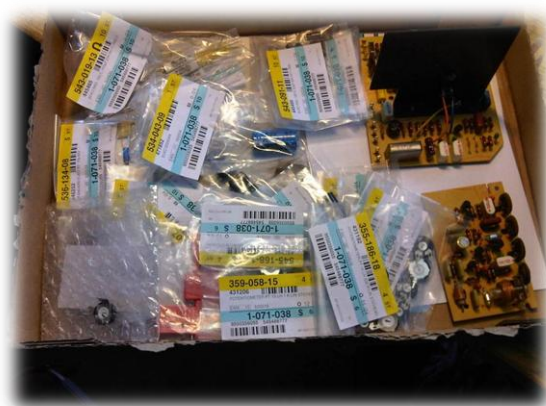
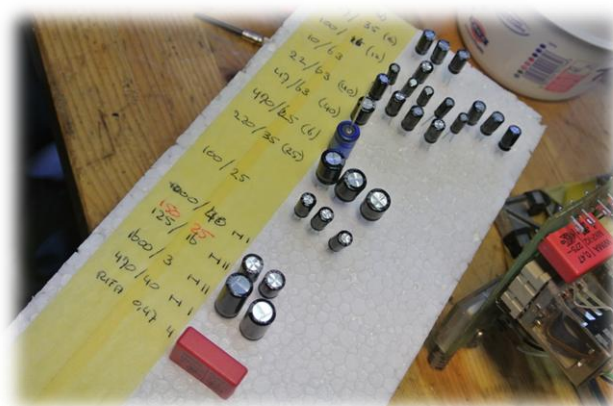
5-11-2014; new parts have arrived, sorting the parts

Always nice to get such a package with new parts with an overhauling in prospect. Right here the capacitors are sorted, this way you save up yourself a lot of time to searching during overhauling.

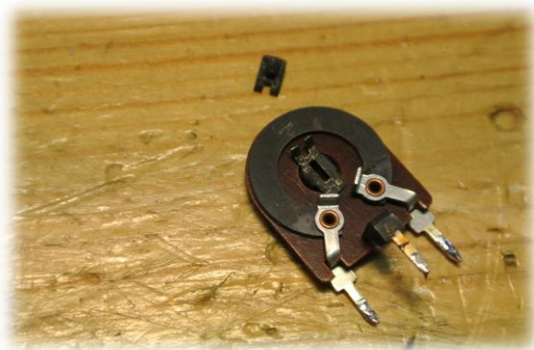
Next I overhauled the plug-in PCB's, all capacitors and weak set-up potentiometers are replaced. Sometimes the runners of the original set-up potentiometers came of spontaneously.

I measured the original setting of the old potentiometer, next I set the new potentiometer to the same value before soldering the new potentiometer on the PCB. Now I know that the setting is at least in the right direction.

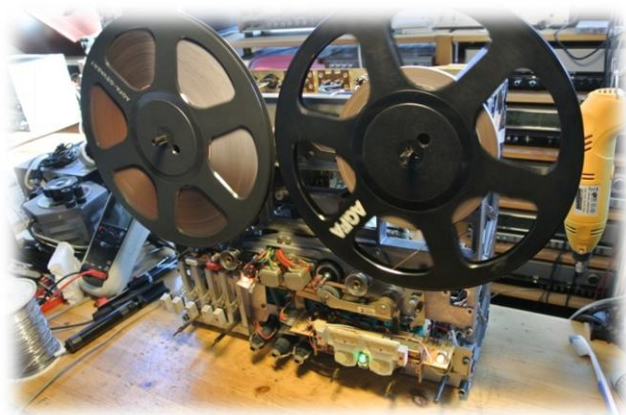
9-11-2014; first checks

At first I check if all functions are working correctly. All functions appear to work fine, play, winding left, winding right, record, brakes, no problems at all. Some creaking of the switches fixed with an IPA treatment. There is also a clear volume difference between source and recording, but that was to be expected given almost all setup potentiometers have been replaced. So the next step is to adjust the recorder in accordance with the service manual.

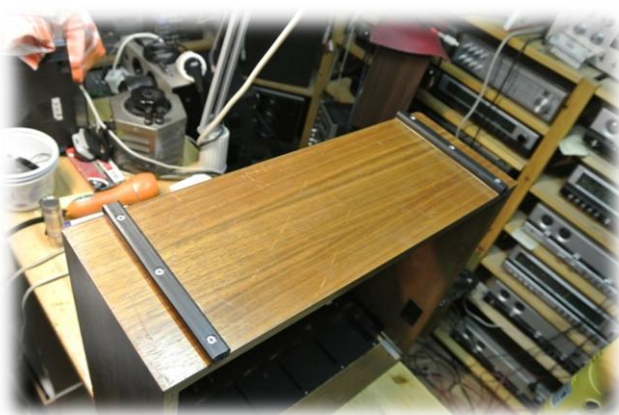
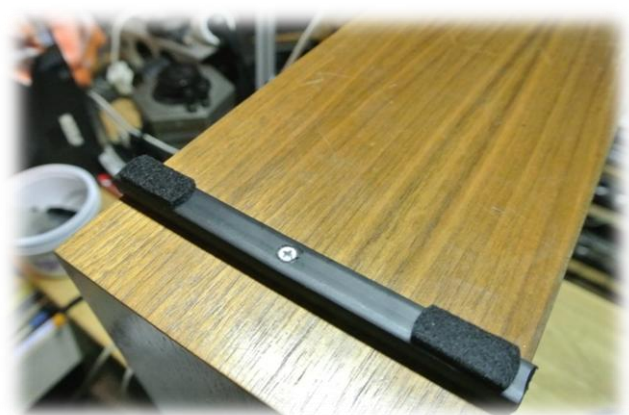
17-11-2014; new supports

The Cabinet provided with two new supports, not original, I know but the height is the right size and it looks acceptable in my opinion.

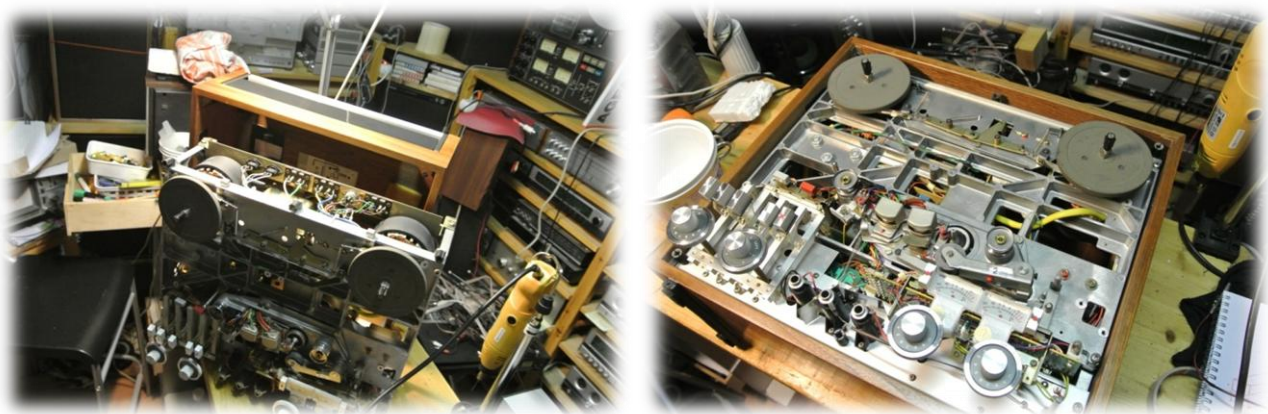
17-11-2014; replacing the A77 in its cabinet

The cabinet is ready and the recorder can be replaced in its cabinet. Replaced bottom plate, removed service pins, removed dummy plug of the remote control and gently placed the recorder back into the cabinet. The mounting screws back in and the recorder can get back on his back. We are not done yet.

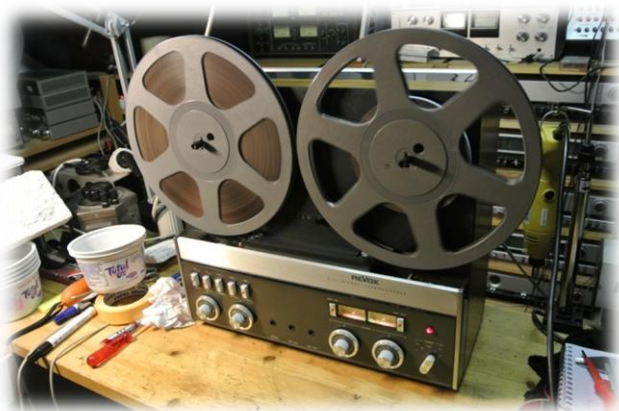
17-11-2014; front panels back on

Finally, the front panels and buttons mounted back on the recorder, two reels, one with tape and we can play. Everything is working fine again, sounds fine to me, no audible difference between source and recording and it looks neat again. I am very satisfied with the result and can enjoy this ReVoX A77 for many years again.
