Service Manual Be-Ge 8652 Recommended Maintenance		Datum/Date 2004-10-22
			Utgåva/Issue 1
			Sida/Page 1(14)

Illustrated seat
Be-Ge 86-52
incl Rotolift 3

Recommended Scheduled Maintenance

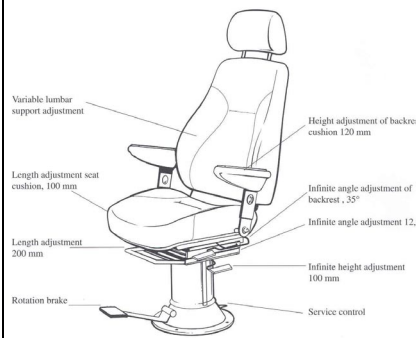
Inspection	Service Instruction	Illustration
<p>1.</p> <p>Check that the seat adjustment controls work normally and that foreign objects do not jam them.</p> <p>If the seat is fitted with safety belt, check that all belt elements are undamaged.</p>	<p>Remove objects, if any.</p> <p>If any adjustment control does not work normally – <i>See service items 3–8.</i></p> <p>If any belt element is damaged, replace the entire belt kit. <i>See service appendix 5.</i></p> <p>If the seat is very dirty then it can be cleaned/sprayed with normal textile cleaning. The textile cleaning and protection kit can be supplied by Be-Ge Industri AB.</p> <p>Instructions on the package.</p>

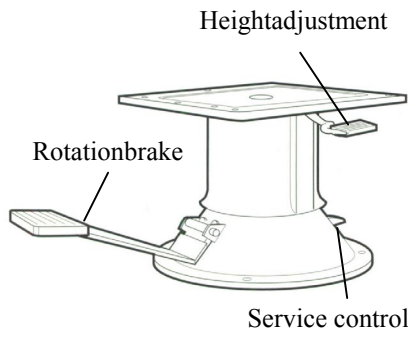
<p>2.</p> <p>Check that the seat retains its adjusted height and that the Rotolifts action is of satisfaction.</p>	<p>If the function does not work satisfactory, i.e. if the seats Rotolift cannot be lowered or raised or does not rotate.</p> <p><i>See service item 8 and service appendix 6.</i></p> <p>If the rotation pedals allowance is more than 2 mm, then the catch plate's needs to be changed.</p> <p><i>See service item 8 and service appendix 6.</i></p> <p><i>An annual maintenance and re-lubricating is to be done according to service appendix 6.</i></p>

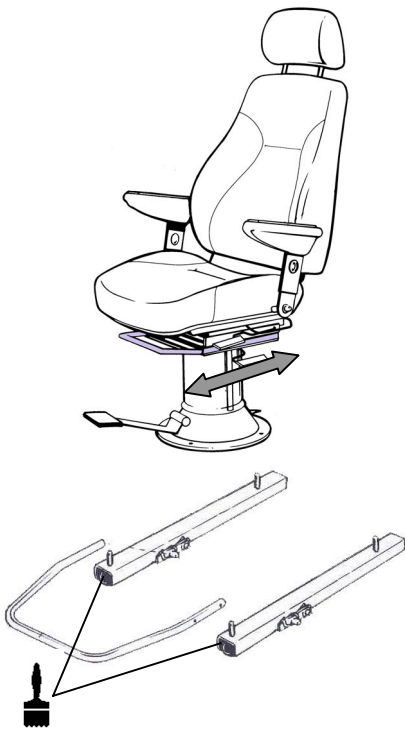
Inspection	Service Instruction	Illustration
<p>3. Check lengthways adjustment.</p> <p><i>Appliances:</i> Lint-free cloth Grease (Texando 20 or the equivalent) Brush Box wrench 13 mm</p>	<p>Lubricate the slide rails of the seat runner thinly with grease (Texando 20 or the equivalent). Move the seat to its end positions in order to lubricate the rails in between. Before lubricating, clean the slide rails with a lint-free cloth.</p> <p>Replace the slide rails, if the allowance (sideways or lengthways) of the slide rails exceeds 1 mm.</p> <p>Replacement of slide rails- <i>See service appendix 4</i></p> <p>An annual maintenance and re-greasing of the seatback and seat cushion slide surfaces is to be done. NB. Make sure of that no grease is added onto the back adjustment locking. Recommended grease is Kernite, Skidoo, or equivalent.</p>

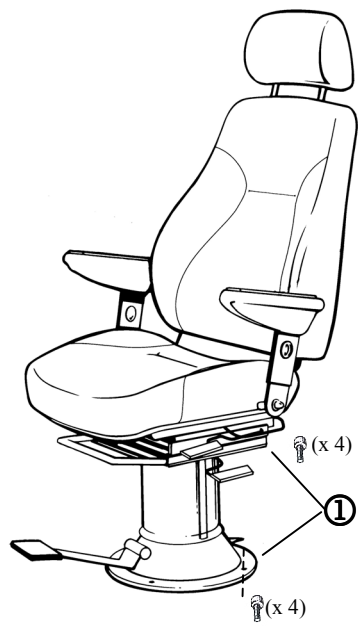
<p>4. Check the bolts and frame fastening of the seat.</p> <p><i>Appliances:</i> Box wrenches 13mm</p>	<p>Check for loose bolts.</p> <p>Check the seat fastening to the floor- and / or the frame (1).</p> <p>To dismantle/assemble driverseat and rotolift- <i>See service appendix 2</i></p>

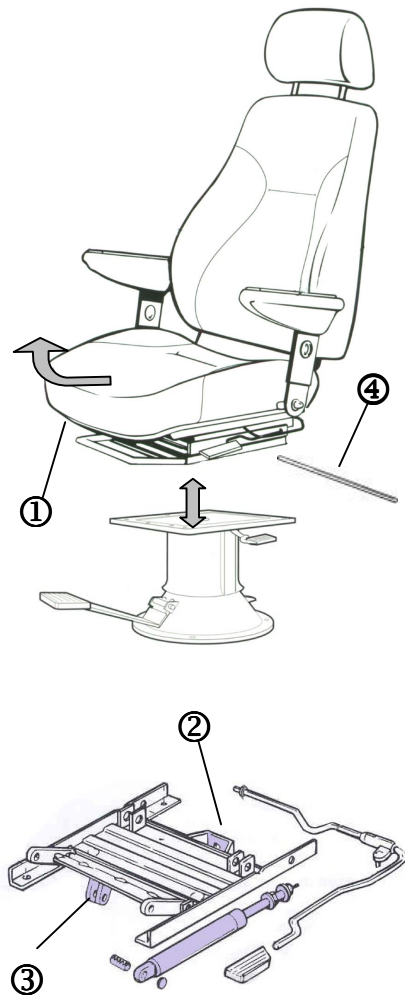
Inspection	Service Instruction	Illustration
<p>6. Check the seat adjuster and the seats lengthways adjustment.</p> <p><i>Appliances:</i> Box wrench 13 mm Slotted chisel Riveting Punch 7 mm Striking tool</p>	<p>If the seat cushion adjuster does not keep position and does not keep the positioned angle, then the seat angle adjustment gasspring needs to be changed.</p> <p>Dismantle the seat from the Rotolift and turn the seat upside down, alternatively remove the seat cushion (1). <i>See service appendix 3</i></p> <p>Loosen the gassprings rear locking (2).</p> <p>Strike out the tension peg at the front attachment (3) on the frame back section alternatively unscrew the gascylinders body from the rear attachments of the fork attachment</p> <p>Change the gasspring.</p> <p>If the seat cushions does not keep it's lengthways position then the latch rod needs to be replaced (4). The latch rod is placed underneath the seat cushion and is dismantled/mounted easily, without tools, by pulling the rod sideways out of its fastening points.</p>

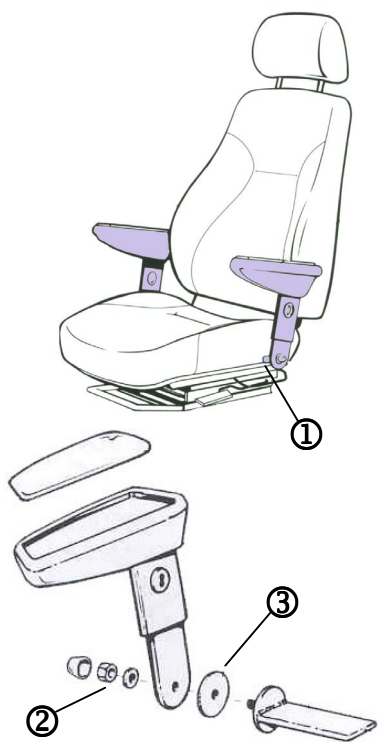
<p>7. Check of the armrests fastening points and folding.</p> <p><i>Appliances:</i> Slotted chisel Box wrench 17 mm Allen wrench 6 mm</p>	<p>If the armrest does not lock in the fastening point in the seat cushion then the lock screw underneath the seat cushion (1) needs to be tightened. (Allen wrench 6 mm).</p> <p>If the folding of the armrest does not work satisfactorily then adjust the nut lock (2).</p> <p>Recommended dynamometric for the inner nut is approx. 10Nm and for the outer nut the approx. minimum dynamometric is 24Nm (max 47Nm).</p> <p>If the slide washer (3) is worn out it should be replaced.</p>

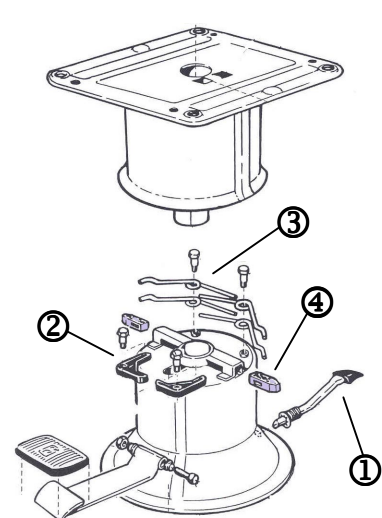
<p>8. Change of catch plate on Rotolifts.</p> <p><i>Appliances:</i> Slotted chisel Box wrench 13 mm</p>	<p>If the rotation barriers function allowance exceeds 2mm, then the catch plate's needs to be replaced. The catch plates are changed by dividing the Rotolift with help of the service barrier (1).</p> <p>Loosen the lock handle (2) and springs (3). Change the catch plates (4) and re-mount the lock handle and springs. See service appendix 6</p> <p>Note. The inner of the Rotolift is sensitive against dirt and great precaution is to be taken when the Rotolift is apart for service.</p>

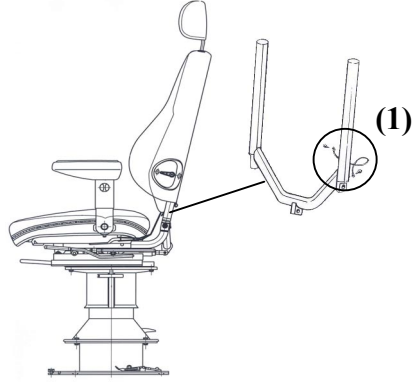
<p>Dismantling seatback</p> <p>1. Disconnect the wire control for the seatback (1)</p> <p><i>Disconnect electrical contacts that are between the back and seat, if any.</i></p>

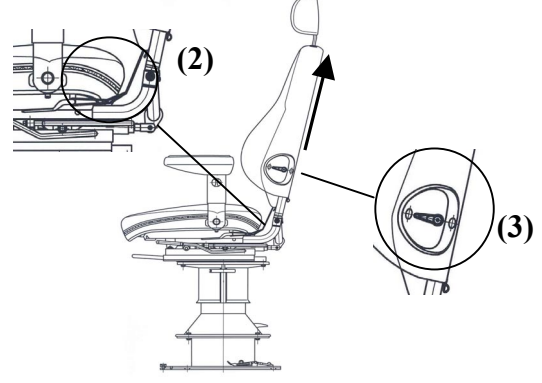
<p>2. Disconnect the rubber band stop in the backrest trim (2) that is connected on the lengthways level in the seat cushion.</p> <p>Release the backrest locking level (3) and pull upwards in order to take away the backrest from the back frame.</p>

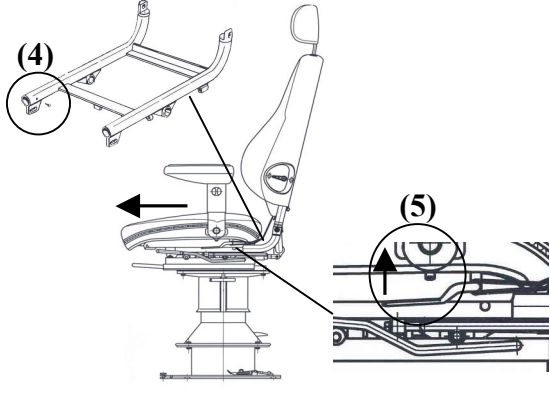
<p>Dismantling seatcushion</p> <p>3. Disconnect the seat cushions locking screw. (4)</p> <p>Disconnect the rubberband stop in the backrest trim (2) that is connected on the lengthways level in the seat cushion.</p> <p>Release the seatcushions lengthways level (5) (two levels, one on each side of the seatcushion) and slide the cushion forwards in order to get it of the seat frame.</p>

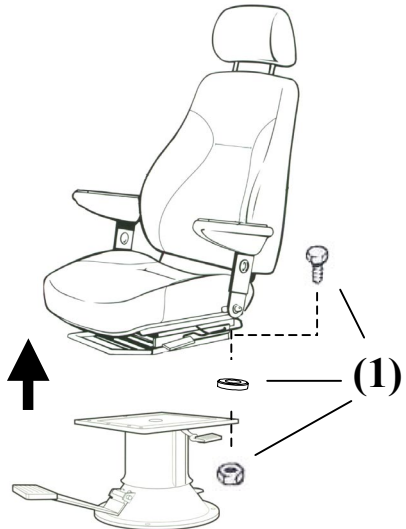
<p>1. Dismantle the seat from rotolift by loosen the bolts (M8x20 x4) and nuts (M8 lockn. x4) (1)</p> <p>NB The washers!</p> <p>Use a spanner, box wrench or a socket wrench 13 mm.</p>

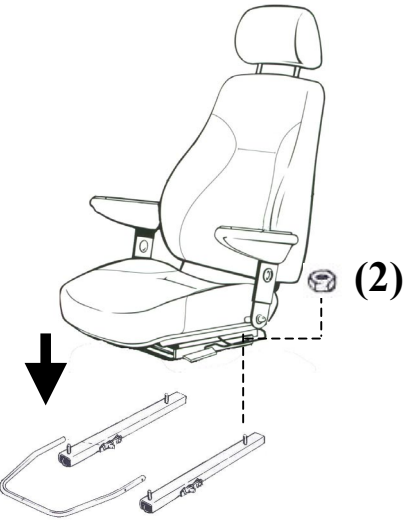
<p>2. Dismantle the slide rails by loosen the nuts (M8 lockn. x4) (2)</p> <p>Move the seat to its front position to reach the rear bolts and to its rear position to reach the front bolts.</p> <p>Use a spanner, box wrench or a socket wrench 13 mm.</p>

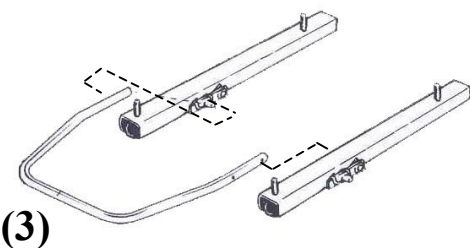
<p>3. Reassemble according to item 1 and item 2 in reversed order.</p> <p>NB the washers!</p> <p>The slide rails loop (3) is attached in pins on the inside of each rail and locked by the tension in springs.</p>

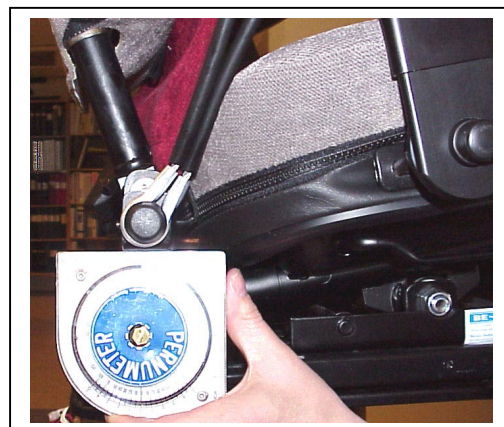
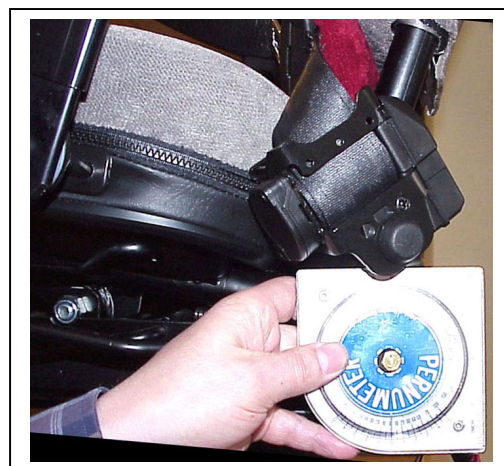
Mounting of 2-point belt on Be-Ge 8652 is done by using existing holes in the seat frame. The belt roller (1) is mounted on the left side of the seat and the belt locking device (2) on the right side.

Dismount the screw that holds the backrest to the base frame and mount the roller belt here with bolt (3), washer (5) and nut (4).

Mount the belt locking device (2) on the oppsite side in corresponding hole with bolt (3), washer (5) and nut (4).

NOTE! The belt roller will not function properly if the angle of its bracket exceeds $\pm 2^\circ$ in comparison with its horizontal plane.

Bracket of the belt roller 0° in comparison with horizontal plane

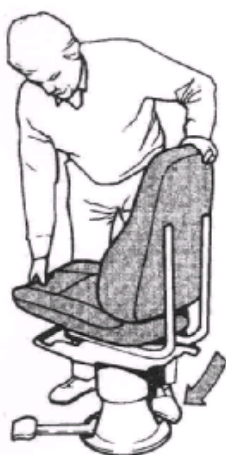
Service instruction **ROTOLIFT 3**

Easy service

The design of the Rotolift permits easy removal of the upper portion when the quick release is depressed. This allows easier access in restricted spaces. When returning the seat to its place, the rotation lock must be pressed down in order to prevent damage to the ratchets of the locking mechanism.

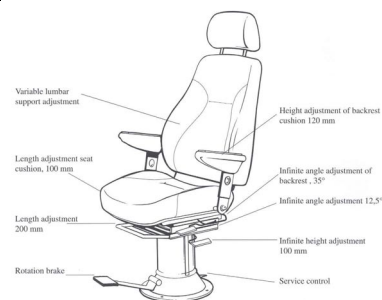
Troubleshooting chart Be-Ge 8652 with Rotolift

Problem	Possible reason	Solution/Action
Be-Ge 8652 with Rotolift 3		
The headrest can not be assembled	Burnt weld in the headrests tubes inside of the backframe.	Drill in the tube with a drill of diam. 10 approx. 200mm
2-way headrest does not stay in requested position.	The headrest pegs has the wrong angle.	Bend slightly the headrest pegs.
4-way headrest does not stay in requested position	The plastic headrest grommet has the wrong dimension	Change the plastic headrest grommet
The seats back seams to have to much allowance and does not work correctly	The gasspring is defected or has got disconnected from its fastening point/s.	Change the gasspring or re-connect the fastening points.
	Heightadjustment barrier does not lock due to dirt/grease or similar	Clean the frametubes, backseats frame and eccenter with CRC TM Bräkleen or equivalent
	Heightadjustment barrier does not lock due to defect eccentric lock	Change backseat cushion

The seats cushion seams to have to much allowance and does not work correctly	The gasspring is defect alternately disconnected from is fastening point/s	Change the gasspring alternately re-connect the fastening points
The armrest seams to have to much allowance and does not work correctly	Need of after adjustment of the nut locking	Adjust the nut locking
	The slide washer is worn out	Change the slide washer
Slide rails of the seat appear to have too much allowance	Defective bearing balls in the rails	Replace the slide rails
Slide rails of the seat appear to be slow	Rails are not clear of the frame	Check for distance washers between seat and rotolift
	Soiled rails	Clean and re-lubricate the slides
Rotolift's heightadjustment does not work or does not work correctly,	The gasspring is defect	Change gasspring
	Dirt or similar is inside of the Rotolift	Clean and re-lubricate the Rotolift
Rotolift rotation does not work or does not work correctly	Catch plates or/and springs are defected	Change the catch plates and/or springs
