Illustrated seat
Be-Ge 9301

Recommended Scheduled Maintenance

— Establ. 1934 —	Service Manual Be-Ge 9000 Mechanical suspension / Static Recommended Maintenance	Datum/Date 2006-07-07
		Utgåva/Issue 1
		Sida/Page 2(12)

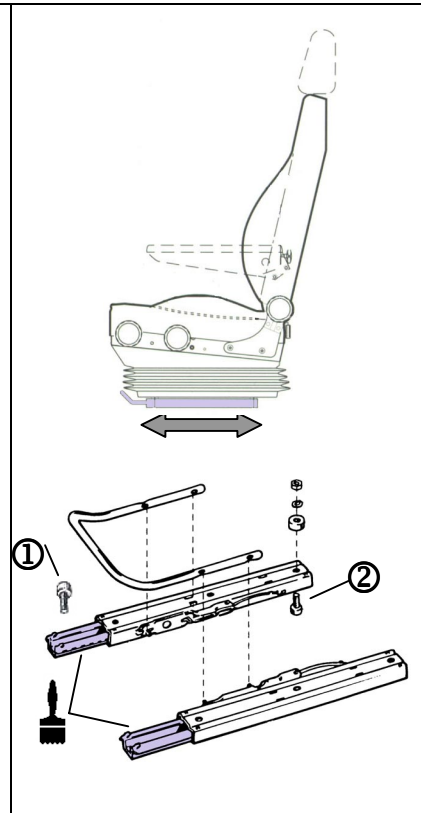
Replace the slide rails, if the play (sideways or lengthways) of the slide rails exceeds 1 mm.

The slide rails are replaced by unfastening the seat from its frame fastening (1).
Move the seat to its front position to reach the rear bolts and to its rear position to reach the front bolts.
Put the seat on its back, ease off the bolts (2) attaching the slide rails to the seat.
To reach, move the slide rails to their end positions.
Fit the new slide rails.
