Insufficient Magneto Voltage Due to Excessive Crankshaft Endplay — diagnoses of the problem and a solution

Kenneth S. Foster
Mentor, Ohio

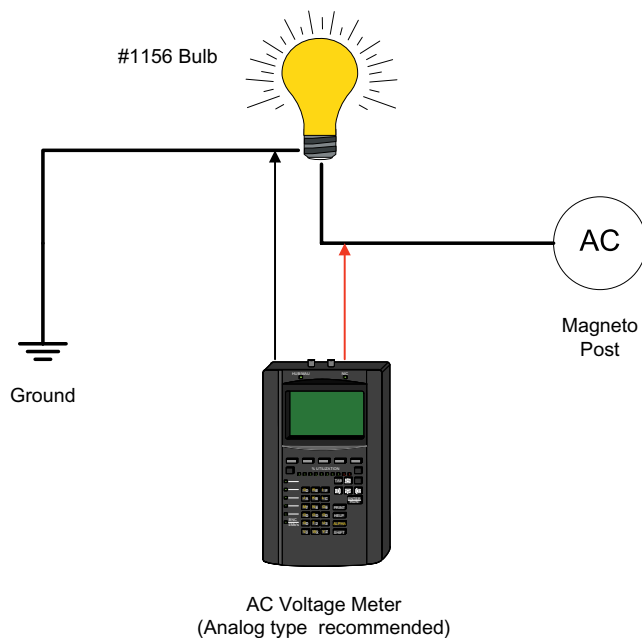
John Regan Magneto Voltage Test Circuit

If all wiring, connections, and switch appear to be in good shape, the next step in the diagnosis is to measure the magneto output voltage. I used the John Regan method. First, you must have a #1156 modern light bulb with a socket to make a test light. This bulb will simulate the electric load of a typical Model T coil. Connect one wire from the bulb socket to the magneto post. Connect the other wire to ground. Start and run the engine on battery with the emergency brake pulled all the way back and set. Using a voltmeter, check the AC voltage across the bulb. I strongly recommend using only an analog voltmeter. Most modern digital voltmeters cannot operate reliably with the varying frequency AC current output of the magneto and the electromagnetic mayhem created by the Model T ignition system. Following is a diagram of the test circuit.

Here is the data I measured on my car:

Engine Speed	Observed Lamp Brightness	Measured Voltage V (AC)	Expected Voltage V (AC)*
Idle	Dull orange	2.97	9.8 @ 400 RPM
Moderate Speed	Somewhat bright	6.42	18.8 @ 800 RPM
High Speed	Somewhat bright	8.56	26.2 @ 1200 RPM

The voltage I measured was definitely low. The general belief is that 7 to 8 volts AC and a dim bulb at a brisk idle is usually good for reliable operation. At moderate speed, expect 12 to 15 V and a bright bulb, and 20 plus volts at high speed with the bulb burning out. But why was my voltage low? Are the magnets too weak? Is there too much space between the coils of the magneto and the magnets on the flywheel? Why did the engine run on magneto for a while during my drive described above?

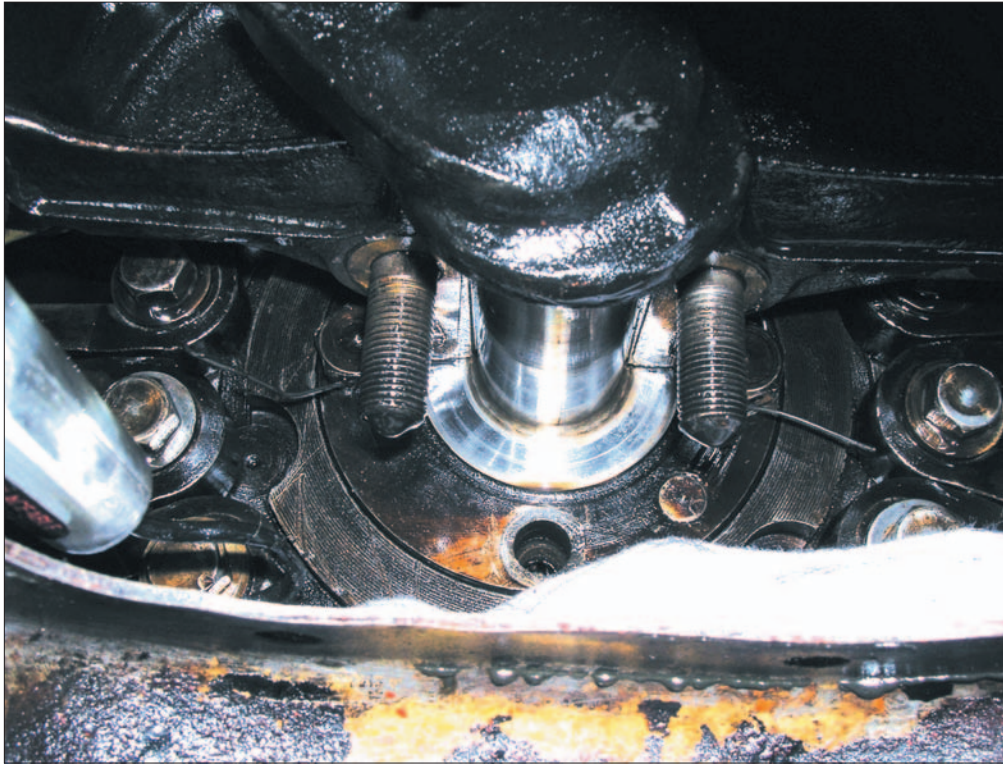
Photo 1: Inside of the engine with the rear main bearing cap removed

Photo 1 is a picture of the inside of the engine with the rear main bearing cap removed. Unfortunately, the picture does not convey the cramped area in which you must work.

main bearing cap. At this point, I made an attempt to get a feeler gauge between the bearing cap and the thrust surface of the crankshaft. This is extremely difficult, but I was able to insert a .013" gauge in the gap, confirming the external measurements I had made earlier. Cotter pins are removed from the two nuts, and the nuts can be removed with a modern wrench. However, the cap cannot be removed until one of the four bolts which hold the flywheel in place is removed. These are safety wired together. First, you must cut the wire and carefully remove it. I stuffed rags into the pan under the transmission so that if I fumbled a wire, it would not fall down out of reach. With the wire removed, a flywheel bolt can be removed, and the bearing cap will slide off the cap bolts. The factory specification length of the rear main bearing cap is 3.125". Mine measured 3.117", .008" under spec. I then sent the cap to Steve Coniff for restoration.

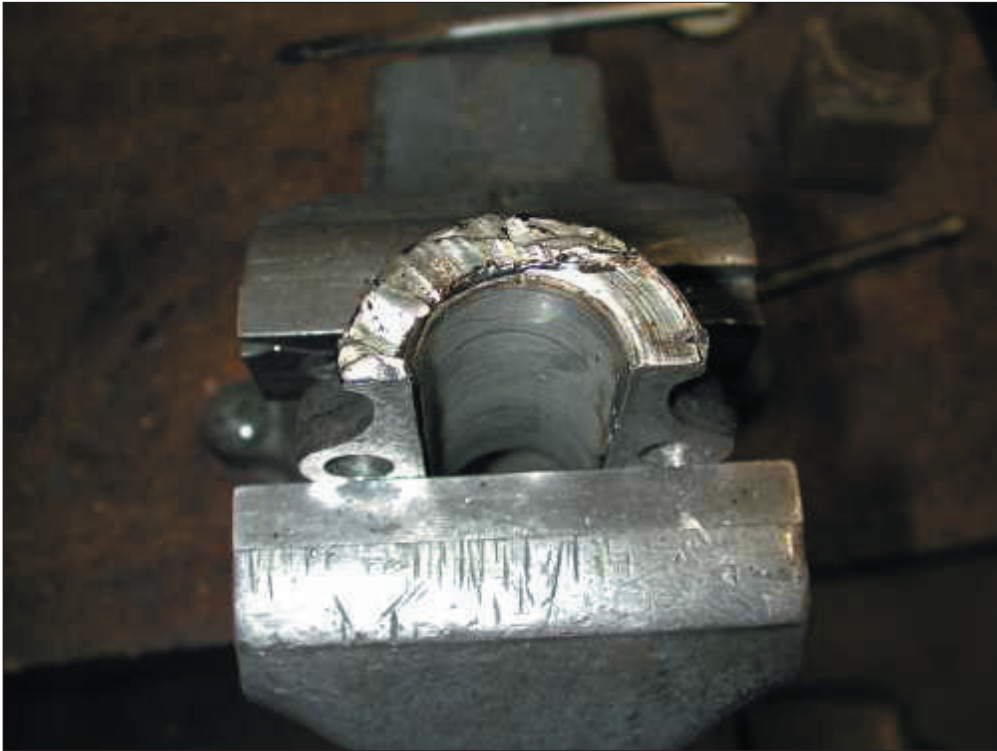
Photo 2: Adding babbitt to the thrust surface of the rear main bearing cap

babbitt on the journal part of the cap is not melted. Repeat this operation until you have covered the entire thrust surface as shown in Photo 2.

The next step is to build up the thrust with new babbitt. Reflux the cap and start applying babbitt with the soldering iron. The surface will be rough until you lay the iron down onto the thrust and rotate it. Again, care must be exercised that the babbitt on the journal part of the cap is not melted.

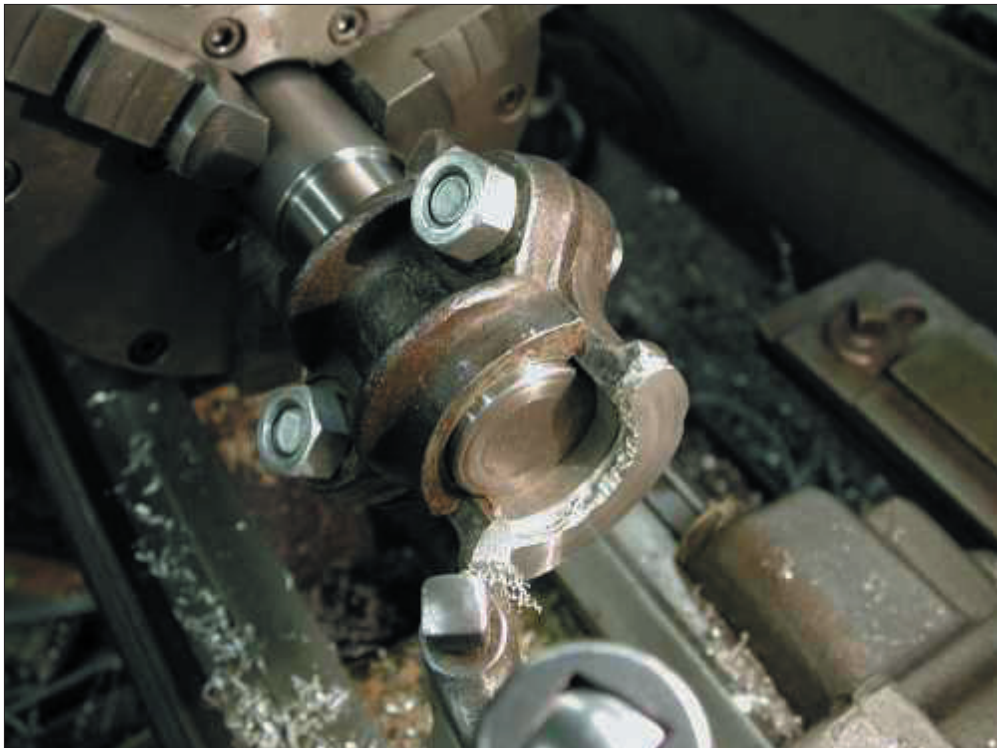
Photo 3: Cutting the thrust surface

The next step (See Photos 3 & 4) is to cut the thrust surface. Measure the inside of the two crank flanges so you know how long to make the cap. When new, the rear main bearing cap had about .003" end play. Typically, a rebabbitted rear main bearing cap

will have .006" to .007" end play because of wear on the crankshaft. There are several ways to cut the thrusts. You can use a K.R. Wilson thrust cutter or cut the cap in a lathe. Cutting the cap in a lathe will result in a more parallel surface. Machine a bar the size of your crank journal and mount it in a chuck. Place the cap on the bar and secure it tight with another main cap. Face the cap until both sides are parallel and smooth. The thrust surfaces should be equal distance from the bolt hole left to right and the total cap length should meet the required length measured earlier. There may be a little work to do with a file to clean up a few rough places.

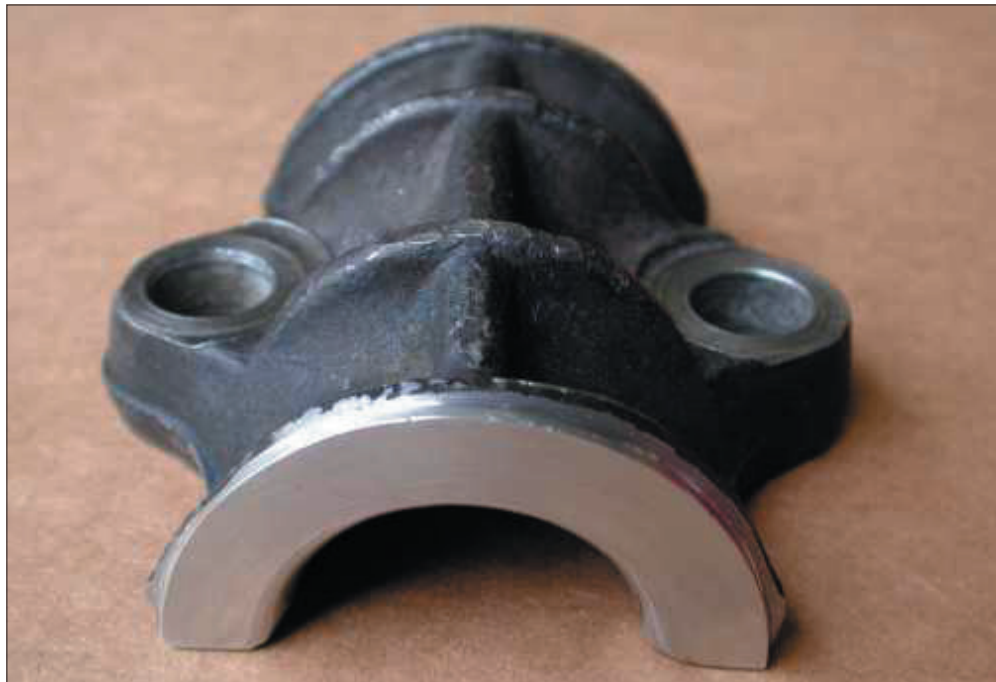
Photo 5: Finished bearing cap

Photo 4 is a picture of the completed rear main bearing cap:

When the cap was returned from Steve, it measured about 3.128" in length and I could not fit it into place. I removed about .0015" of cap length by carefully rubbing each end of the cap on 320 grit wet sandpaper on a piece of glass. It then would slip into place. Note that at this step the clutch pressure should be released with the emergency brake lever all the way forward. The crankshaft can be moved forward and back slightly to facilitate the cap installation. Nuts are reinstalled and cotter pins replaced. The flywheel bolt removed is reinstalled, and the safety wire is replaced.
