Keeler Applanation Tonometer

Service Manual

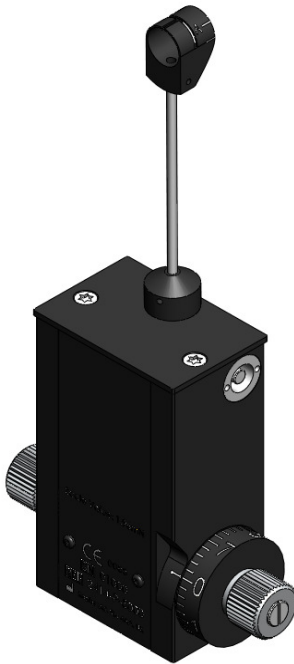
Figure 3 – 2414-P-5000

This document will focus on the calibration of the main assembly of the tonometer (2414-P-5000) shown in Figure 3. Both the R-Type and the T-Type use the same main assembly.

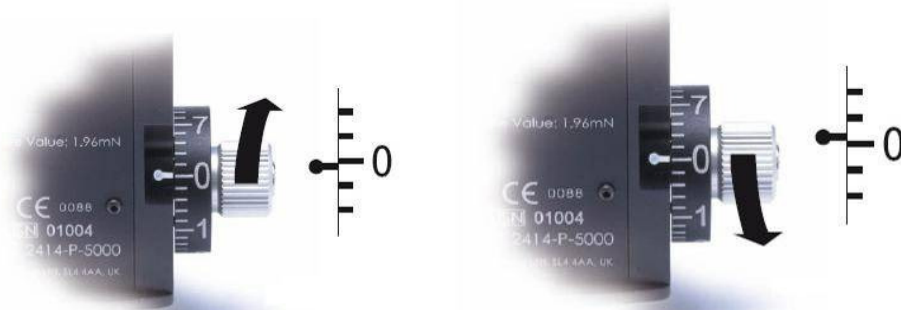
Figure 4

The swing arm should swing when the dial is moved from the positions shown in Figure 4.

If the arm does not swing in this location it has failed calibration at 0

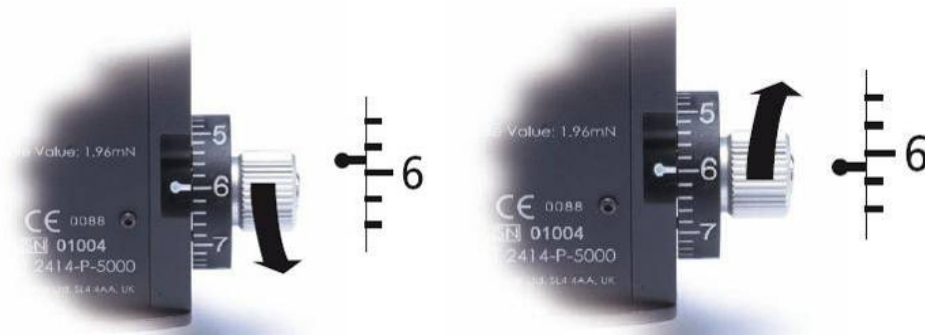
Figure 5

The swing arm should swing when the dial is moved from the positions shown in Figure 5.

If the arm does not swing in this location it has failed calibration at 6.

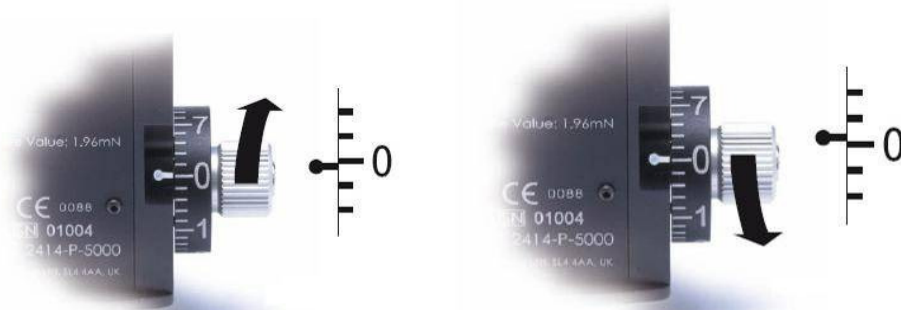
Figure 23

If Zero reading is towards '7' on Dial – Move Pendulum toward operator.

If Zero reading is towards '1' on Dial – Move Pendulum away from operator.

Pendulum is set correctly when Prism Arm swings each side of the Zero line as shown in figure 69. After adjustment of Pendulum, lightly tighten Grub Screws to hold in place.

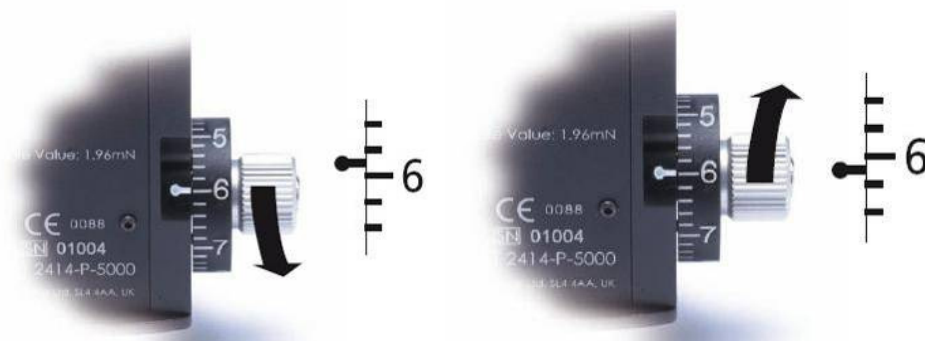
Figure 24

If reading is greater than 6 on Dial – Move Tee Arm Weight out.

If reading is less than 6 on Dial – Move Tee Arm Weight in.

Adjust until Prism Arm swings each side of 6 on Dial as shown in figure 70.
