Gunite Brake Drums

Maintenance and Installation Manual

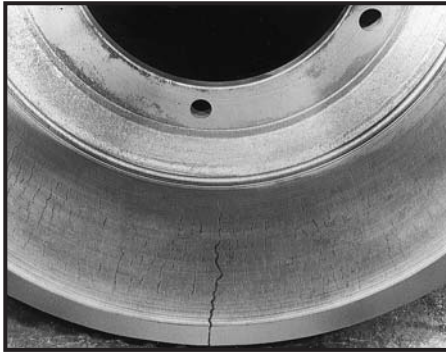
Following are some of the more common problems encountered during regular brake drum inspection and the recommended procedures for correcting the problem.

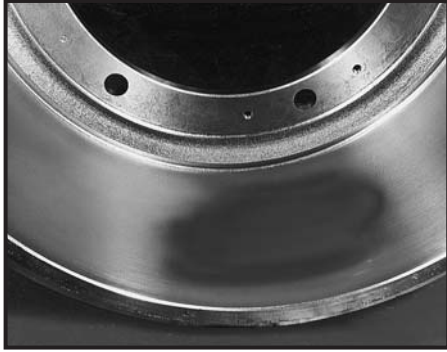
Grease-Stained Drums

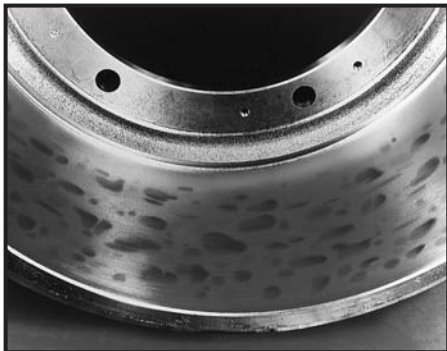
Martensite Spotted Drums

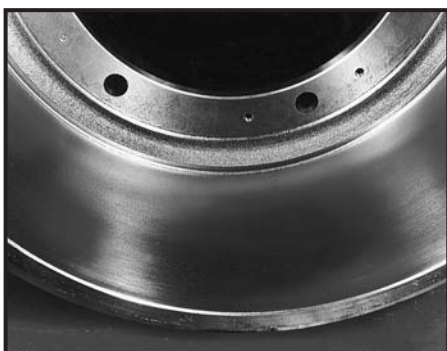
When checking brake drum diameter for wear, the diameter should not exceed 0.120" over the original diameter. When reboring brake drums, the finished diameter should not exceed 0.080" over the original diameter.

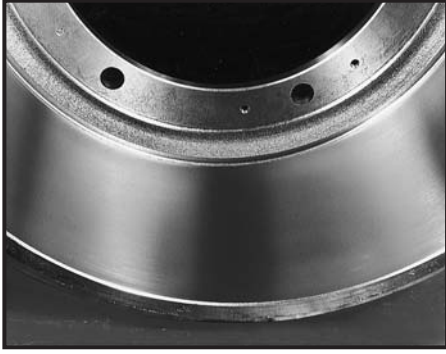
If this condition is left unresolved, it can result in the development of a martensite condition or cause the drum to crack.

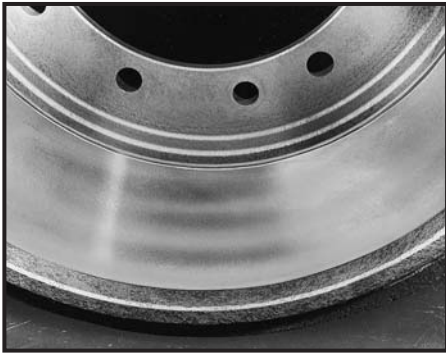
It is a recommended procedure to sand the braking surface of the drum at the time of relining.

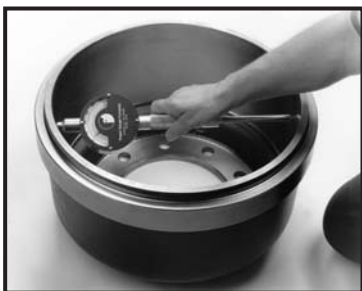
When checking brake drum diameter for wear, the diameter should not exceed 0.120" over the original diameter. When reboring brake drums, the finished diameter should not exceed 0.080" over the original diameter.

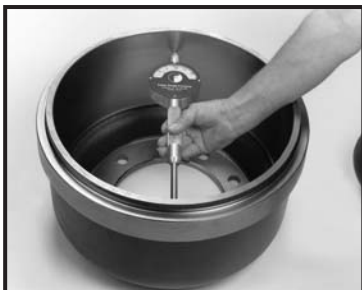
When checking brake drum diameter for wear, the diameter should not exceed 0.120" over the original diameter. When reboring brake drums, the finished diameter should not exceed 0.080" over the original diameter.

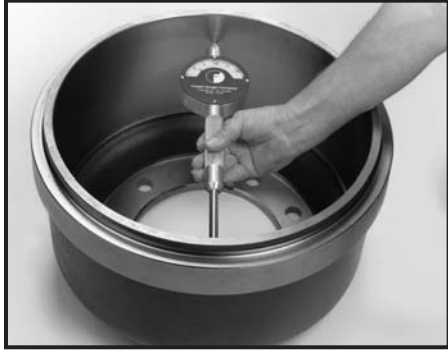
Oversized (Worn) Drums

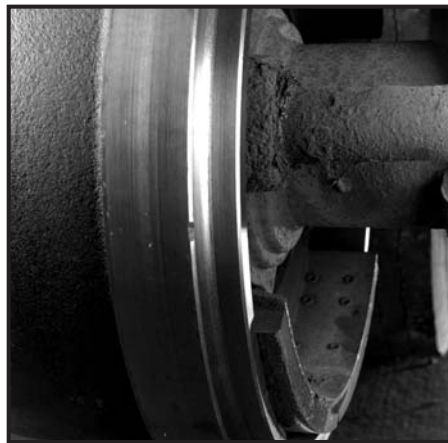
Improper Application Of Brake Drum

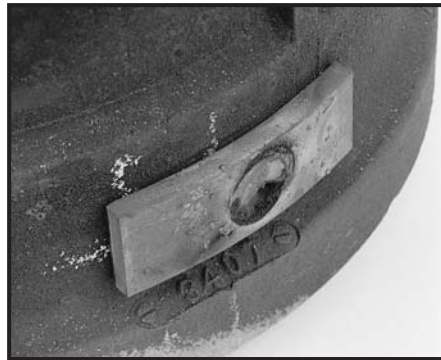
Welded balance weight

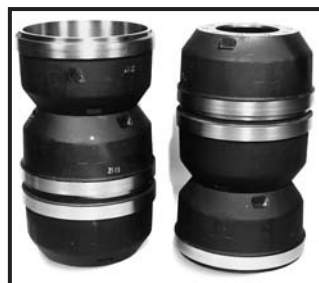
Drums should be stored in an area free from excess moisture and stacked as shown in Figure 1, to ensure proper distribution of weight on the sidewalls of the drum. Properly stacking new drums will avoid distortion of the sidewalls or damage to the braking surface.

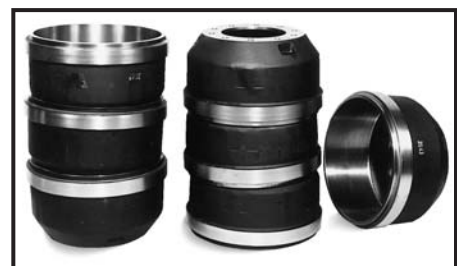
Storing brake drums by “nesting” one drum in another without a designed stacking feature or resting the drums on their side “book end”, as shown in Figure 2, will result in damage to the drums. Storing drums in any of these ways will cause an out-of-round condition to occur which will require machining to restore concentricity before installation. This will significantly reduce the service life of the drum and create unnecessary expense due to the machining of a new drum.

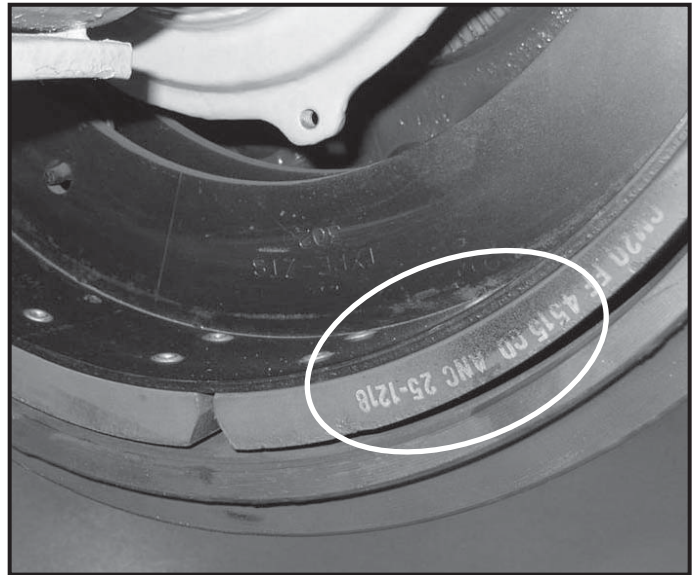
Mounting Gunite Brake Drums on "Hub Piloted" Wheel-end Assembly

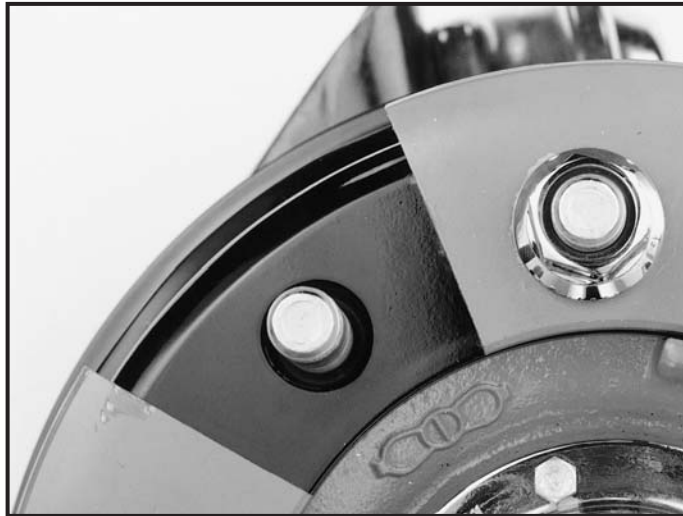
1-1/4" Bolt Hole Front Steer Axle Application
