Copper Cabling Troubleshooting Handbook

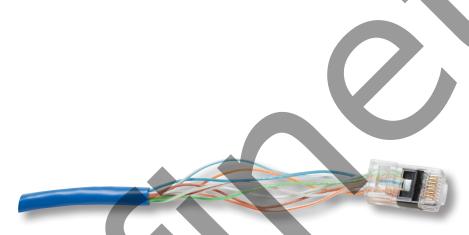
Figure 7: This photo shows a close up of the wire pair termination at one end of the 2-meter patch cord. This is the defect in the tested link.

Figure 7 shows a picture of the actual defect. The wire pairs at the end of the 2 m patch cord are untwisted in an excessive manner and cause the NEXT failures at that connection as well as the marginal return loss problem for pair 4,5 at that same location. The diagnostics described above locate the defects at 18 m from the Smart remote unit for return loss and at 17 m for NEXT. This is indeed an accurate diagnostic. When the test technician locates this point along the physical link, the defect indeed stands out. The most expedient and typically best remedy for a failing patch cord is to obtain and install a good Cat 6 replacement cord. At that time, you should retest the link to ensure that all defects have been corrected and that the link passes. The actual time to execute this repair should not exceed a few minutes.

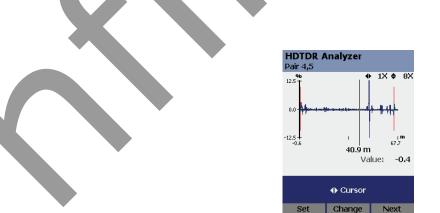
Figure 15: This figure shows the reflection for pair 4,5 only. To show the spike in the reflections more clearly, we moved the cursor a bit to the left. The more significant points of reflection toward the ends show the location of the connectors. The cable segment L2 on the right shows significant reflections in the cable itself.
