# **L23 and 23SL**

## **Owners Manual**

**Leisure Owners Association**

**Issue 1  
May 2012**

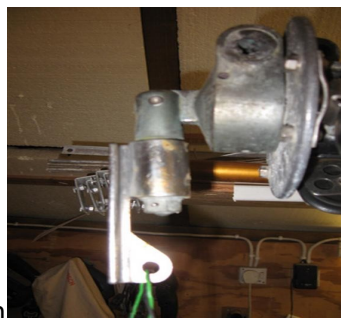
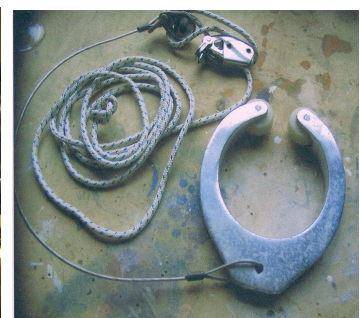
Insert the second split pin into the hole in the track just above the upper gate. There should be a boom downhaul which is fitted between the lug on the under side of the gooseneck and the mast step bolt so that the mainsail, once raised and with the lower split pin removed, can be tensioned by pulling the boom down with the downhaul (Fig 2).

the claw and the mast step bolt. However, many owners have changed to slab reefing, where the sail is pulled down onto the boom and not wound round it. In this case, there should be a fitting underneath the boom so that a kicking strap, with its own jamming block, can be connected between it and the mast step (Fig 2).

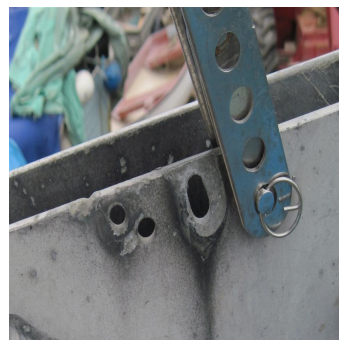
All the deck hardware - cleats, tracks, Samson post, bow roller, etc, are through-bolted pieces of kit, and with the exception of the stanchions, there have been few reported problems. The picture, showing a badly elongated fixing hole in the stemhead, illustrates the need, occasionally, to inspect such items.

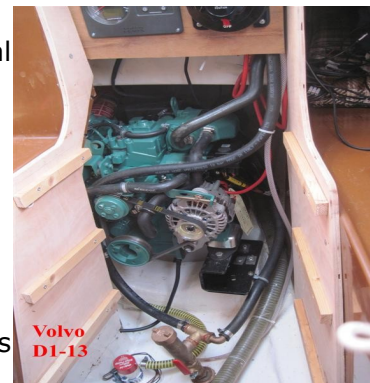
The vast majority of boats now have inboard diesel engines, a few of these being shaft driven, and the information below essentially relates to these inboard diesels. The picture shows a newly-installed Volvo D1-13

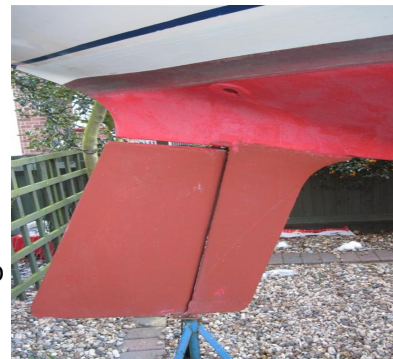
The basic construction of the rudder is a stainless steel frame (though some frames of mild steel are known to exist), encased in a GRP moulding, and filled with foam. Welded tangs secure the frame to the rudder stock. The foot of the rudder stock sits in a pintle bolted to the skeg. The geometry at the foot of the rudder is not good. The stock runs through a plain bearing on the underside of the hull, and through a stainless steel plate holding a (replaceable) nylon bearing at the top of the housing in the cockpit. The stock also runs up through a tube glassed to the bottom of the hull. Although the top of this is open, it is above the waterline, thus effectively sealing the lazarette from water ingress. The tiller pivots vertically in an alloy tiller head casting, which is internally tapered to fit the taper on the rudder stock. The head casting is held either by a screw into the rudder stock, or by a nut on the threaded end of the stock. There is also a grub screw through the side of the casting which locates in an indentation in the rudder stock.

If the GRP moulding becomes damaged by accident, or repeated heavy grounding, it can lose its integrity, allowing water to ingress. If the internal structure is of mild steel, then this rusts, and the fault in the GRP becomes more pronounced. Repair of this critical item is sometimes possible; if this is not practicable, replacement units are available through the Association's approved supplier, Hurst Marine ([Hurst Marine](#)), though not from stock.

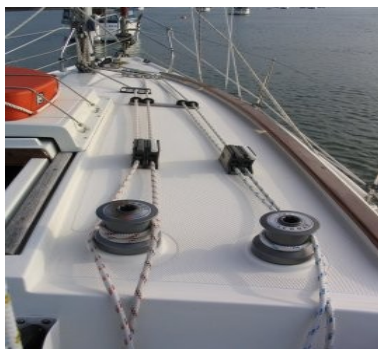
For safety and convenience reasons, many boats have their control lines led back to the cockpit via various turning arrangements of blocks, and via clutches or jammers on the coach roof. The picture shows one such arrangement. Note also in the other picture that there is no downhaul on this gooseneck; it is fixed rigidly to the upper mast step bolt by a metal strap (15mm stainless tubing flattened at the ends), the luff of the main being hauled tight by the main halyard.

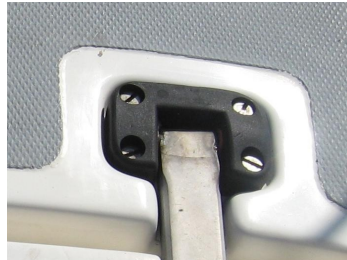
The fore hatch is also a double-sided moulding, which is secured to the deck by two 'rubber' hinges. Many of these hinges have deteriorated with time, and now show severe cracking. The LOA has sourced replacement items, which are available from Hurst Marine, together with

comprehensive instructions for the simple replacement job. The pictures show the 'before' and 'after' situation.

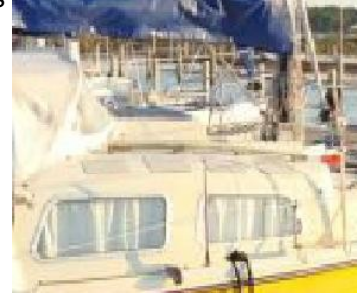
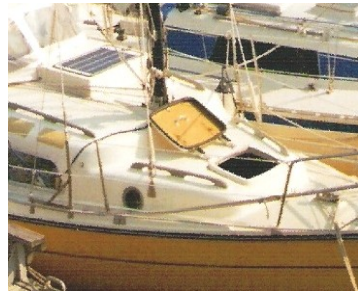
The principal differences from the 23SL are that the main hatch does not incorporate a translucent panel, and it does not slide back, when open, under a protective garage roof as the hatch on the 23SL does. One member built his own garage as can be seen in this picture.

The grp of the forehatch is also a bit thin, which causes the hatch to deform when stepped on. One member laminated an extra layer of 600 grams glass fabric to the back (pictured) which eliminated the problem, and allowed the hatch to be walked on.
