## Step Step Step

### User Manual

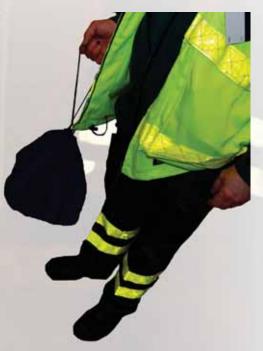
The Carrying Kit is stored in a practical bag that takes up a minimal amount of space.

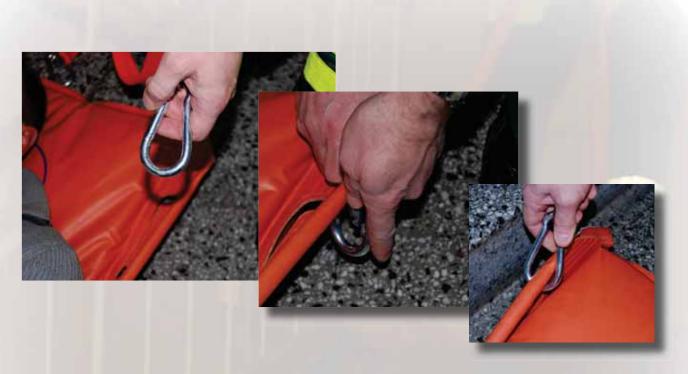
This is how the Carrying Kit and the Emergency Mattress look like when everything is assembled.

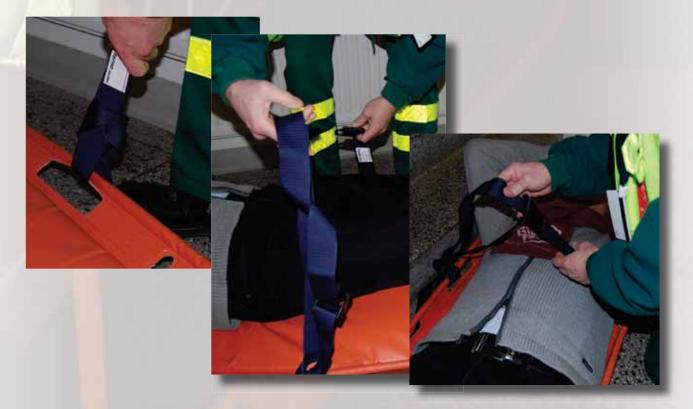
Start by fastening the orange strap without a bag on the top handles on the Emergency Mattress. Insure yourself that the snap hooks, straps and handles are whole.

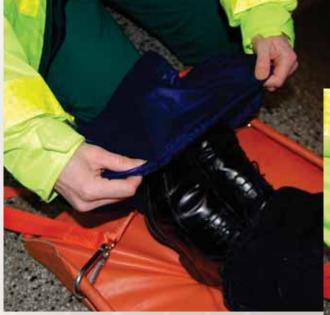
Then you fasten the two blue patient straps on the side handles on a suitable place, the top strap should be as close to the arm crease as possible. The lower strap is appropriate to fasten high on the thigh but under the hip.

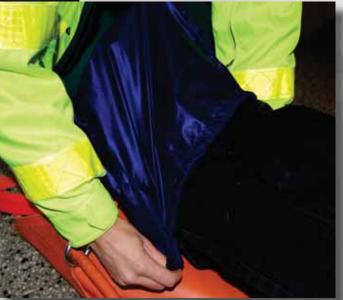
The lower orange strap with the bag should be fastened on the bottom handles on the Emergency Mattress

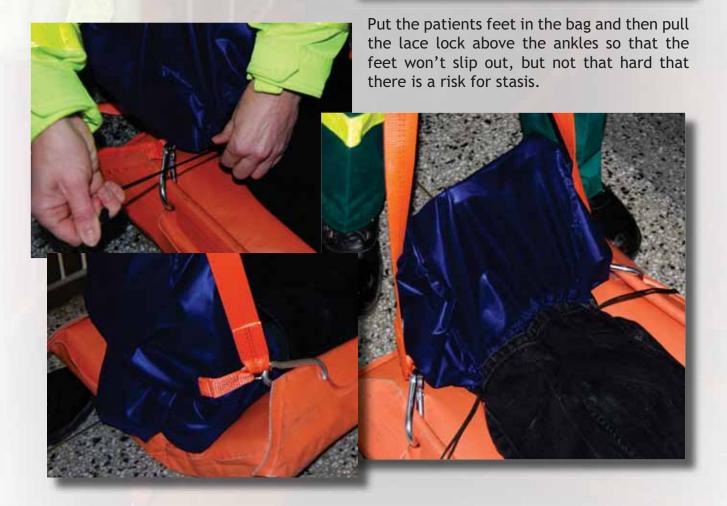
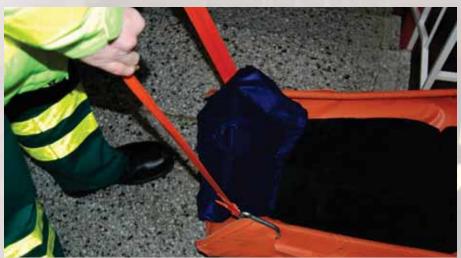
When the patient is secured on the Emergency Mattress the transport can begin.

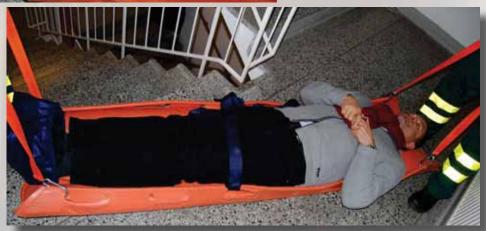
Both operators should hold the orange straps with a firm grip (adjust the grip and position for the best ergonomic position). The operator on the foot end backs down at the same time as he holds the mattress by lifting lightly.

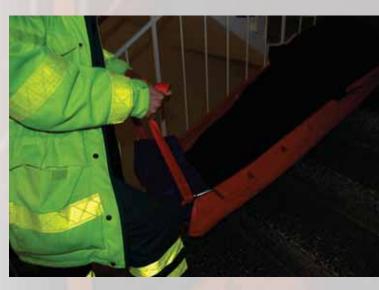
The operator on the head end holds against any pull at the same time that he lightly lifts, so that the patient's head won't hit against the steps.
