WINE CHILLER

Model Number: **WBV21DZ**

SERVICE MANUAL

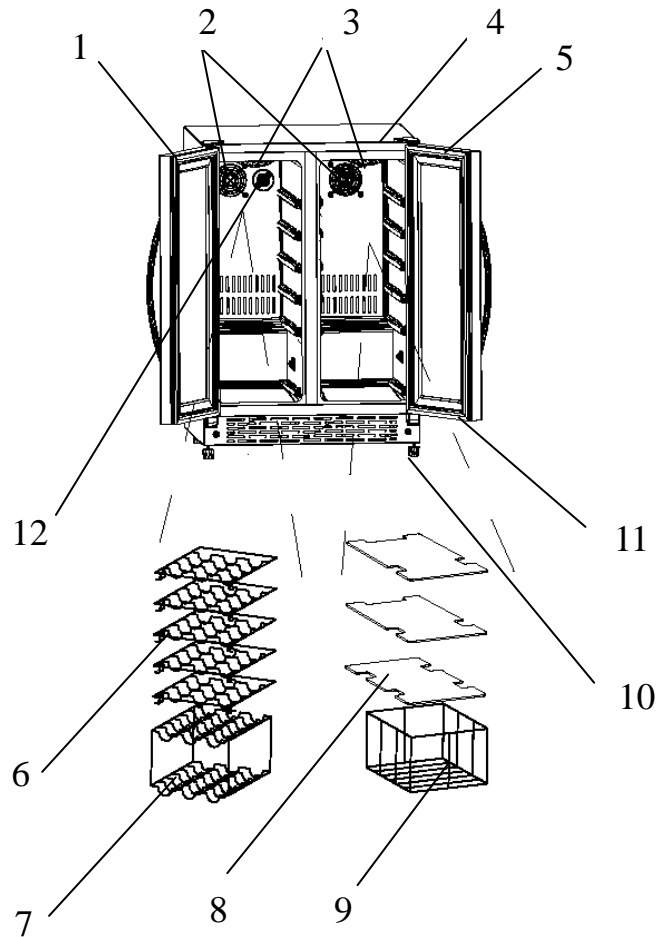
2.1 WBV21DZ

1. WINE CHILLER TEMPERATURE CONTROL PANEL
2. INTERIOR FAN
3. INTERIOR LIGHT
4. CABINET
5. BEVERAGE CENTER TEMPERATURE CONTROL PANEL
6. WINE BOTTLE SHELVES
7. WINE BOTTLE STORAGE RACK / BASKET
8. BEVERAGE SHELVES
9. STORAGE BASKET
10. LEVELING LEGS
11. LOCK
12. CHARCOAL FILTER

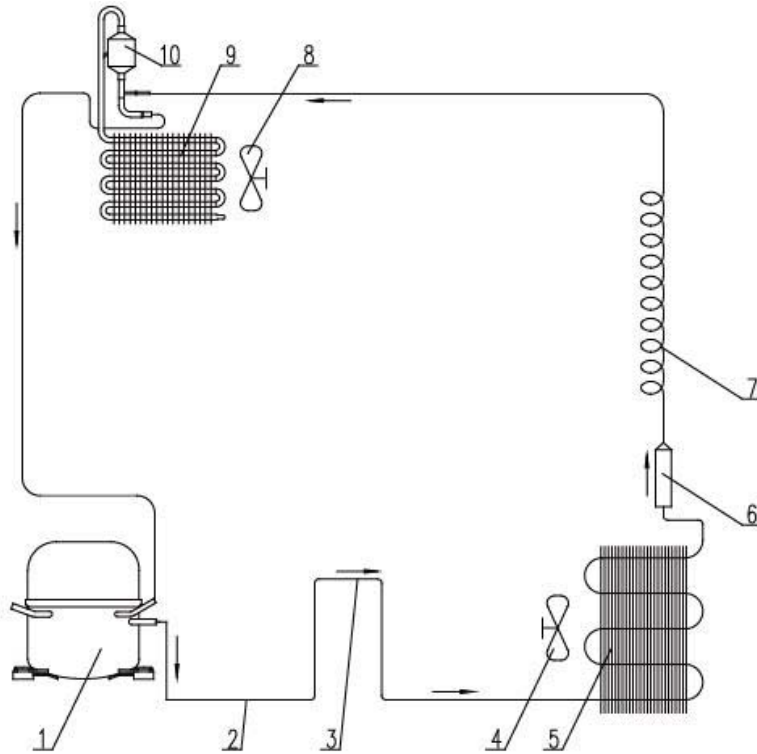
3. REFRIGERANT CYCLE DIAGRAM

1. Compressor
2. Hot Pipe
3. Condenser (Internal)
4. Condenser Fan
5. Condenser (External)
6. Dry Filter
7. Capillary
8. Evaporator Fan
9. Evaporator
10. Accumulator

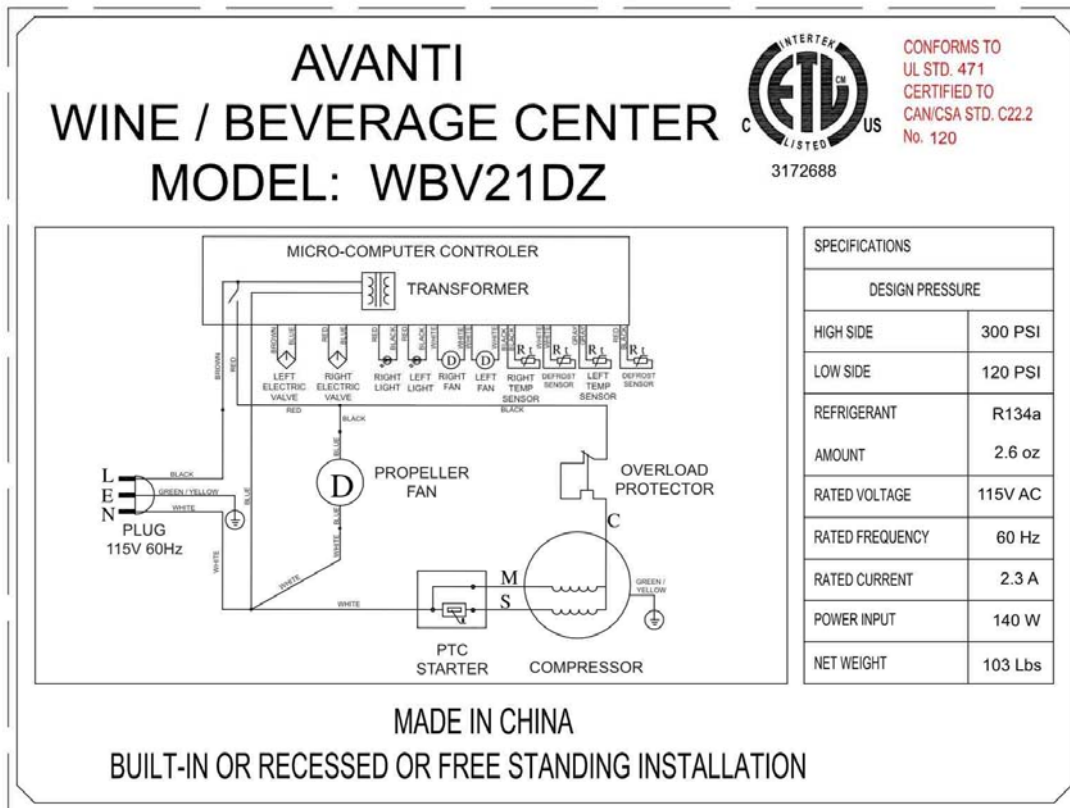
4.1 WBV21DZ

4. WIRING DIAGRAM

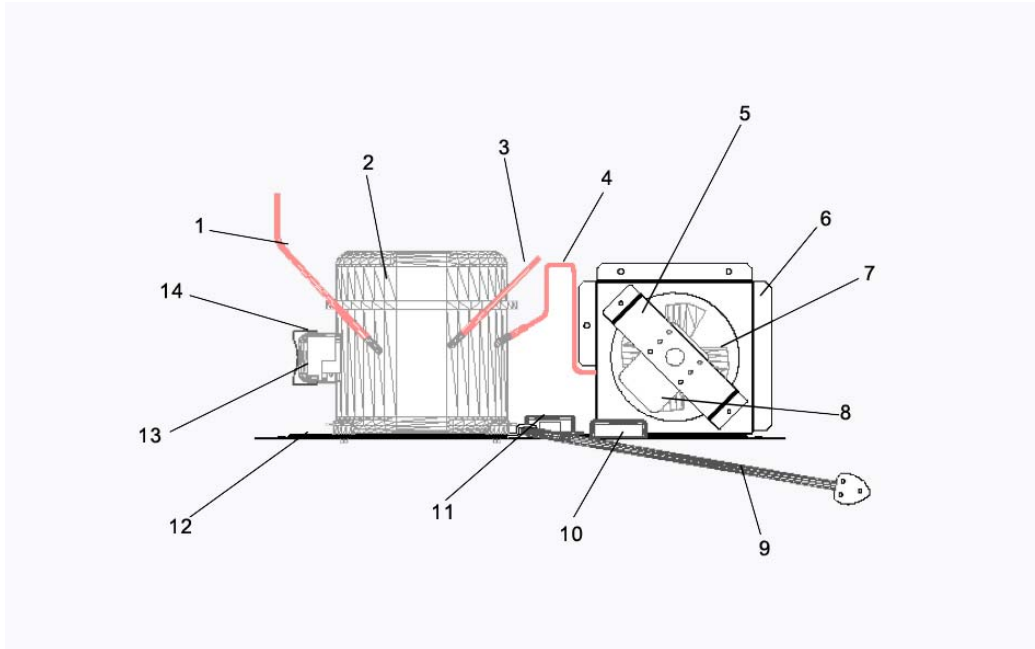
5. COMPRESSOR VIEW AND PARTS LIST

- 1. Suction Pipe
- 2. Compressor
- 3. Process Pipe
- Outlet Pipe of Condenser
- 4. Discharge Pipe
- 5. Condenser Fan Supporter
- 6. Condenser Fan Cover
- 7. Condenser Fan
- 8. Condenser Fan Motor
- 9. Power Supply Cord with Plug
- 10. Junction Box
- 11. Electrical Box of Compressor
- 12. Compressor Base
- 13. Compressor Junction Box
- 14. Compressor Junction Box supporter

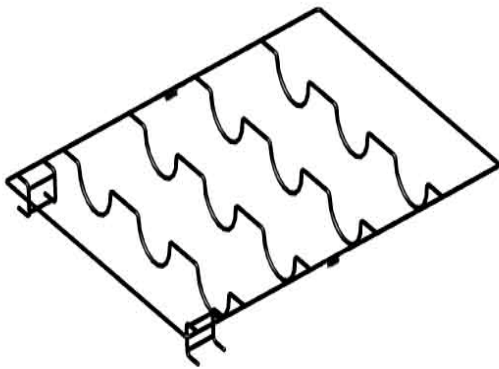
Wire shelf

The appliance is equipped with the wired shelves and beverage shelves. You can move the shelves out and in smoothly.

- To prevent damaging the door gasket, make sure to have the door all the way opened when pulling the bottom shelf out of the rail compartment.
- For easy access to the storage content, you must pull the shelf approximately 1/2 out of the rail compartment, however this unit was designed with a plastic post on each sides of the shelf track to prevent bottles from falling.
- When removing the shelf out of the inner rail, make sure to remove all items first. Then move the shelf to the position where the notch of shelf is exactly under the plastic post and lift the shelf. In order to replace the shelf, repeat steps described above in reverse.

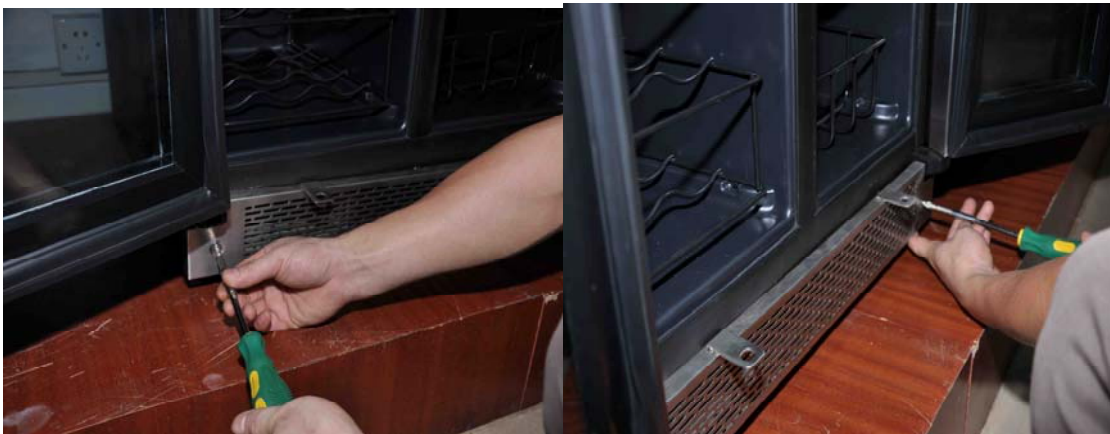
1. Remove two screws that are used to fix the bottom grille with the cabinet.

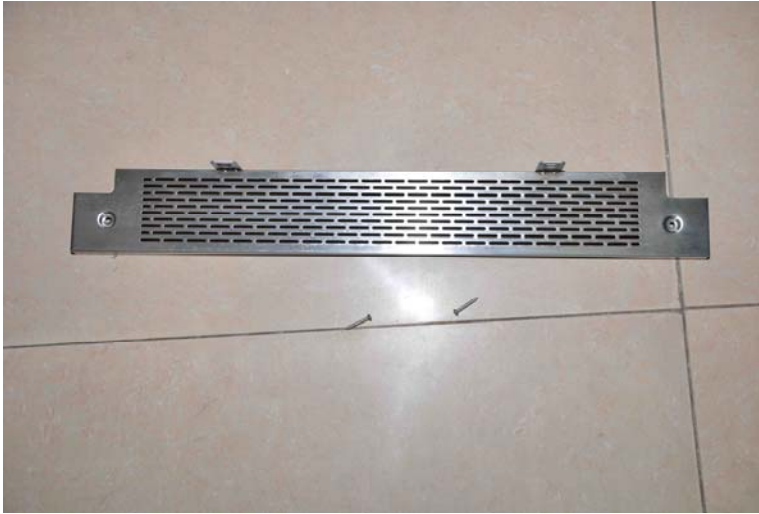
-
1. The bottom grille is shown as below.

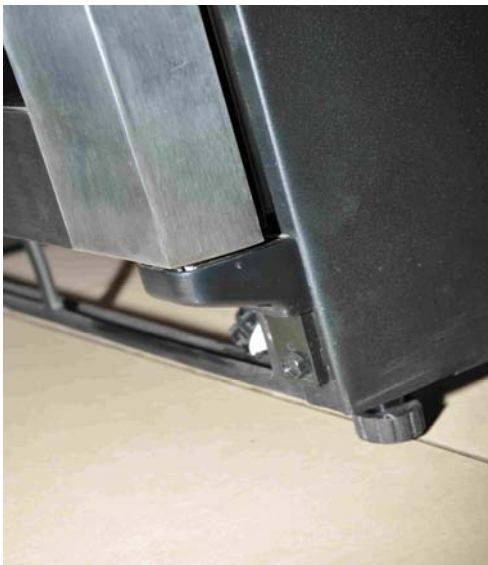
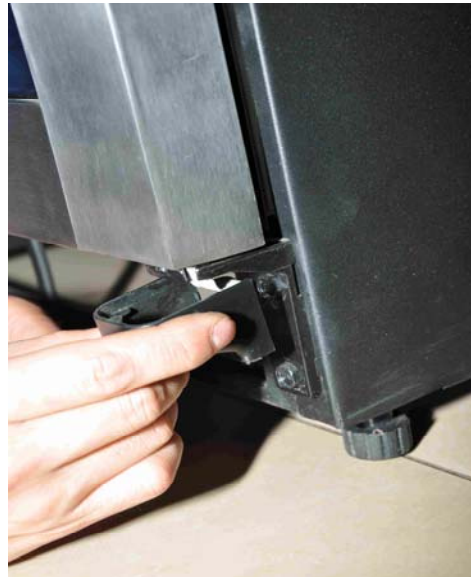
1. Remove the bottom grille according to "Replacing the Bottom Grille".
2. Pull out and remove the lower hinge cover.

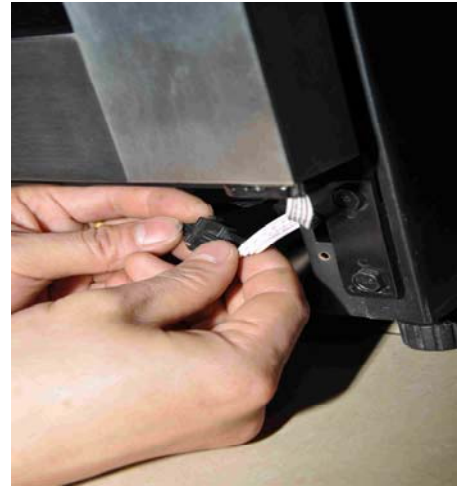
-
3. Disconnect the communication cable between the door and the cabinet.

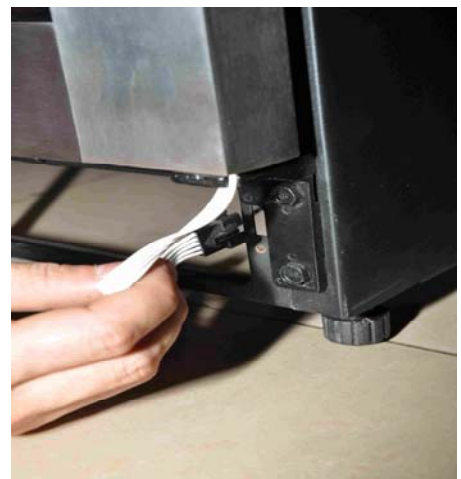
4. Pull out the wire from the cabinet.

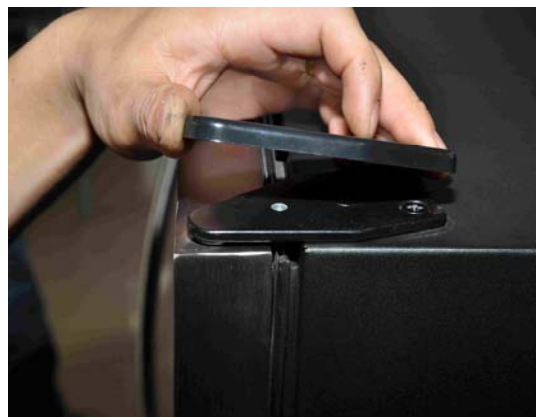
5. Remove the upper hinge cover from the top right of the door

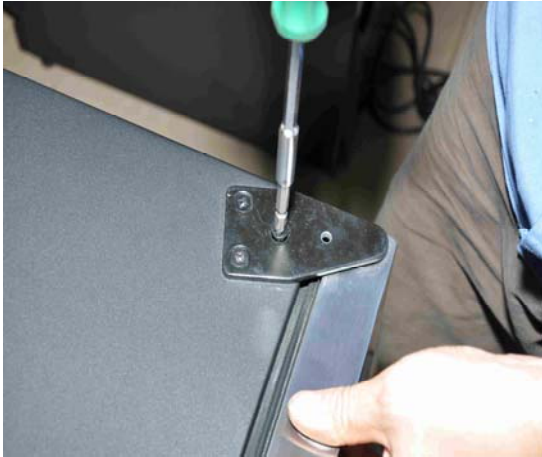
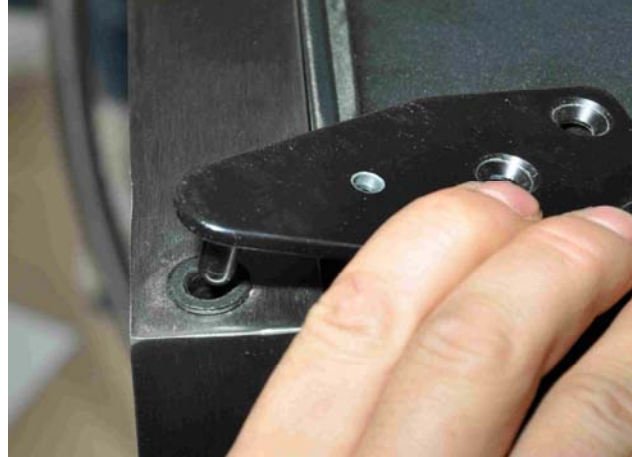
6. Remove the three screws with the upper hinge and remove the upper hinge.

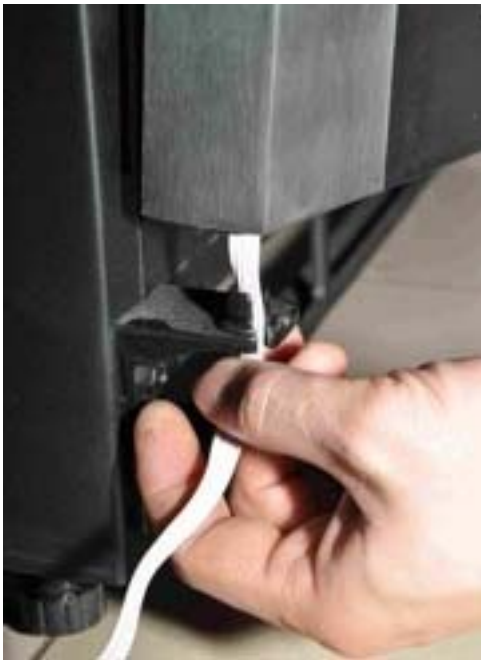
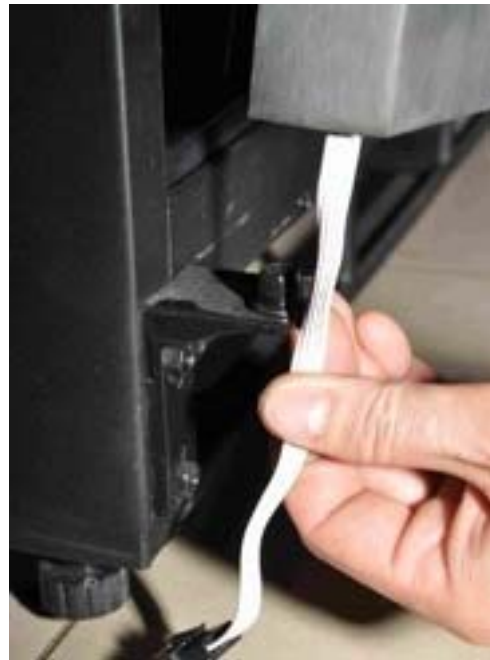
7. Lift up the door slightly and remove the wire from the lower hinge.

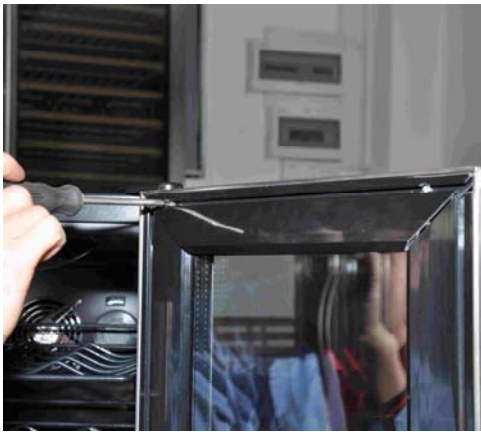
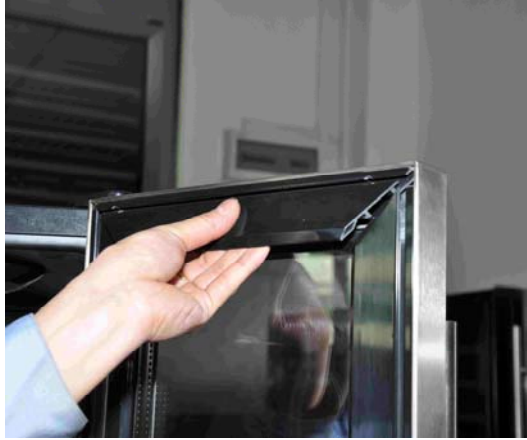
1. Remove the cover behind the control panel with a screw driver.

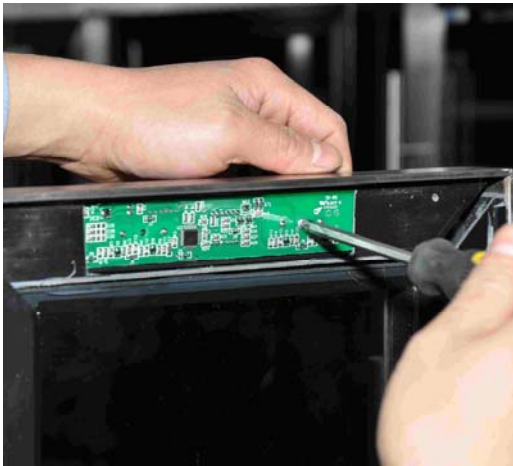
2. Remove two screws that are used to fix the PCB board.

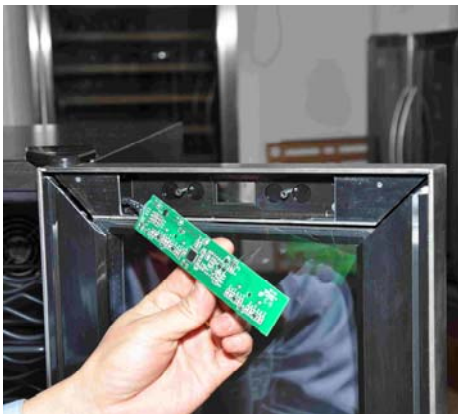
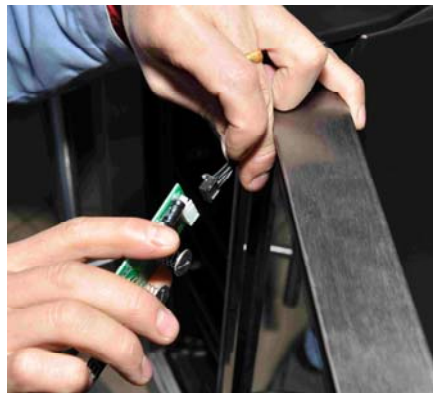
3. Remove PCB board and disconnect the cables.

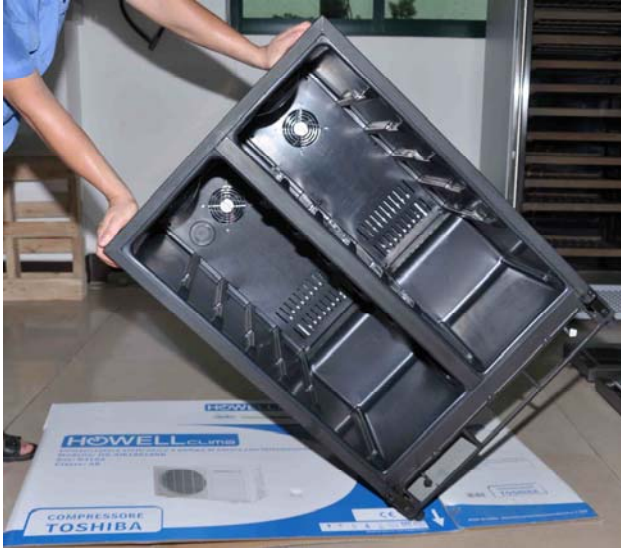
1. Lay down the cabinet to the left side and place it on a padded surface to prevent scratching it. The main PCB is located at the bottom of the cabinet.

Note: Never lay down the cabinet to the right side as it may damage the compressor.

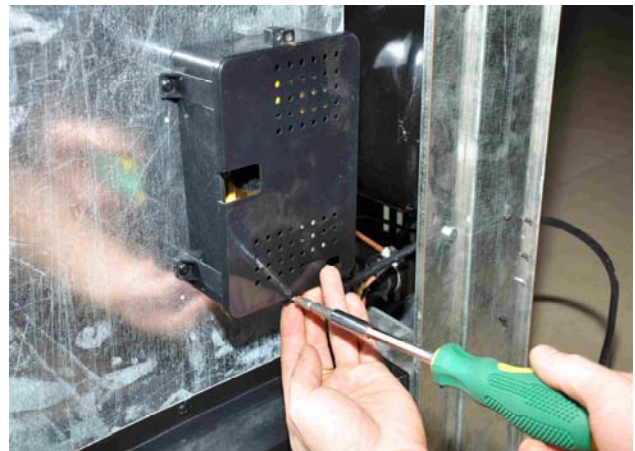
2. Remove the main PCB box cover

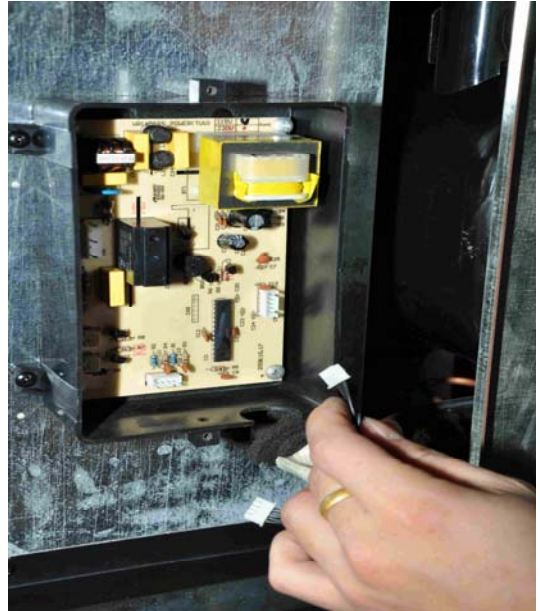
-
3. Disconnect all terminals on the main control PCB.

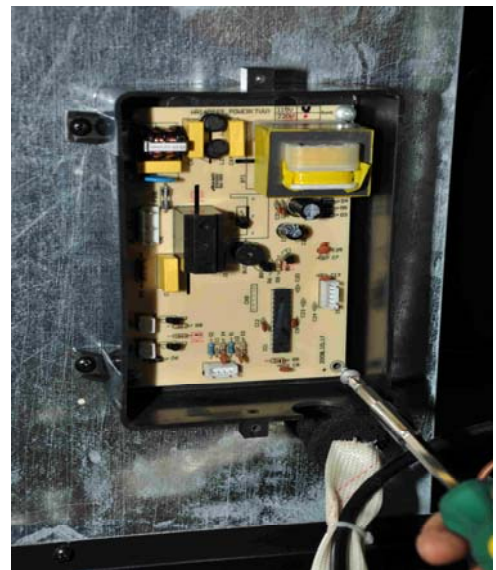
4. Remove four screws that are used to fix the main control PCB. Now you can replace the main control PCB.

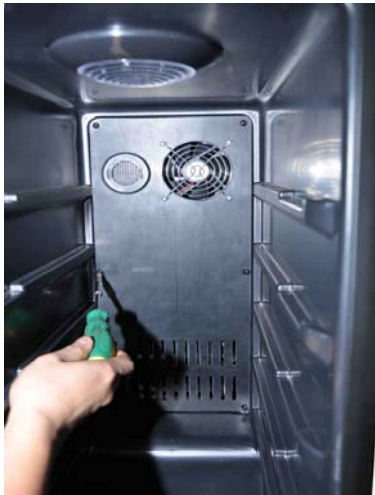
1. Remove all the shelves according to “How to remove the shelves”.
2. Remove the screws that are used to fix the air duct with the cabinet.

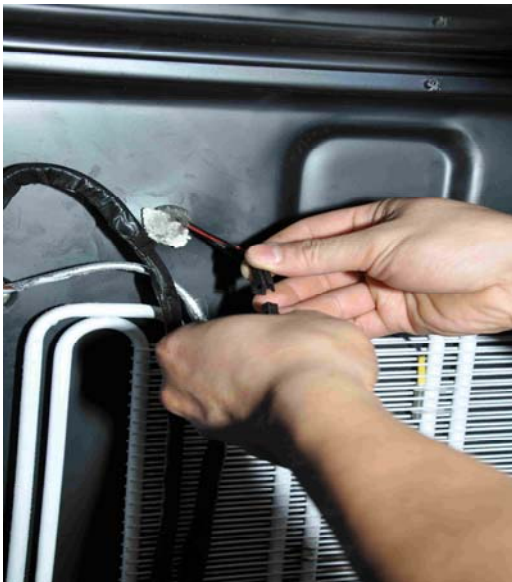
2. Disconnect the wires then you can replace the evaporator fan motor.

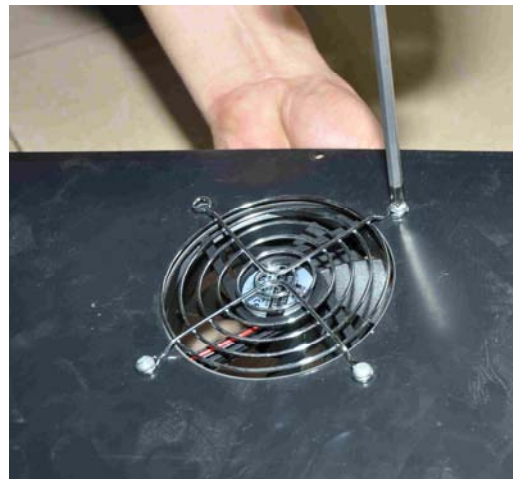
-
4. Remove screws between air dust and the evaporator fan motor, then you can replace the fan motor.

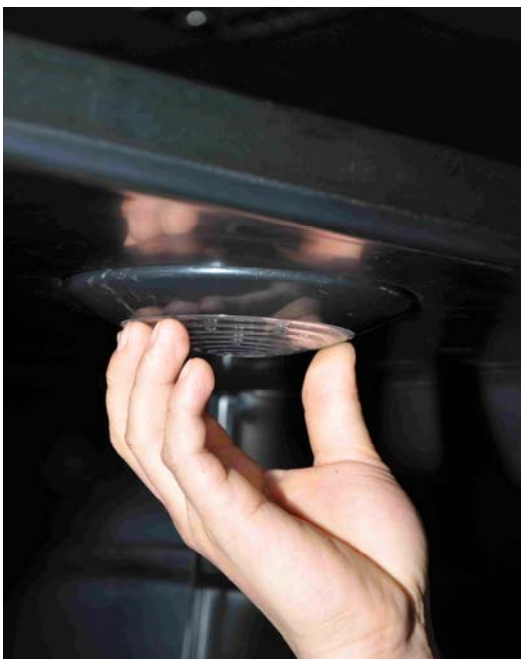
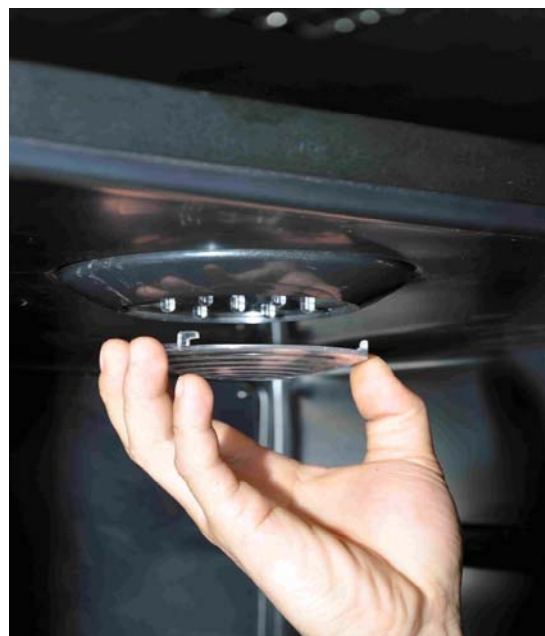
1. Remove the top two shelves according to “How to remove the shelves”.
2. Turn the light cover counter-clockwisely to remove.

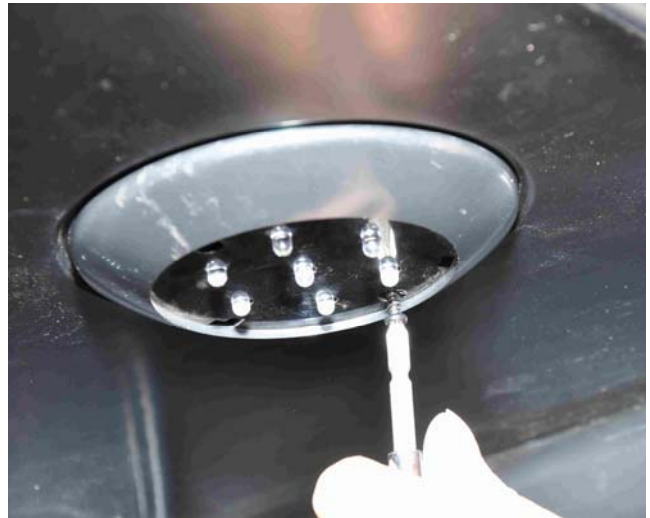
-
3. Remove the two screws that are used to fix light holder.

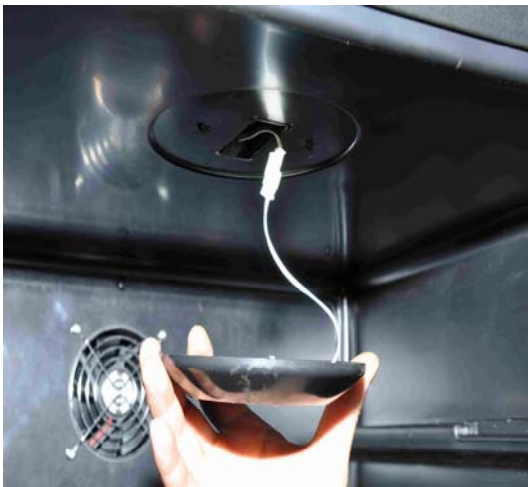
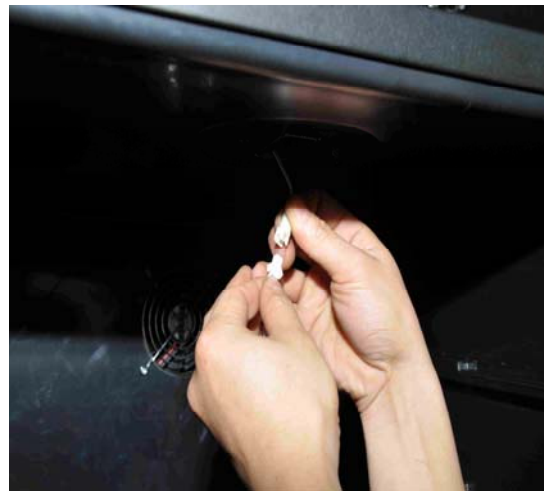
4. Disconnect the cables then you can replace the LED light assembly.

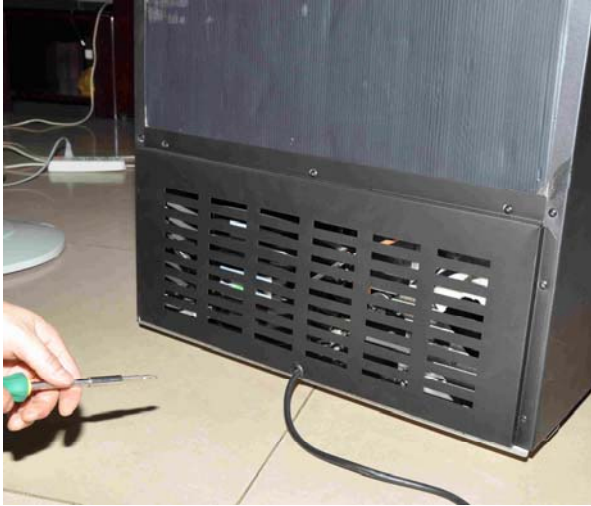
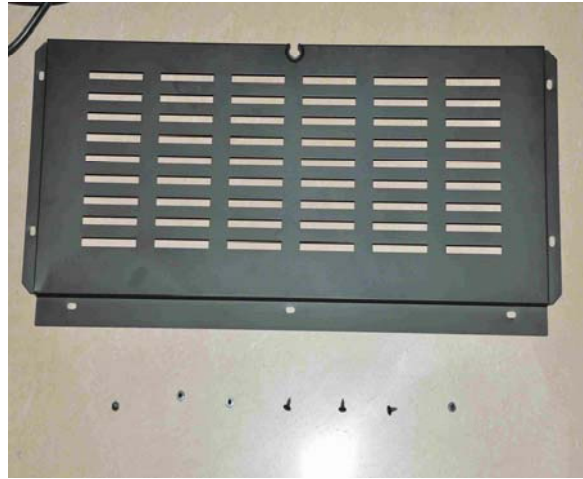
1. Remove the seven screws that are used to fix the condenser fan motor with the compressor base.

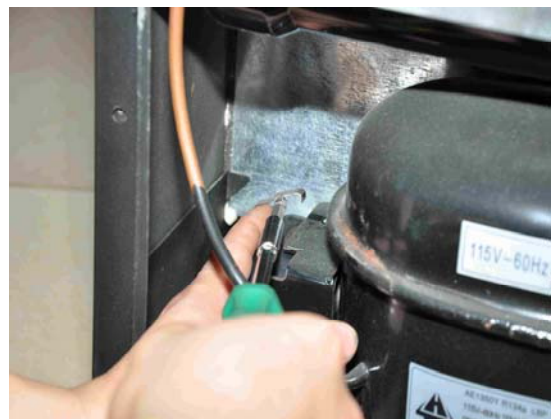
2. Remove the clamp that is used to fix the junction box of compressor. Then dismantle the junction box cover.

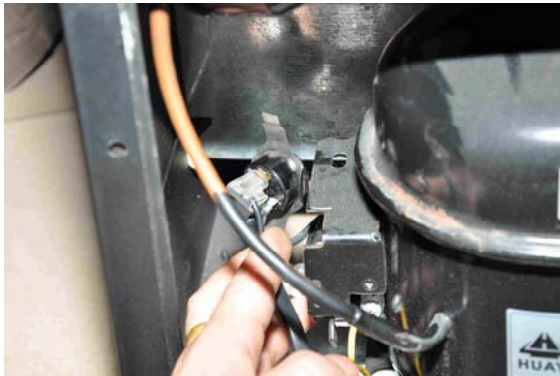
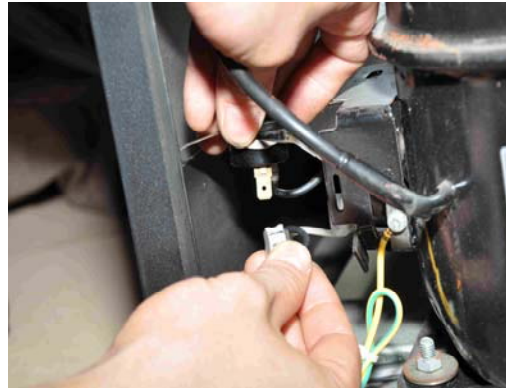
-
3. Disconnect the condenser fan motor cable with compressor. Now you can replace the condenser fan motor.

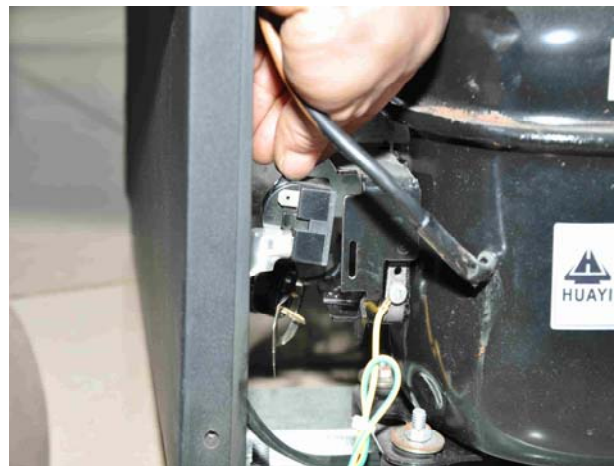
4. Disconnect the compressor **PTC** starter and overload protector cable with compressor. Now you can replace the compressor **PTC** starter and overload protector.

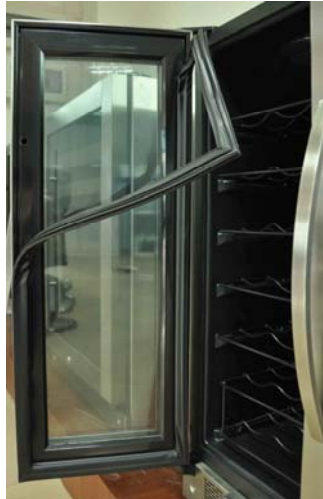
1. Open the door and detach the old door gasket from the doorframe by pulling off the gasket.

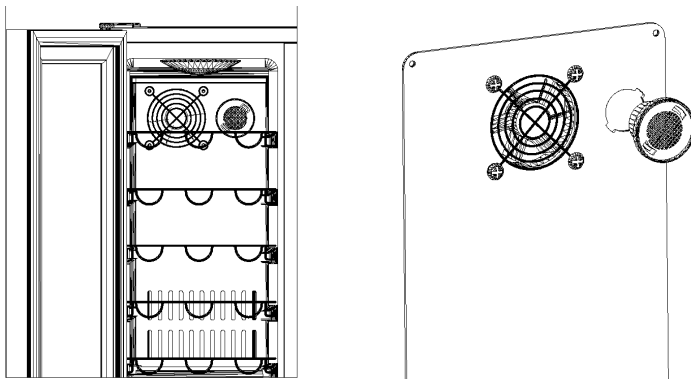
1. Remove the bottles of wine stored on the two(2) shelves in front of the filter.
2. Remove the shelves and set aside to be replaced once you have changed the filter.
3. Hold the filter and turn it counter-clockwisely and then pull it out.
4. Remove the existing filter and replace with a new one.
5. Put the new filter into the hole and then turn the filter clockwise.

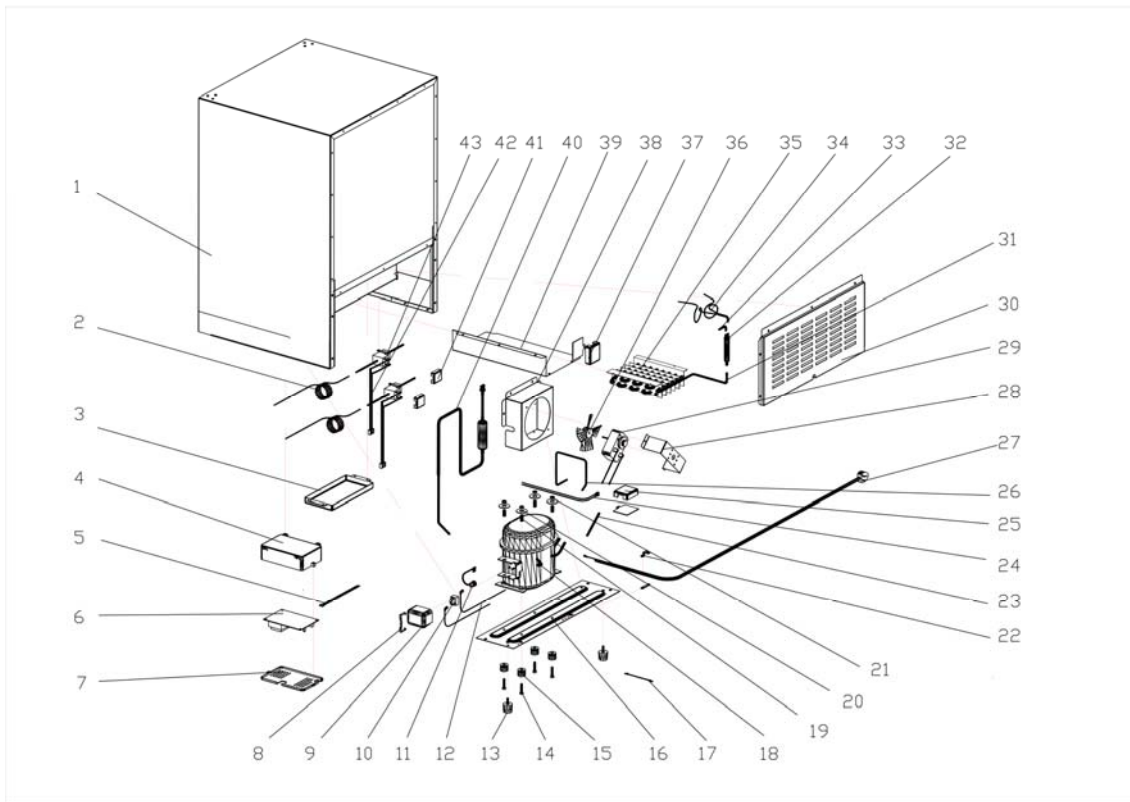
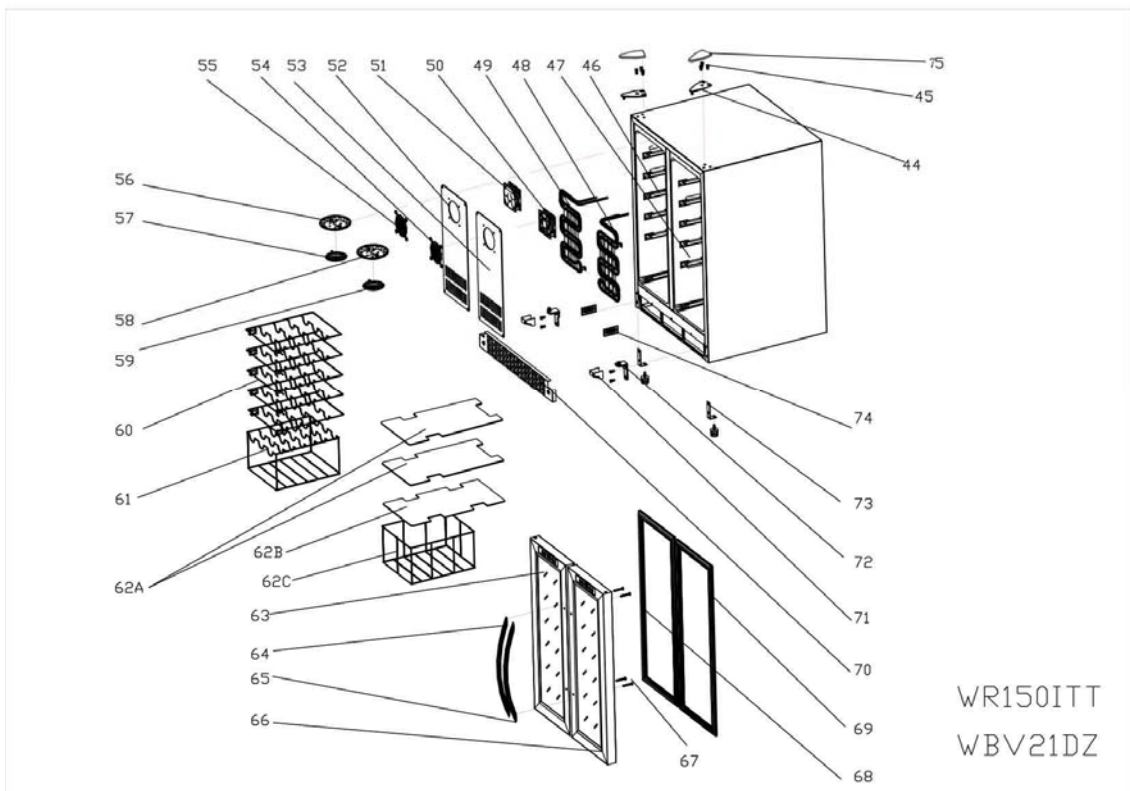
17.1 WBV21DZ EXPLODED VIEW

No	Part name	Qty
1	Cabinet	1
2	Capillary	1
3	Connect water dish	1
4	Box of electronic plate	1
5	Power importation/signal output	1
	Electric wire	
6	Electronic plate	1
7	Box cover of electronic plate	1
8	Connect line cover supporter	1
9	Connect line cover	1
10	PTC starter	1
11	Overload protector	1
12	Compressor conjunction electric wire	4
13	Leveling leg	4
14	M6 Stud bolt	4
15	Compressor leg	4
16	Compressor base	1
17	Earth wire	1
18	Compressor	1
19	Compressor leg supporter	4
20	Washer	4
21	M6 nut	4
22	Wire fixation	1
23	Low pressure vacuum tube	1
24	Motor fan conjunction electric wire	1
25	Connect line box of Motor fan	1
26	Suction pipe	1
27	Power supply plug wire	1
28	Motor fan fixation	1
29	Motor fan	1
30	Backboard	1
31	Condenser liquid tube	1
32	Dry filter	1
33	High pressure vacuum tube	1
34	Shunt resistor	1
35	Condenser	1
36	Fan	1
37	Main connect line box	1
38	Motor fan supporter	1
39	Cover of condenser	1

40	Accumulator	1
41	Top hinge	1
42	M6 nut	3
43	Liner	1
44	M6 bolt	1
45	DC fan	1
46	Shelf holder	5
47	Shelf holder	5
48	Evaporator	1
49	Evaporator	1
50	DC fan	1
51	DC fan	1
52	Black plank	1
53	Black plank	1
54	DC fan cover	2
55	DC fan cover	1
56	LED light cover	1
57	LED light broad	1
58	LED light cover	1
59	LED light broad	2
60	Wine bottle shelves	3
61	Wine bottle storage rack (Wine Storage)	1
62A	Beverage Shelf (Beverage Storage)	2
62B	Beverage Shelf (Beverage Storage)	1
62C	Storage Basket (Beverage Storage)	1
63	Left door	1
64	The left door handle	1
65	The right door handle	1
66	Right door	1
67	Handle setting bolt	1
68	Left door gasket	1
69	Right door gasket	1
70	Bottom grille	1
71	Lower hinge cover	2
72	Lower hinge	2
73	Lower hinge supporter	2
74	Sensor-temperature detector cover	2
75	Upper hinge cover	2
