INSTALL INSTRUCTIONS C-3190-F 1996-2007 FORD CROWN VICTORIA

TECHNICAL SERVICE BULLETIN

Subject: Trunk Tray Installation (Part # C-3190-F: Full Width Tray)

Vehicle: 2005 and newer Ford Crown Victoria Police Interceptor

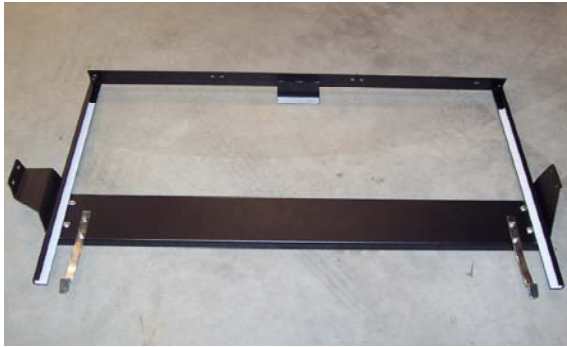
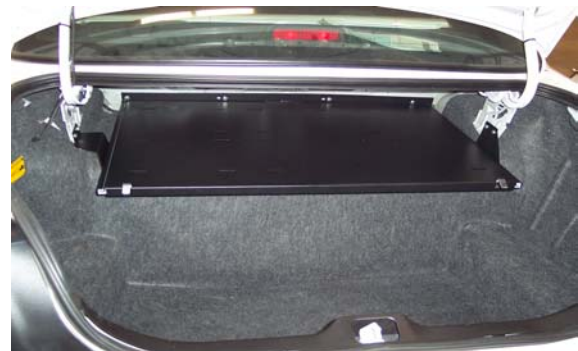
- Step 1.** Slide Tray out of housing.
- Step 2.** Place left and right support arms in place and fasten down with (4) 1/4-20 x 1/2" hex head cap screws and (4) 1/4" flat washers.
- Step 3.** Place lock arms in place with (4) 1/4-20 x 1/2" hex head cap screws and (4) 1/4" flange nuts.
Note: Do not tighten down lock arms at this time. Place 1/4-20 x 1/2" hex head cap screws from bottom to top on lock arms.
- Step 4.** Slide tray back into housing. Adjust lock arms then tighten from bottom.
- Step 5.** Place radio tray on back shelf in trunk. Align rear support bracket with existing holes in trunk using (4) 1/4-20 x 1" hex head screws, (4) 1/4" flat washers, (4) 1/4" flange nuts and (4) 3/8-16 hex nut spacers.

- Step 6.** Drill 1/4" hole into trunk hinge, support base on drivers and passenger side and fasten down shelf by using (4) 1/4-20 x 1" hex head cap screw, (4) 1/4" flat washer and (4) 1/4" x flange nut.

Note: On 2005 and newer models, Hex Nut spacers must be installed between rear support bracket and OEM sheet metal. This will space tray off seat wall so not to crush fuel pump harness. Loom is provided to cover harness for extra protection.

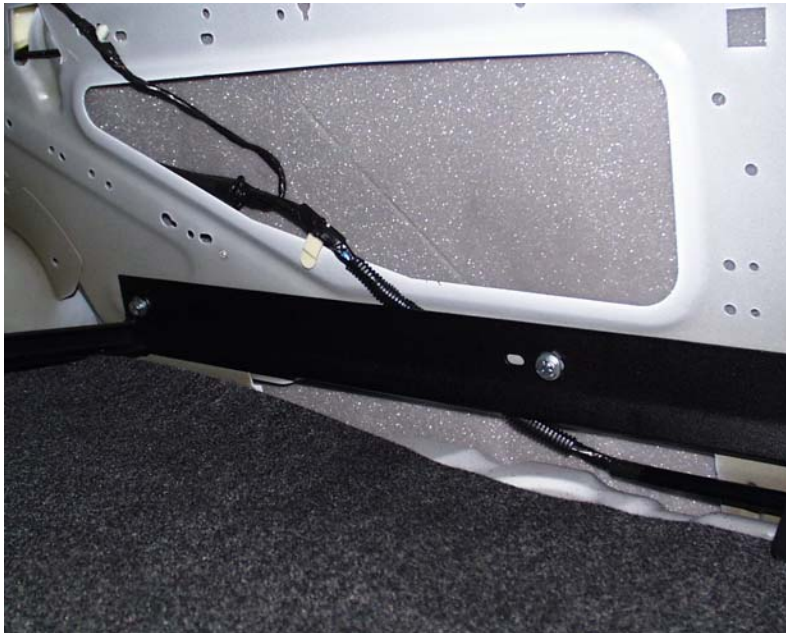
Problem: The Fuel Pump wire harness on 2005 mid model year Crown Victoria's and newer is now routed on the rear (trunk) side of seat strainer (metal framework behind rear seat). The location of this harness now interferes with the mounting bracket for the Havis-Shields full width trunk tray. Harness is subject to being pinched by bracket.

Solution: The mount plate that connects to the seat strainer must be spaced out so it will not damage harness. In addition to the original hardware kit, four (4) # GSM30008 3/8-16 hex nuts and one (1) foot # PRM97913 protective wire loom must be used. One (1) 3/8-16 hex nut spacer is used with each of the four 1/4" x 1" bolts (between the seat strainer and tray mount plate). The protective wire loom must be wrapped around wire harness before mount plate is fastened.

Check: Before and after all hardware is tightened, make sure wire harness is not pinched.
