LEON-PCI-UMC Development Board

Test Report

GAISLER RESEARCH / PENDER ELECTRONIC DESIGN Rev. 1.1, 2003- 12- 25

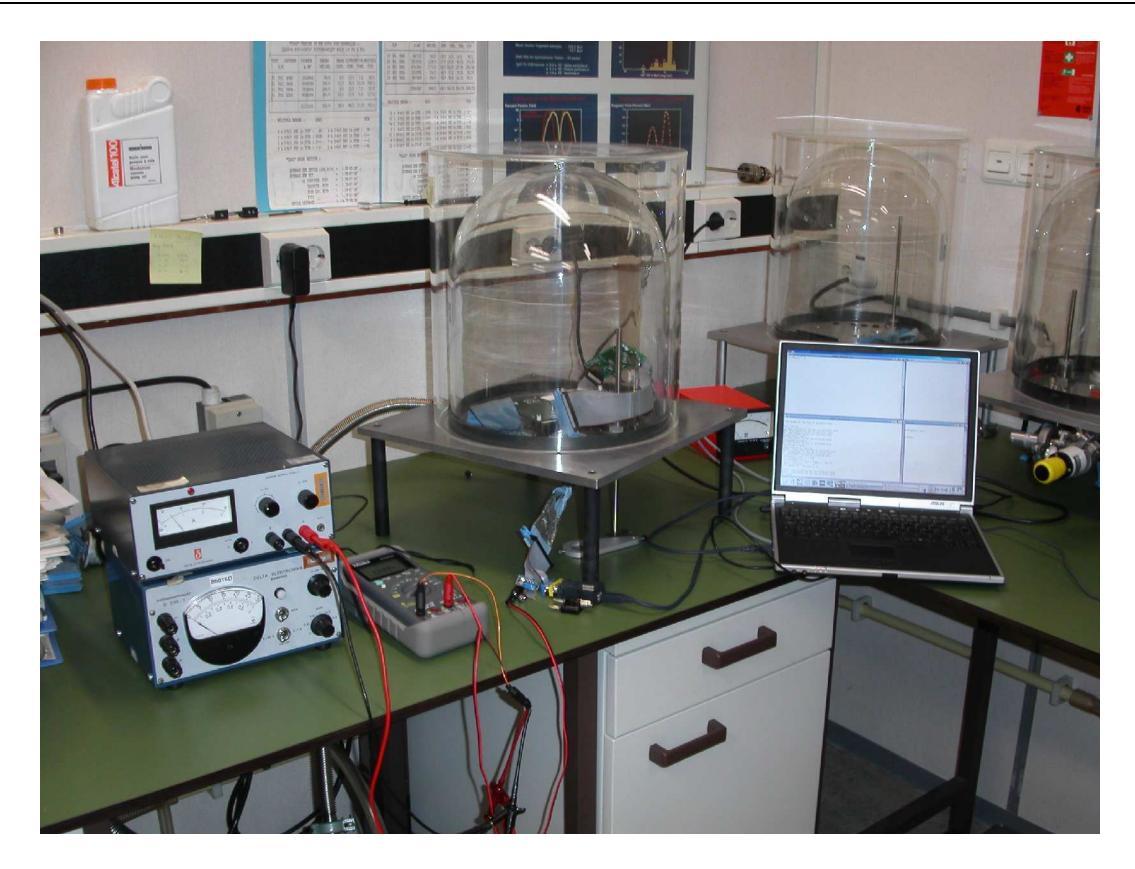
Figure 3-1: ESTEC Californium SEU Test Set-up

The test equipment consists of the following items as shown in Figure 3-1:

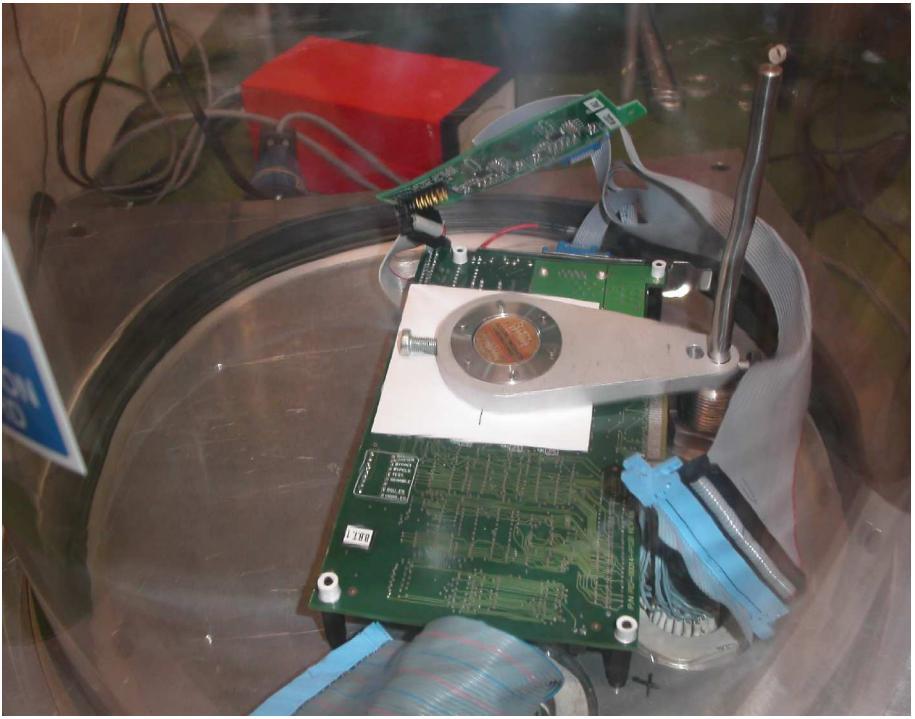
Figure 3-3: Cf-252 source placement above die cavity

The UMC ASIC is packaged in a 299 pin Pin Grid Array, with the cavity on the bottom of the device. This requires that the design of the board incorporates an appropriate cut- out, and that the source irradiates from the 'bottom' of the PCB.

The Californium test source used was labeled as 480-87-1A with an indicated activity of 1.781uCi 27 April 1995). The corresponding flux was calculated to be 800 particles/cm /min at 1.5cm distance. All testing was performed at normal incidence to the die. The mean LET₁value for all fission particles from the Cf source is given in literature as 43 MeV.mg⁻¹.cm⁻¹

A vacuum in the pressure range 1×10^{-2} to 6×10^{-3} mBar (ca. 1 Pa) was achieved during testing.
