Customer Notification

EW78K

Embedded Workbench® for 78K

Operating Precautions

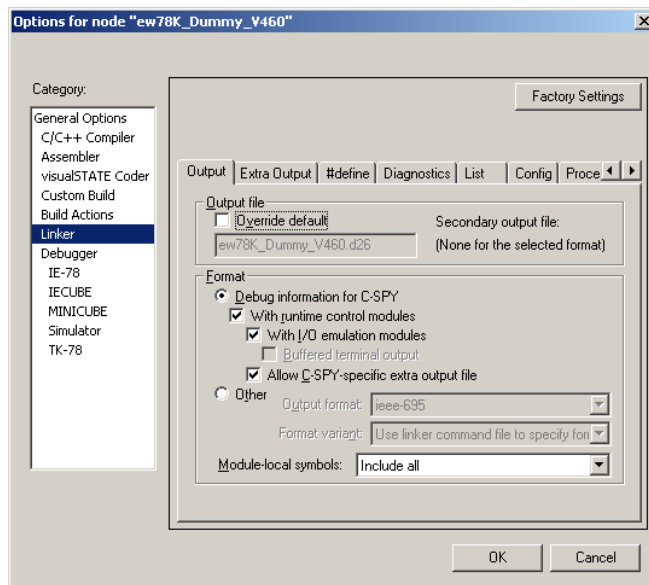
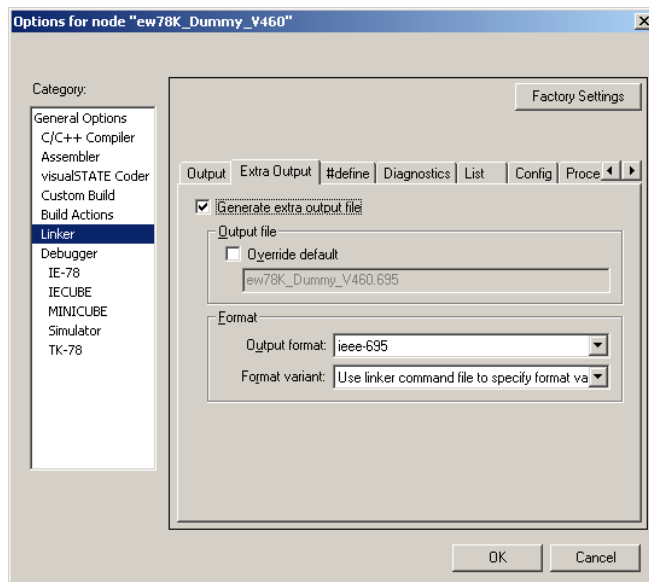
No. A10 Usage of Soft-Links in output path definition could cause the IDE to link two copies of the output files in the Workspace Windows

Please select another output file format (e.g. C-SPY Debug Format), enable the generation of a second output file, and select the format IEEE695 for the second output file:

The problem will be fixed in the next EW78K platform update.

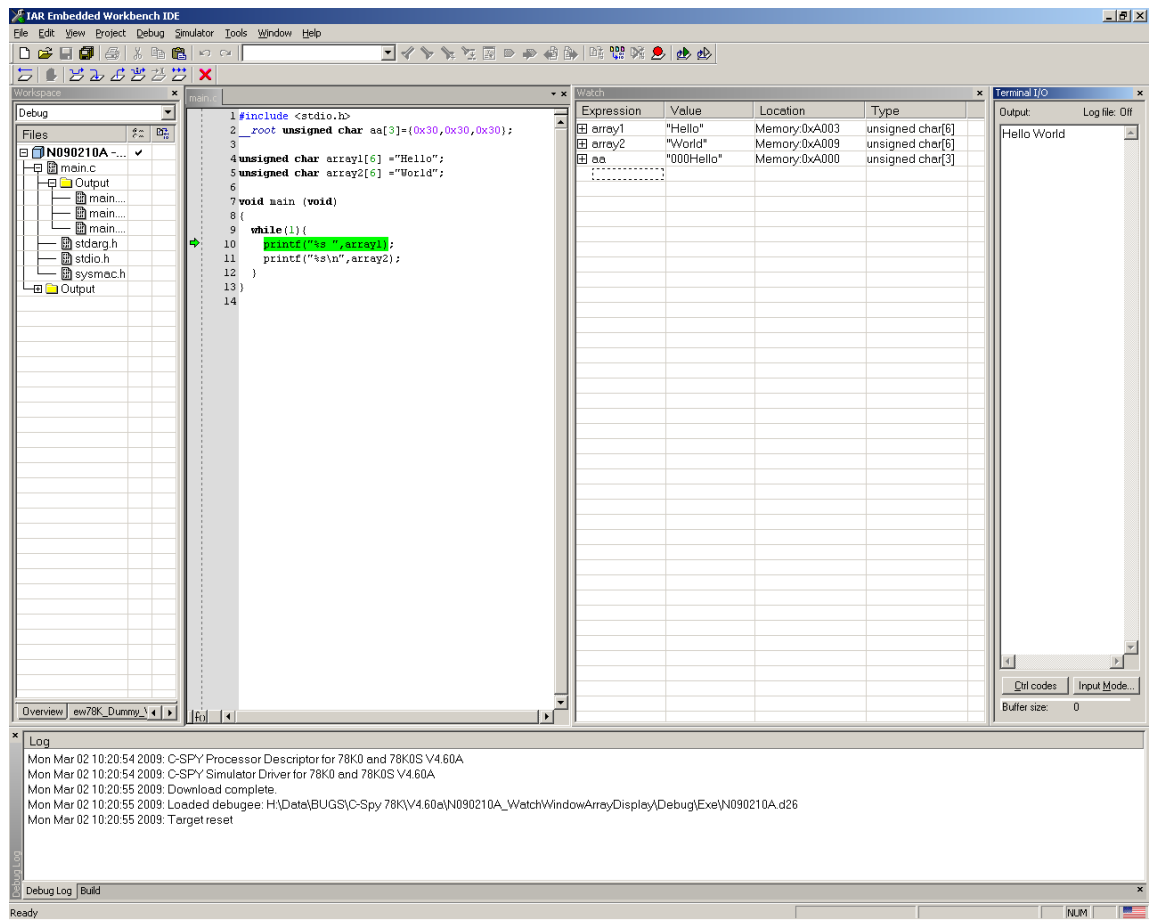
```
#include <stdio.h>
__root unsigned char aa[3]={0x30,0x30,0x30};

unsigned char array1[6] ="Hello";
unsigned char array2[6] ="World";
```

Workaround

None. The issue will be fixed in a future update.
