# HP LaserJet Product UPDATE Newsletter.

# HP Monochrome LaserJet printer updates

## HP LaserJet P2015 Series Printer: Abnormal LED pattern

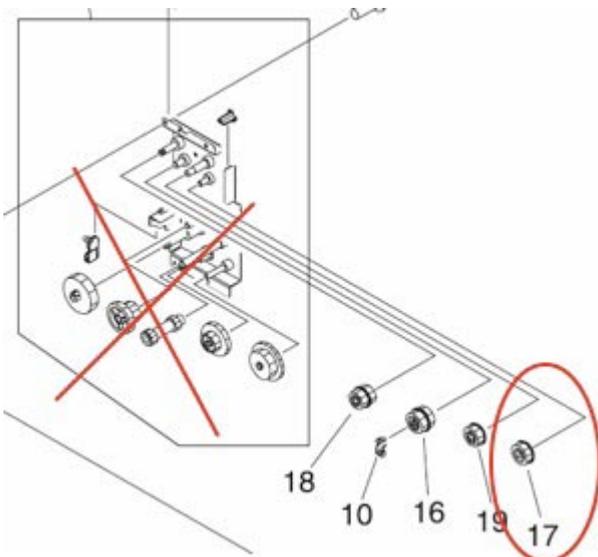
**Caution:** Gears 17 and 19 have teeth that slant in opposite directions. Please be careful that these gears are installed in their proper positions or gear grind will occur. You shouldn't need to remove gear 19 to perform this service.

Currently we believe these noise issues can be resolved by replacing the fuser or the Fuser Idler Gear RU5-0957-000CN. We have not seen a unit that exhibited both worn parts. It is important to inspect these two parts to understand what component is causing the issue. If the fuser bushing is brown, it is probably good and there should be no need to replace the fuser. If in doubt, it is best to err on the side of caution and replace both parts.

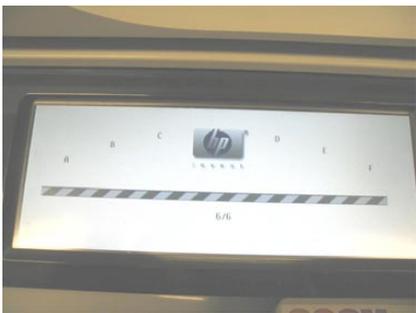
**Figure 2.** Boot Progress Indicator

Beginning with the HP LaserJet CM3530, LaserJet MFPs will now display a "Boot Progress Indicator" from power-on to Ready state. (see *Figure 2 below*)

If a boot-up hang occurs, record the phase and component of the failure (ex. 6/6B). See the table below for troubleshooting information.

Phase ( 1/6 – 6/6 )	Component (A – F)	Troubleshooting steps
1/6	A - F	more troubleshooting info will be added later
2/6	A - F	more troubleshooting info will be added later
3/6	A - F	more troubleshooting info will be added later
4/6	A - F	more troubleshooting info will be added later
5/6	C	Scanner communications
6/6	B	1) Check cables: <ul style="list-style-type: none"><li>• At top of ICB, reset USB and PCI-e cables</li><li>• Reseat PCI-e at SCB (see troubleshooting section below)</li></ul> 2) Reseat formatter 3) Replace SCB Hard disk drive (HDD) communications 1) Try a DISKINIT 2) Reseat HDD cables connections at HDD and formatter 3) Replace HDD (Note: unlike previous mfps, the CM3530 will NOT boot without a HDD)

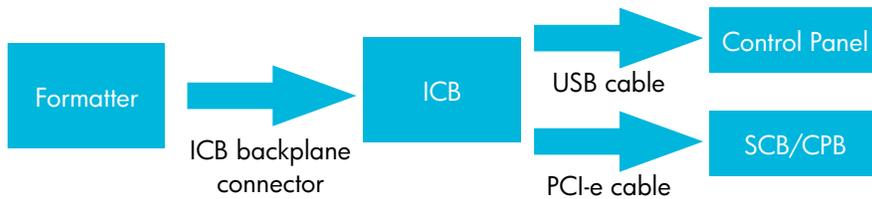
The 30.01.41 scanner error is the result of lost communication between the formatter and the scanner control board (SCB). The message can also be displayed as “Scanner error, Scanner power, Cable, and CPB” (the copy process board [CPB] on this product is combined with the SCB).

If the 30.01.41 is a hard failure, try reseating the cables as indicated above. Carefully inspect the standoffs into which the cable attaches on the SCB. Verify the standoffs are securely fastened to the SCB. If the failure persists, replace the SCB (CC454-60003).

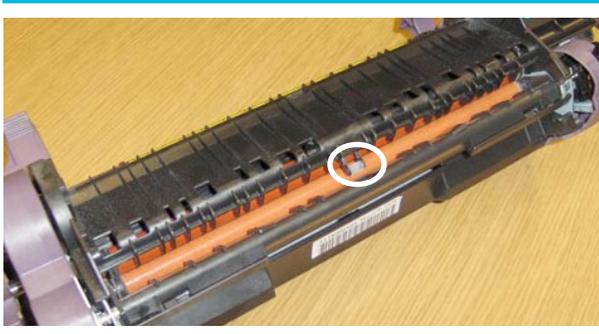
Use the following steps to locate and remove the paper. (Note: The fuser may be hot. Be careful when removing the fuser.)

Once the paper has been cleared, please elevate the case to level 3 for visibility to the case. This is a firmware issue that is being investigated. The correct 13.20 paper jam message will be posted in the event log, but is not being correctly posted on the touch panel.

1. Open the MFP’s upper right door.
2. Using the green handle, lift the fuser access door to reveal the fuser.
3. Grasp the purple handles on either side of the fuser and pull the fuser out of the MFP.
4. Locate the output sensor flag on the back side of the fuser, as shown below. It is a black flag with a small clear roller on the end.

5. Clear any paper located in the fuser. The paper is likely near the fuser exit flag, which is being blocked by the paper.
6. After clearing the paper, reinstall the fuser in the printer and close the upper right door.

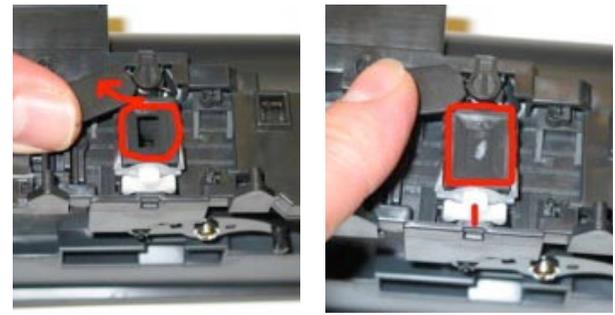
Note: It's important to make sure the gate is closed when the cartridge is being installed or removed from the printer, as toner can easily escape the cartridge if the gate is open.

4. If the gate is open, push the release lever up, then turn the white gear 90 degrees until the gate closes (see picture below). The white gear should end straight up (note: it can actually be turned in either direction).
5. Once the gate is closed, reinstall the cartridge into the printer.

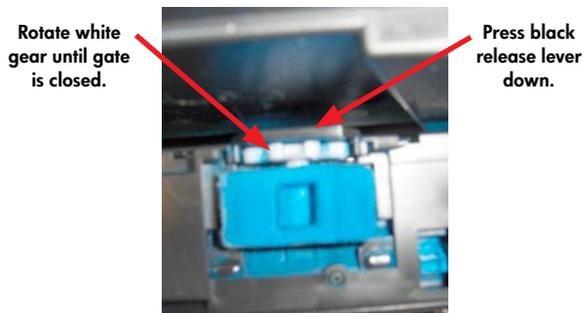
Note: It is important to make sure the gate is closed when the image drum is outside the printer, as toner can escape the drum if the gate is open.

8. If the gate is open, press the black lever release down, then turn the white gear until the gate closes completely (see image below).

9. Once the gate is closed, reinstall the image drum into the printer.
10. If the message does not clear, power cycle the printer.
11. If the message still does not clear, replace both the image drum and print cartridge. If the Replace Cartridge message has been posted to the control panel, then the cartridge e-label may have been written to with information that indicated the cartridge life has been fully consumed. Because of this, the error may not clear. If that is the case, both the image drum and print cartridge must be replaced to clear the error message.
