## Editorial

With this in mind, this bulletin proposes three examples of excessive pitch attitude during critical flight phases: takeoff rotation and landing flare.

# Bounced landing followed by tailstrike - 1

## Bounced landing followed by tailstrike - 2

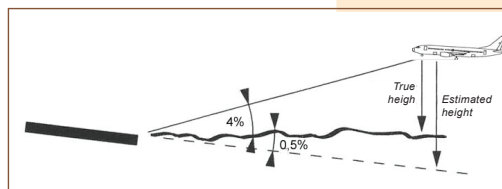
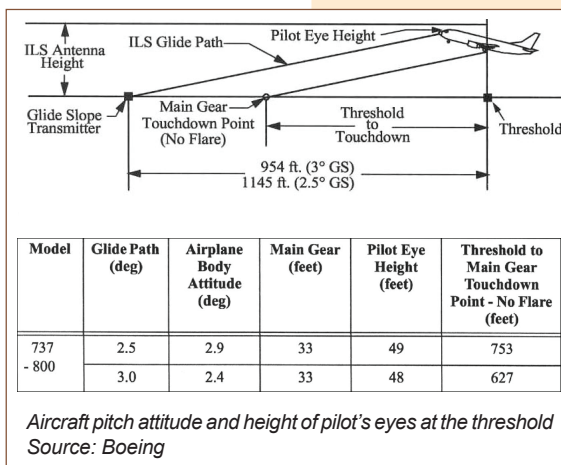
Because the power levers were set to idle while the aircraft landing gear was still compressed, all the spoilers extended before the bounce. Given the system's operating logic, flight spoiler extension continued during the bounce, whereas the ground spoilers retracted. Low speed combined with the stalling moment caused when the spoilers extended led the aircraft to exceed its maximum landing attitude.

Bounced landings are rare events on transport aircraft. Specific simulator training is not provided on the subject and knowing how to handle the event depends mainly on basic training. The operator had not yet provided the crews with the supplementary information from Boeing on how to deal with the specific problem of tailstrikes.
