**FINAL REPORT ON THE
ACCIDENT
TO ASSO AEREI CHAMPION V
UL260i REGISTERED OO-G08 AT
EBZH ON JULY 4, 2010.**

Ref. AAIU-2010-34
Issue date: 22 March 2011
Status: FINAL

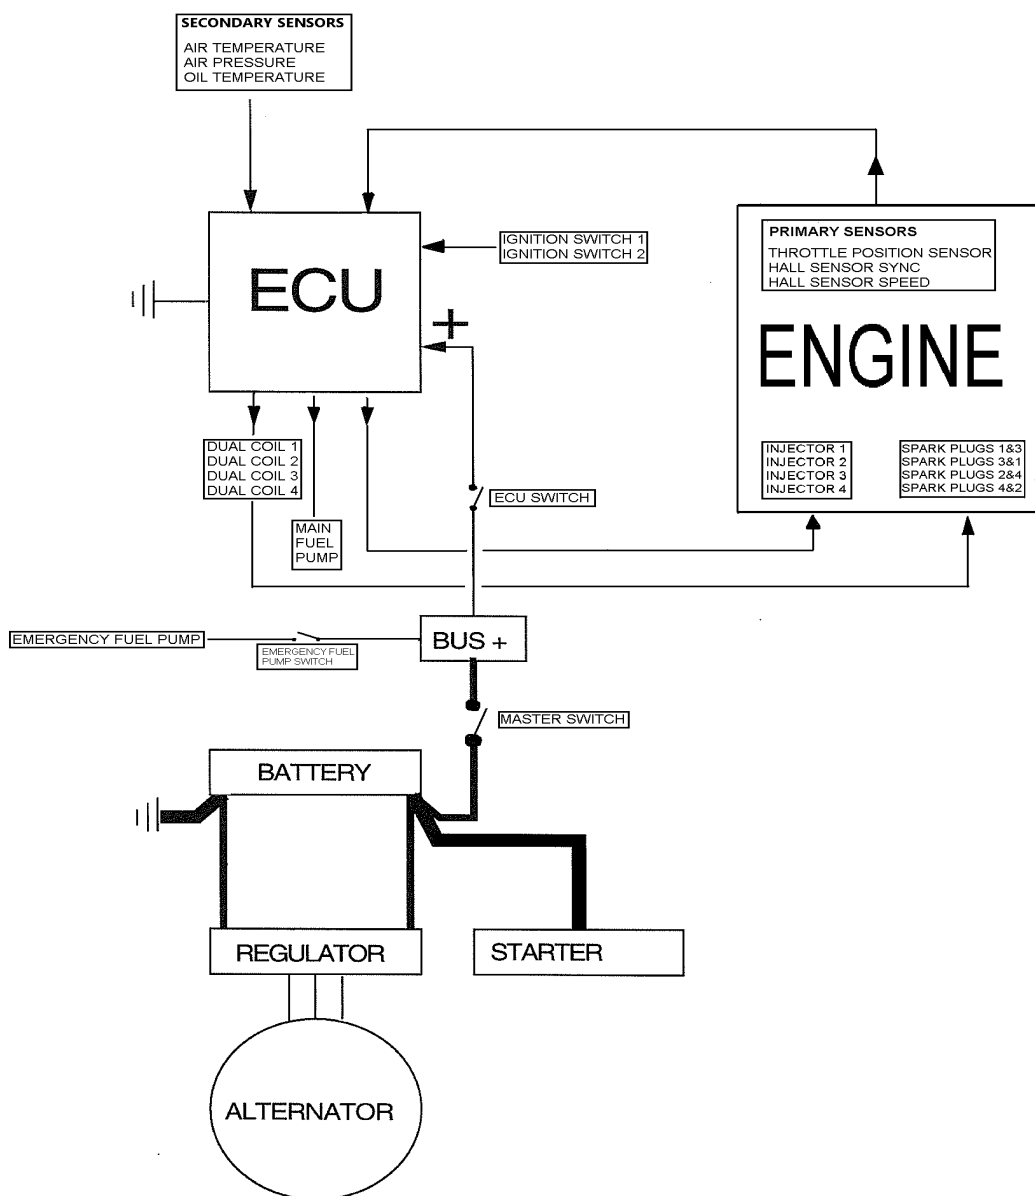
ULPOWER Engine electrical / electronic schematic diagram

The engine is equipped with an electronic injection and ignition system. The fuel and the ignition systems are both managed by the “Engine Control Unit” (ECU).It was decided to install the ECU of OO-G08 on the engine side of the firewall due to the lack of space between the fuel tank and the rear

side of the fire wall. The cooling of the ECU was made by a fresh air flow coming from a LH engine cowling NACA air intake.

RPM and Throttle Position are the main inputs to the ECU. Three primary sensors are necessary to make the engine run: “Throttle position sensor”, “Hall sensor sync” and “Hall sensor speed”.

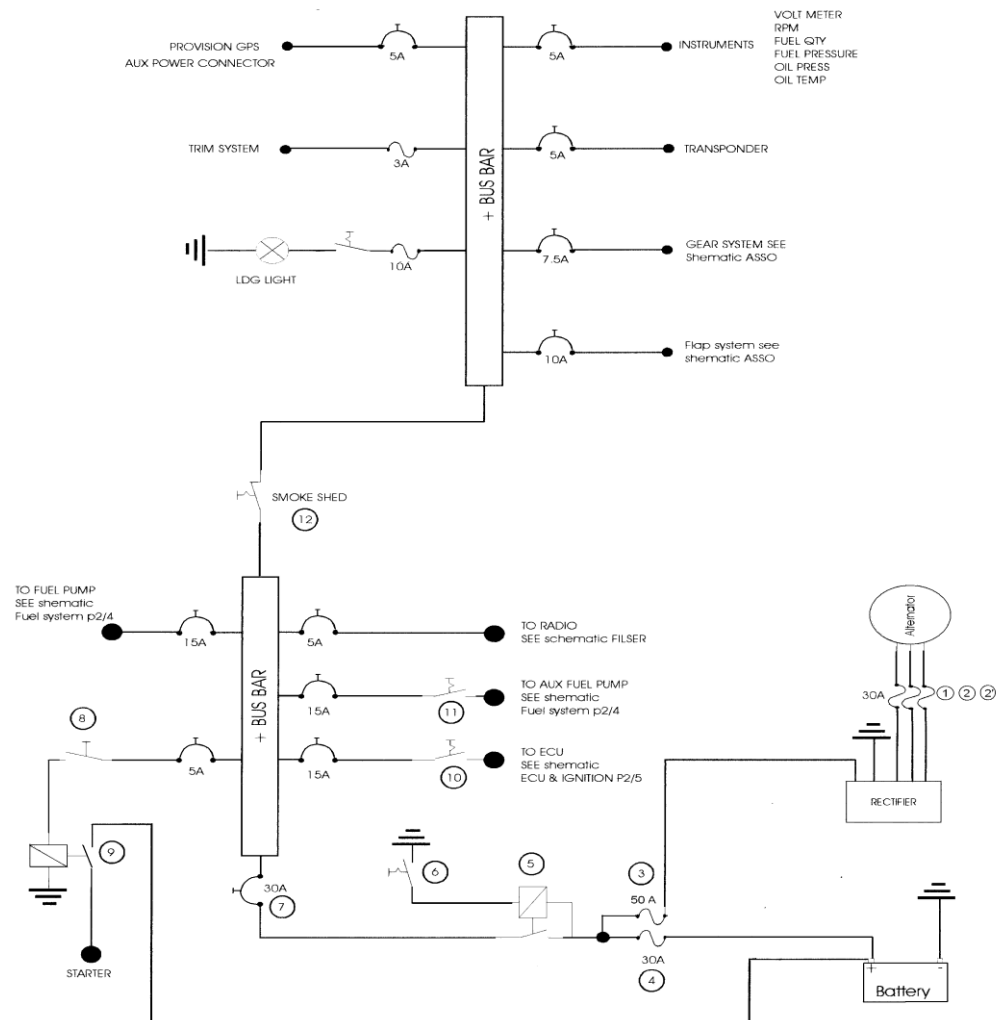
OO-G08 Electrical Schematic Diagram

- The 20 Amp fuse number 3 that was installed downstream of the "Regulator Rectifier" blew during the first test flight. It was then decided to replace it by a 30 Amp fuse. At the same time, the three 20 Amp alternator fuses were also replaced by 30 amp fuses.

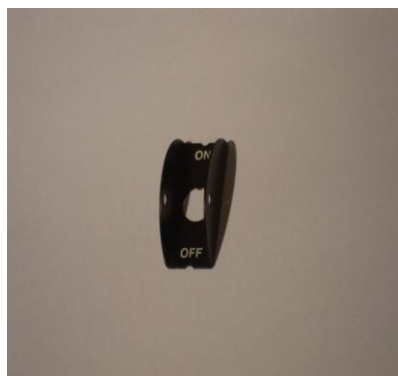
Airplane on the ground, all switches are normally selected DOWN.

In flight, the normal position of the switches is UP except for the smoke shed switch and the emergency fuel pump switch that normally remain down.

The ignition switches A and B were at the time of the accident properly identified and protected against inadvertent switching OFF (The protections are not visible on the instrument panel picture).

The flaps and the trim switches were spring loaded, and normally remained in neutral position.
