ECS Noise Detection Alarms due to Periodic 24-VDC Low Insulation

SL2012-561/KBH
April 2012

Ident No.: 3093078-1

Troubleshooting Electrical Noise

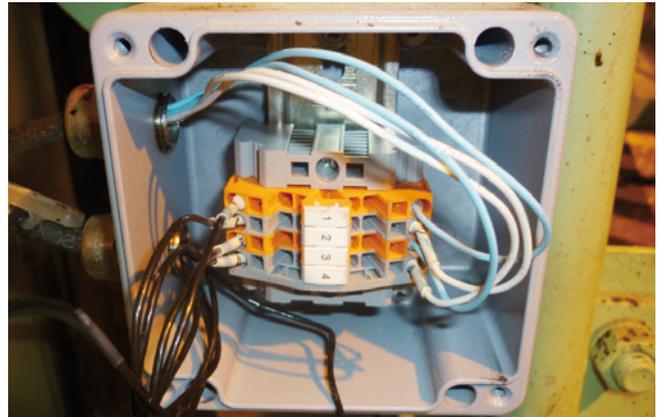
Chafed wiring inside an MTBEV

Example of rectification of chafed wires in an MTBEV:

1. Switch off the power on the unit before starting the work.
2. Cut off the wire straps on the internal wiring.

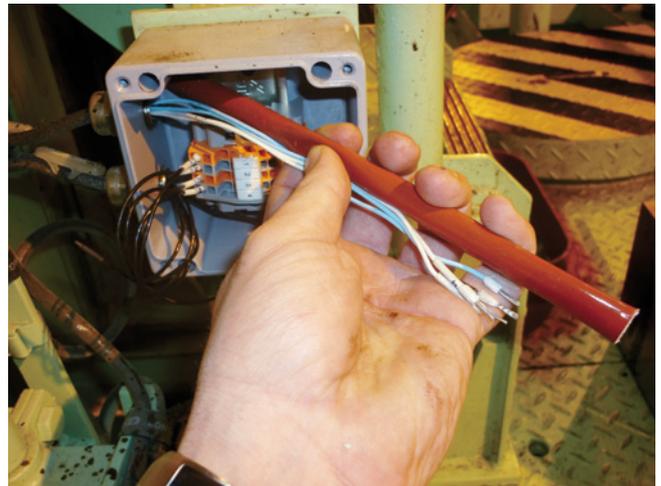
Wiring in contact with TB-LOP interior

3. Check that the wires are all marked correctly and installed in the right terminals (correct numbers).
4. Dismantle the wires in one side of the terminal.
5. If wires are chafed, they have to be rectified with a heat shrinking tube or insulation tape.
6. Cut the silicone flex material so that it is 30 mm longer than the wires.
7. Check that the wire ferrules are properly installed.

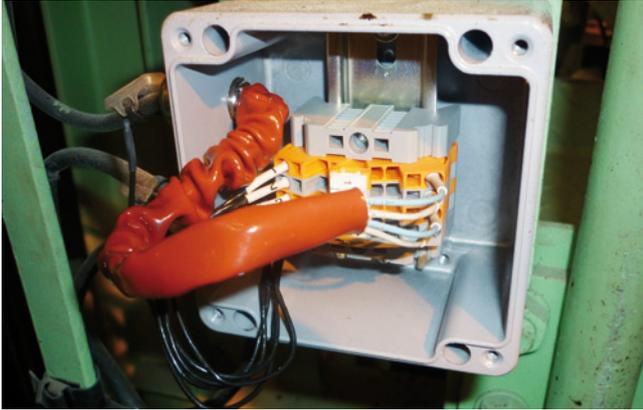
Chafed wiring inside a TB-LOP

8. Fit the silicone flex tube onto the wires (max. 5 wires inside one silicone flex tube).
9. Pull back the silicone flex tube on the wires, and install them in the terminal row.
10. Position the silicone flex tube on the wires so that they cover all the surface of the wires.

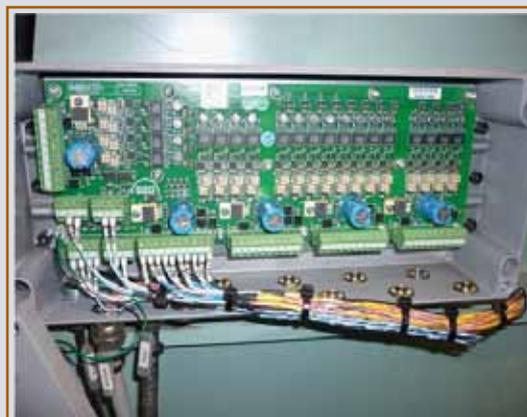
Correct cabling is essential to avoid electrical noise

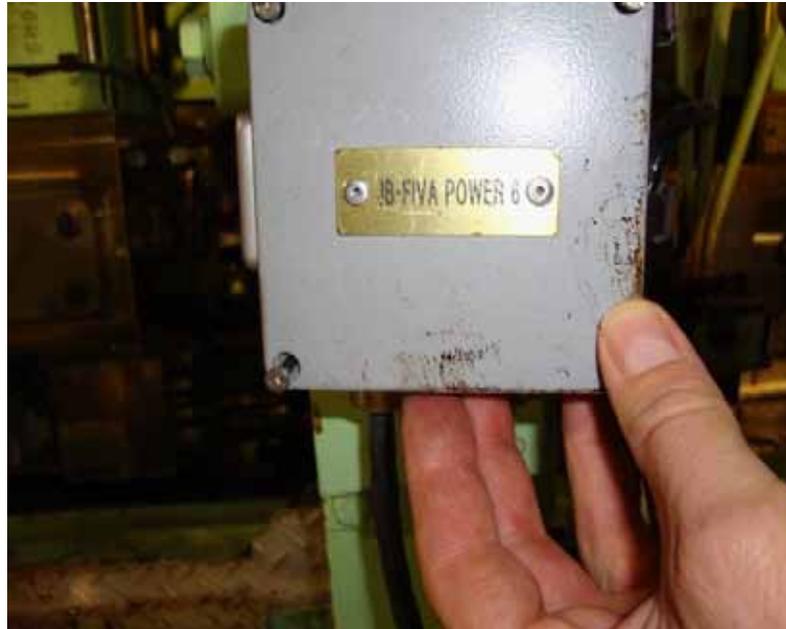
5.2. Example 2: Failure found in junction box for FIVA tail

Figure 6: Junction box for the FIVA tail. Lid closed.
