Lifejacket Recalls (also see www.rnli.org/seasafety/safety_issues)

CREWSAVER Crewfit 290N Lifejackets – June 2011 to October 2012

Date: November 2012

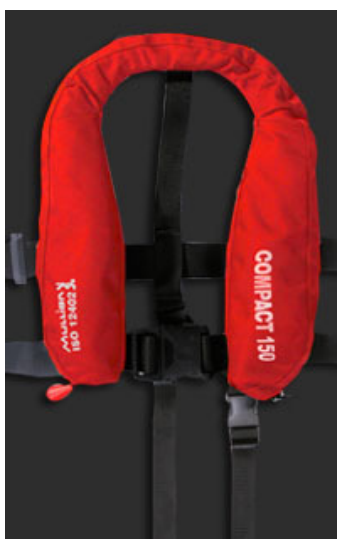
Mullion Compact 150N life jacket

It has come to our (Mullion) attention that a problem may occur during the inflation of some of the COMPACT 150N ISO 12402 lifejacket.

The affected lifejackets are being recalled as a precaution for inspection and, where appropriate, repair or replacement. Owners of affected lifejackets should:
