New MyLink Apps in Radio Software Update

TECHLINE news

TECHLINK

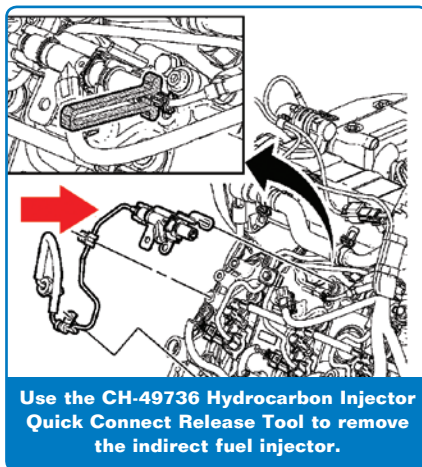
GM Engineering is asking to document the following information on the repair order if diagnosis leads to replacement of the Q57 indirect fuel injector for DTC P0420, including:

- Quantity of fuel flow measured (ml) after performing the exhaust aftertreatment fuel injector diagnosis
- Engine hours as found on the Driver Information Center

- Type of vehicle/general usage (shuttle bus, commercial vehicle, light duty, hauling, etc.)
- Estimated percentage of time the vehicle spends at idle

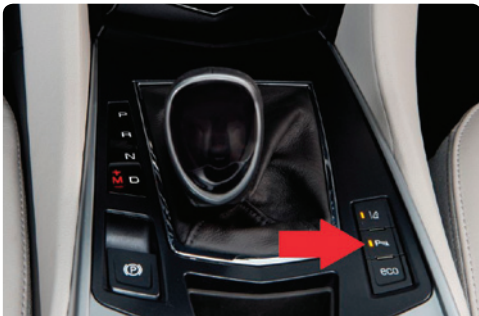
Unwanted rear Parking Assist alerts and/or unwanted Automatic Braking while backing up may occur if the rear sensors are dirty.

Parking Assist button on the SRX.

If the customer feels the brakes apply or experiences unwanted parking assist alerts while backing up, the rear bumper should be cleaned as soon as possible. If the rear bumper cannot be cleaned immediately, the Parking Assist and Automatic Braking features can be turned off by pressing the Parking Assist button on the center console next to the shift lever each ignition cycle to disable the system until the rear bumper can be cleaned.

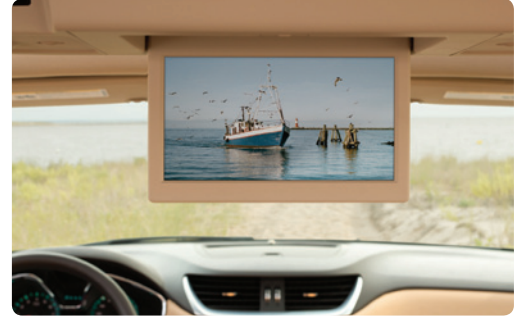
The rear DVD video screen will not turn back on after an ignition key cycle on 2013 Enclave, Traverse and Acadia models. This is a normal operating characteristic and no repairs should be made.

For the 2013 model year, the operation of the video screen with an Ignition off cycle is to power down the video screen when the Retained Accessory Power is disabled. When the ignition key is turned on, the video screen will remain off -even if the DVD was the last active source.

To turn on the video screen, press the power button on the remote control or, from the front seat, toggle the pause/play button on screen control (viewable by touching the radio screen) with the active source as DVD.
