Repairhints

Communicator 9110/9110i RAE 2

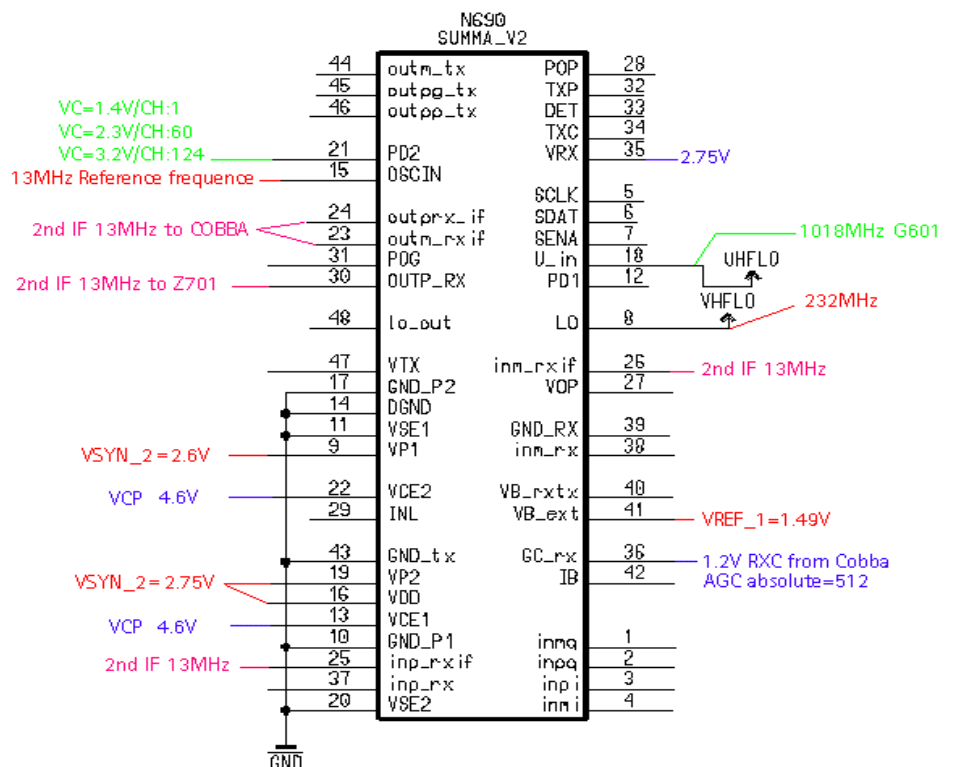
SUMMA N690 faulty

- Check VCP=4.6V at Pin 13, 22
- Check VREF_1=1.49V at Pin 41
- Check RFCLK=13MHz at Pin 15
- Check VSYN_2 = 2.75V at Pin 16,19 and 2.6V at Pin 9
- Check RXC=1.2V (AGC absolute=512)at Pin 36
- Change SUMMA N690 if all Values are in limit

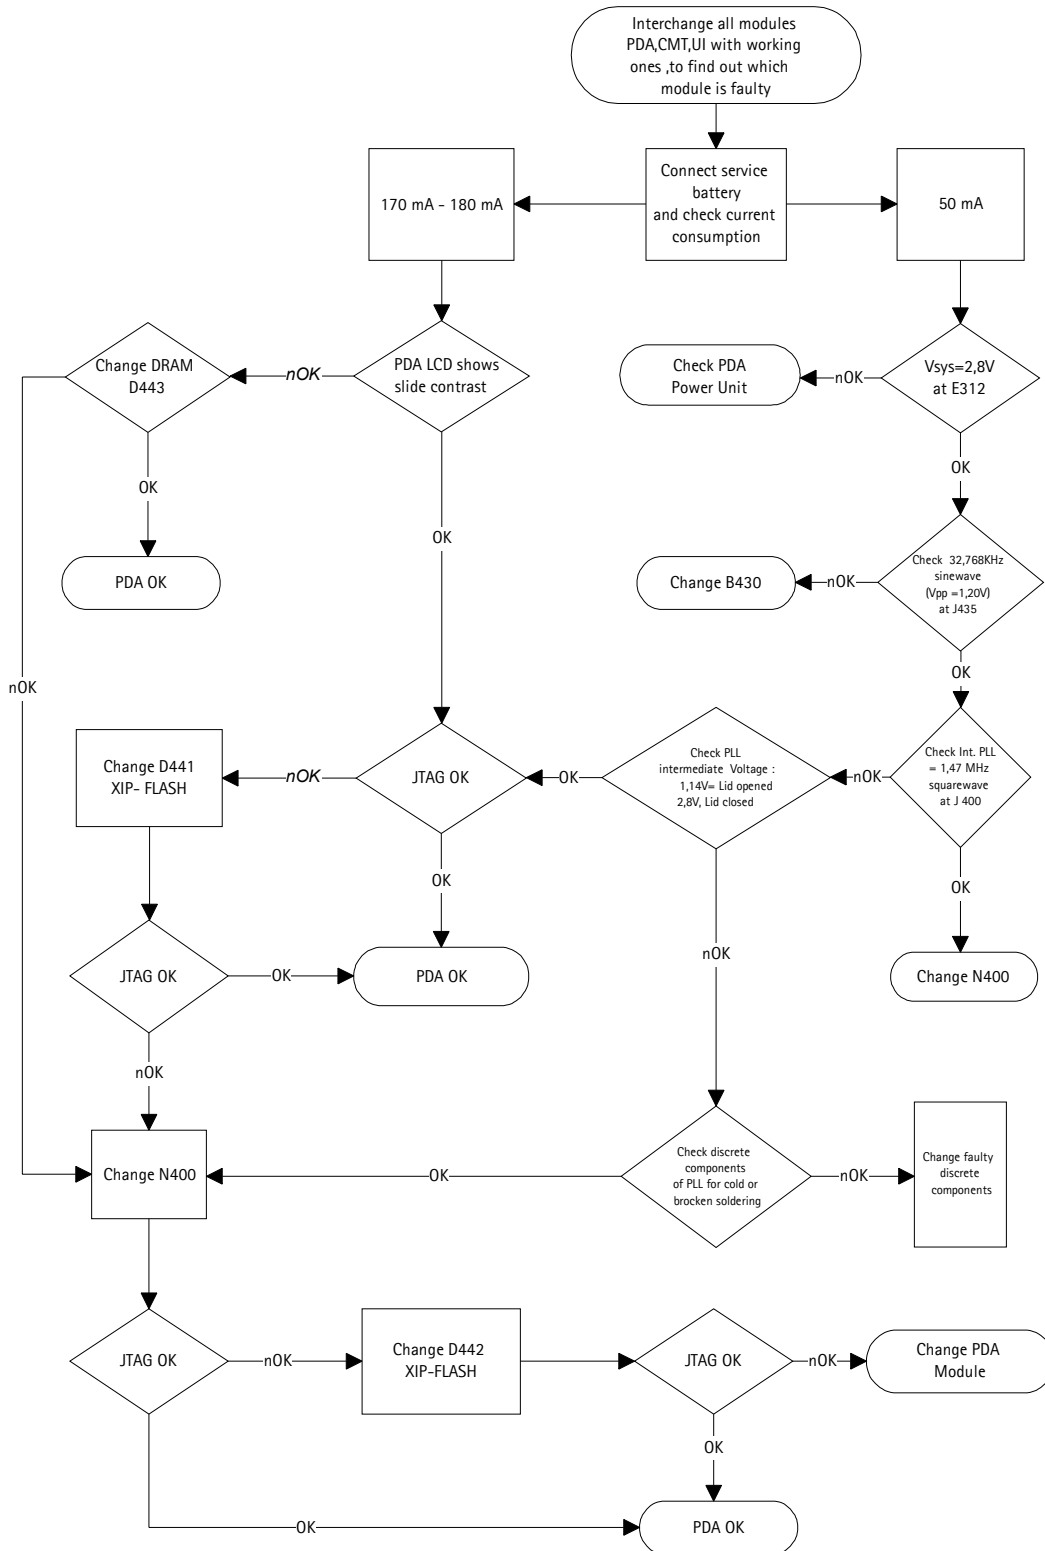
PDA fail

(Note: If you do not have the possibility to JTAG (JTAG=Joint Test Action Group), send the PDA to the next authorized local service center. Everytime changing the XIP-FLASH'S (D441, D442), the JTAG is needed).
