**TECHNICAL BULLETIN**  
**CS 250ci/300ci400ci/500ci**

<b>Bulletin #</b> CS 250ci/300ci/400ci/500ci-10	<b>Model</b> CS 250ci/300ci/400ci/500ci	<b>Date</b> 02/11/11
<b>Updated Serial Number</b> N/A		
<b>Subject</b> <b>500ci SERIES TROUBLESHOOTING GUIDE</b>		
This technical publication is confidential information that is the property of Kyocera Mita America, Inc. It is solely for the use of Kyocera Mita's authorized dealers. This information may not be published, reproduced, sold, or copied in any media. Its unauthorized use is prohibited. Copyright © 2011 by Kyocera Mita America, Inc. All rights reserved.

# 500ci Series Troubleshooting Guide

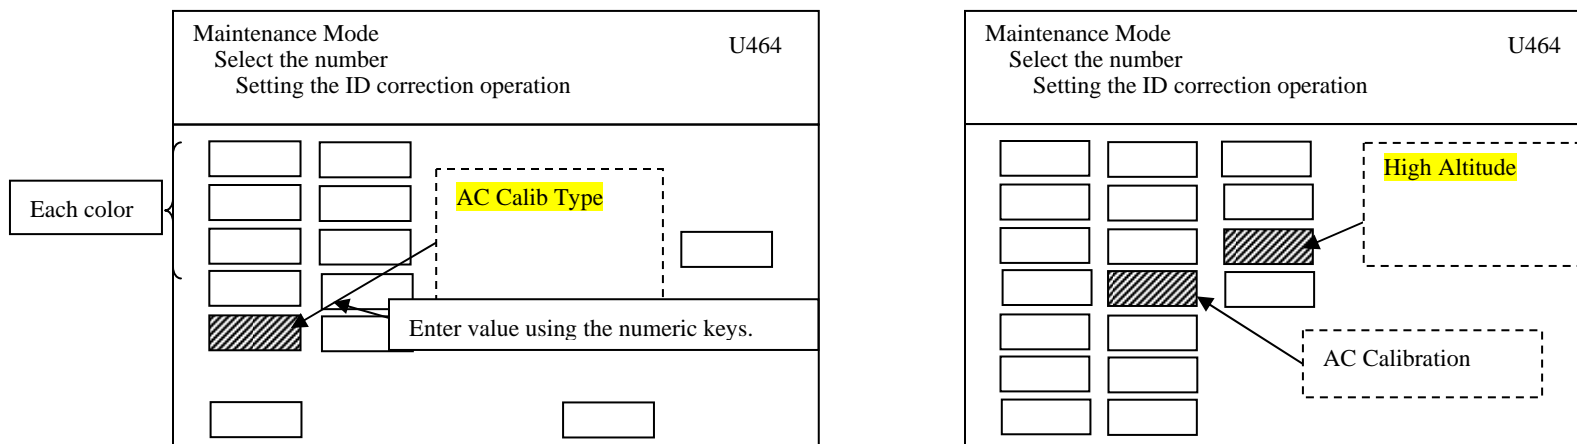
“AC Calibration Type” under “AC Calibration” Normal setting “0”  
“High Altitude” (MODE1, MODE2) Default: MODE1

1. When color dots appear on the image, set the “AC Calib Type” to “2” (Color dots mode 1) or “3” (Color dots mode 2) if the previous setting does not help.
2. Set the color C/M/Y/K to (ON) that requires Dev unit calibration with reference to the color dot and then execute the AC Calibration.
3. When Normal Mode “0” (OFF) is entered for “AC Calibration Type”, the value will be internally set to the value acquired after executing the previous AC Calib Type operation. Reference (C) and (D) on the chart below. **Normal Mode “0” is set when firmware is upgraded in the field.**
4. (Default mode) “4” is set in new MFP’s from the Factory. Leave at this initial setting unless there is a problem.

**Note: When executing calibration after a new developing unit is installed, set to “4” (Default mode), select the applicable color unit and then execute AC calibration.**

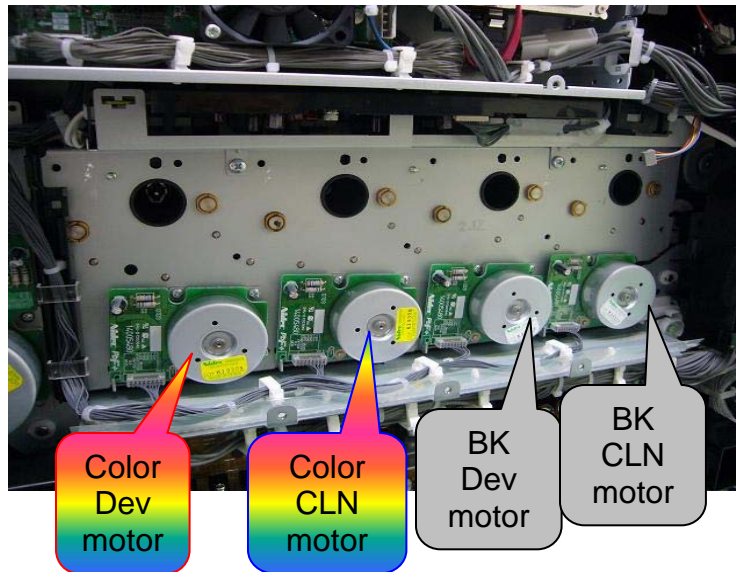
## C-Call (CLN Motor/DLP Motor Reference)

Item	Object part	Relating C-Call
PARTS MOTOR DLP (302H79309) <u>Label: Yellow</u>	Color CLN Motor	C2352
	Color Dev Motor	C2102 C7102 C7103 C7104
PARTS MOTOR CLN (302H79310*)	BK CLN motor	C2351
	BK Dev motor	C2101 C7101
	Container Agitator Motor	C7010
PARTS DC MOTOR ASSY (302H79444)	Toner supply Motor	C7000
