Information on Software Update
BERNINA 8 Series, V29.39.00

BERNINA 830 / 820

The Release Note V29.39.00 is in addition to the Release Note V29.21.40 (6/2009).

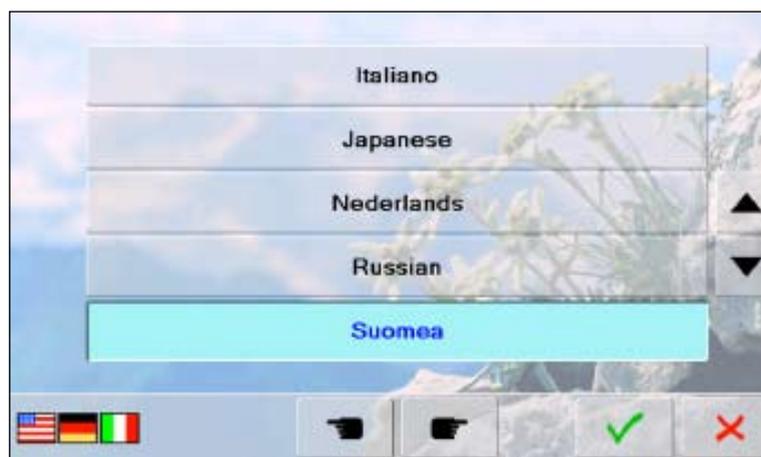
1.1 Language "Finnish" integrated

The following languages are now integrated: Danish, German, English, Spanish, French, Italian, Japanese, Dutch, Russian, Swedish, Turkish and Finnish.

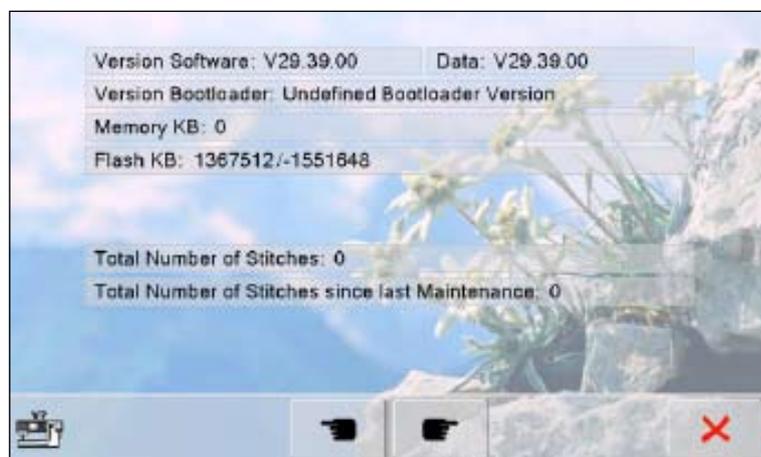
1.2 Display of data version number

In "Setup-Program/Information/Version", the version of the data is visible. Data contains all sewing and embroidery stitches.

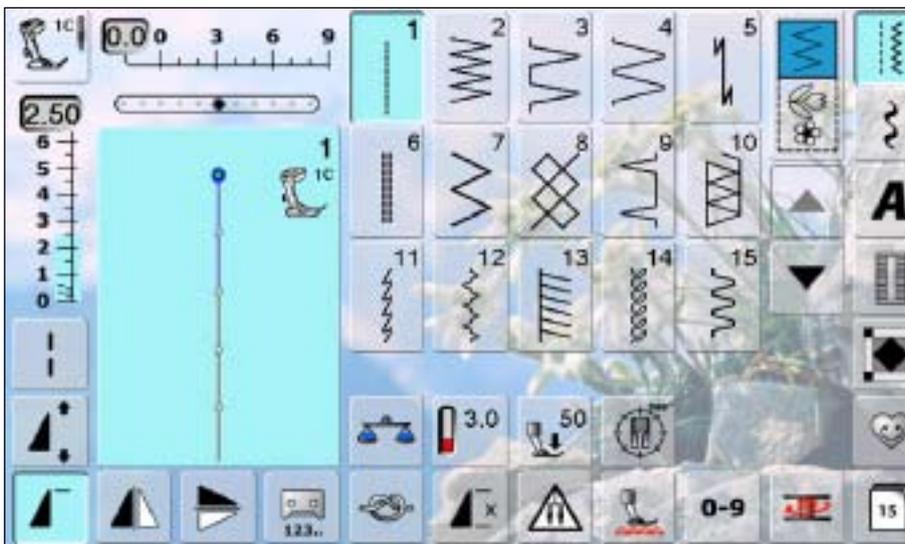
2.7 Winding indicator during sewing/embroidery

When closing the winder menu during winding, the clock symbol changes to the winding symbol and allows switching back to the winding menu.

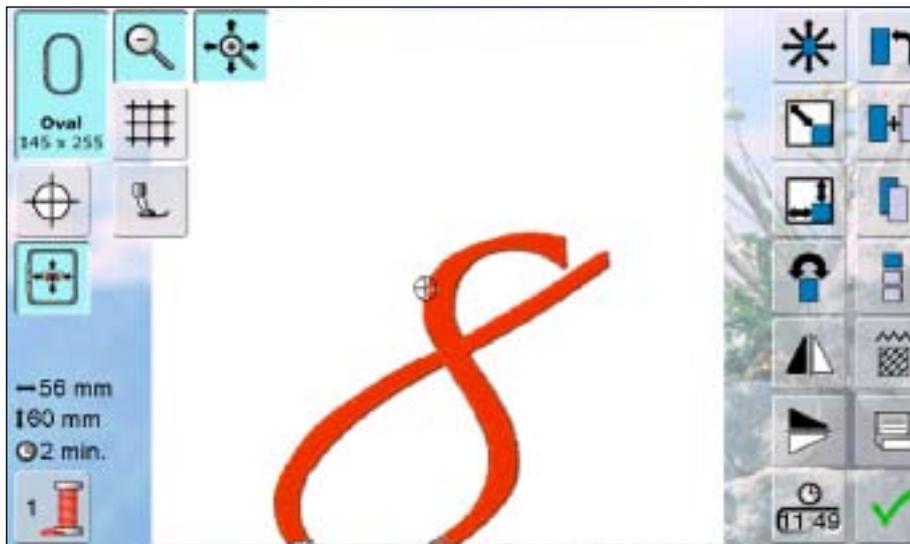
3.2 Using zoom option with panning

When using the zoom option, only the view of the design will be moved. The hoop position relative to the design will not be changed.

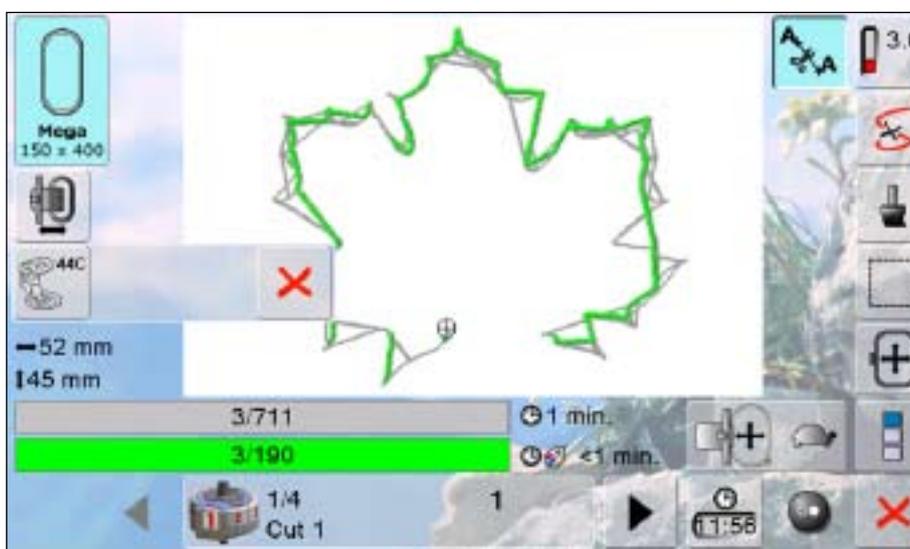
3.3 Using Foot #44C (The new CutWork & Echo quilting foot)

Developed for the CutWork tool, this foot can also be used for quilting.

For designs with "cut" and "normal" embroidery layers, the foot #44C can be selected in the stitch out mode. The outlines for the selected foot will be immediately set. The position of the design will not change.

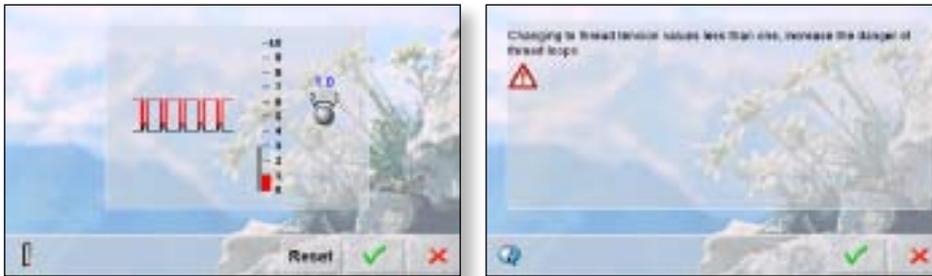
3.4 Thread tension can be changed to a minimum of 0.5

A new parameter controls the minimum thread tension range (between 0.0 - 1.0)

In the embroidery mode, the thread tension can be lowered to a minimum level of 0.5, instead of 1.0.

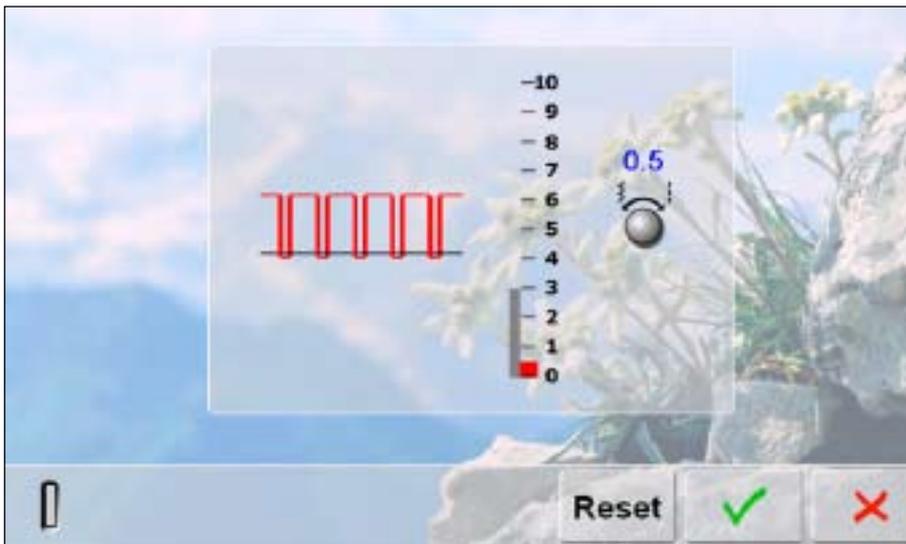
When decreasing the tension values to less than 1 a warning message appears. After confirmation, the minimum tension of 0.5 can be set.

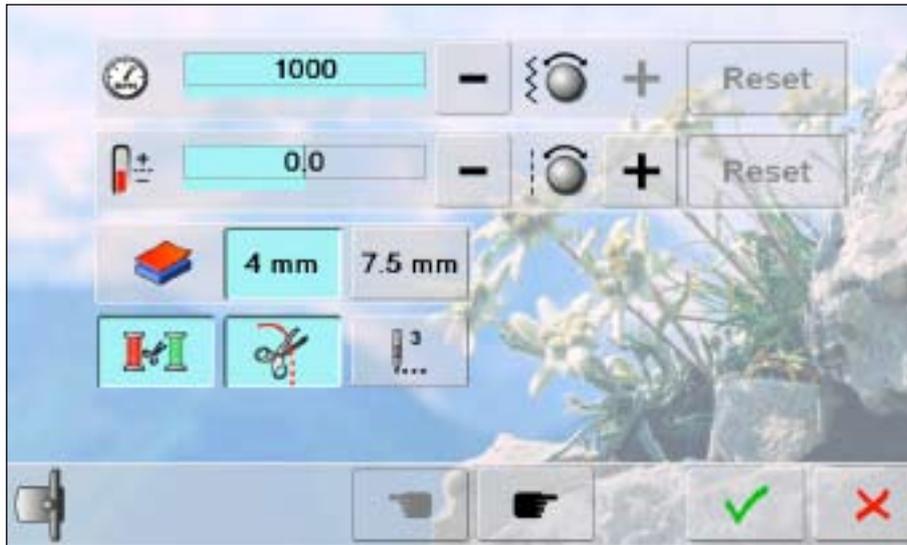
3.5 Stop for manual cutting can be switched off

Deselecting of the scissor symbol, will disengage the stop sequence for manual cutting at the beginning of a design or color.

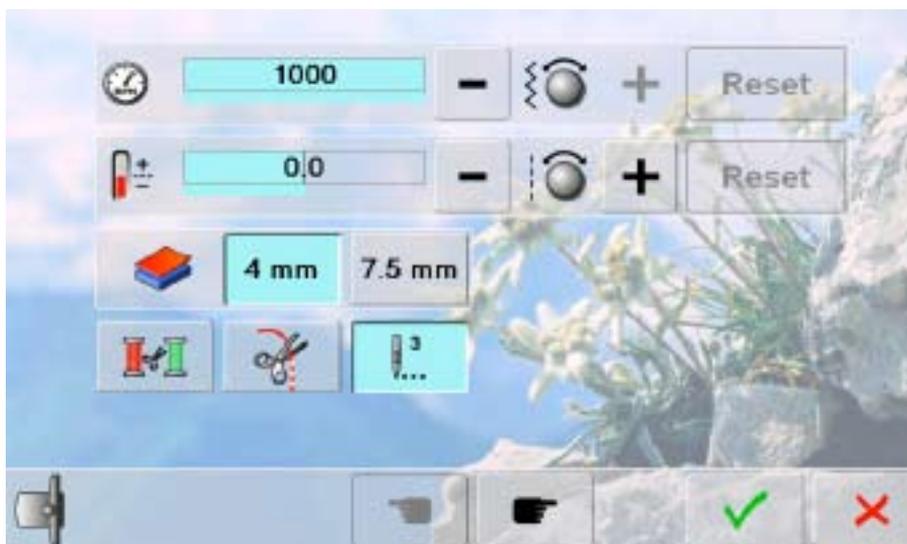
3.6 Manual "tie on" for embroidery

Disabling of the "tie on" button will disengage the automatic tie on. User brings up the lower thread manually and during the first stitches the thread must be held.

Attention: If "tie on" is deactivated, the setting for jump stitches will be ignored and the cutting of jump stitches is NOT possible.

When the machine is turned off it returns to "activated".

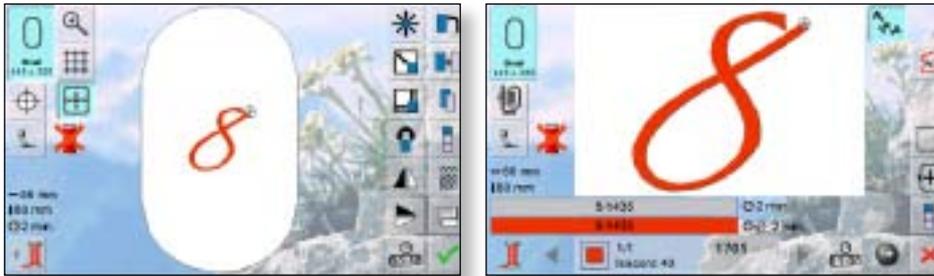
3.9 Stitching "without thread", is displayed in embroidery mode

As is in sewing mode (in setup), the selected "no thread" mode will be displayed.

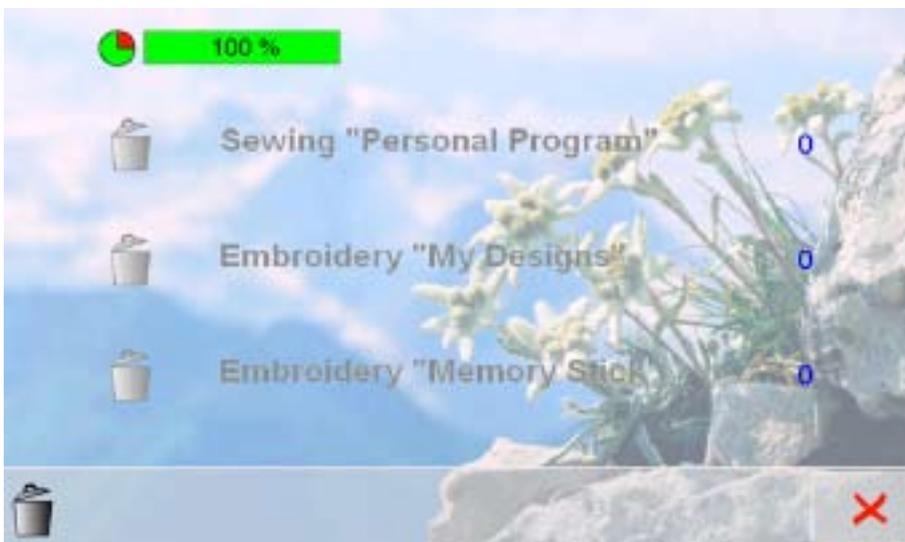
4.3 Free memory

If there is nothing stored on the sewing machine memory and the free memory counter does not show 100%, the software version has to be updated again (this will free all allocated memory not used).
