Troubleshooting: C130, 140, 150 or 160 Error for e-STUDIO205L/255/305/355/455 Series

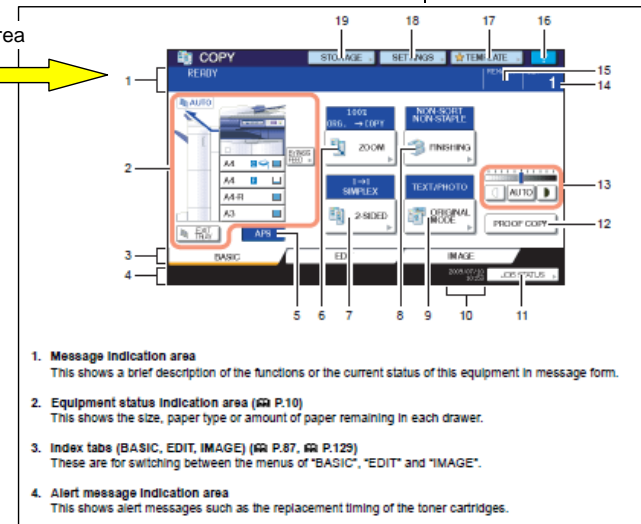
Fig. 1

- 3) Check the message indication area on the touch panel. (Fig. 1)
Either of following messages appears in this area.
It does not appear in the alert message indication area (black part of the bottom of the menu).

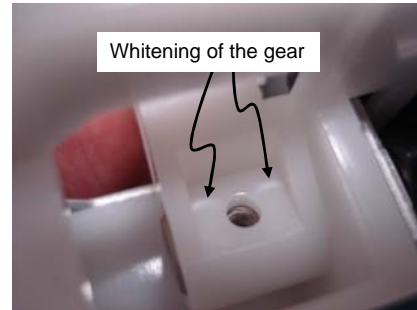
Picture 3
Refer to Fig. 3.

If the gear and the plate contact as shown below, the error may occur again and the gear may be damaged.

If "Yes", replace the gear with the new one.
Moreover, since the gear in the drive unit of the drawer tray-up may be damaged, refer to "8.6.25 Upper tray-up motor (M11)" in the Service Manual (page 8-27 and 28) and check whether the gear tooth flank is damaged.

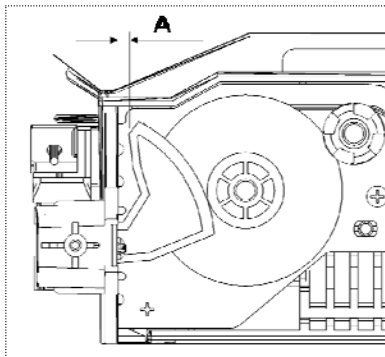
Fig. 2

If there is a clearance (A) between the gear and the plate as shown in Fig. 2, the gear condition is normal.

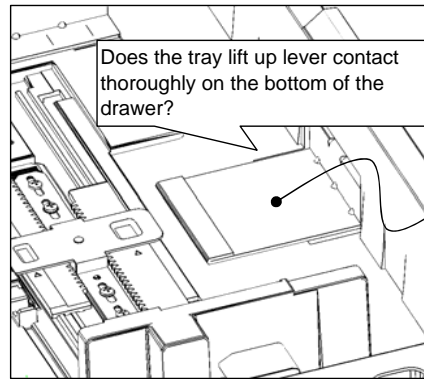
Fig. 5

If the tray lift up lever does not contact thoroughly on the bottom of the drawer, the screws in Fig. 4 may become loose or the lever may be deformed. If the lever is not bent at a right angle, replace it with a new one.

If the screws are loose, tighten them firmly.

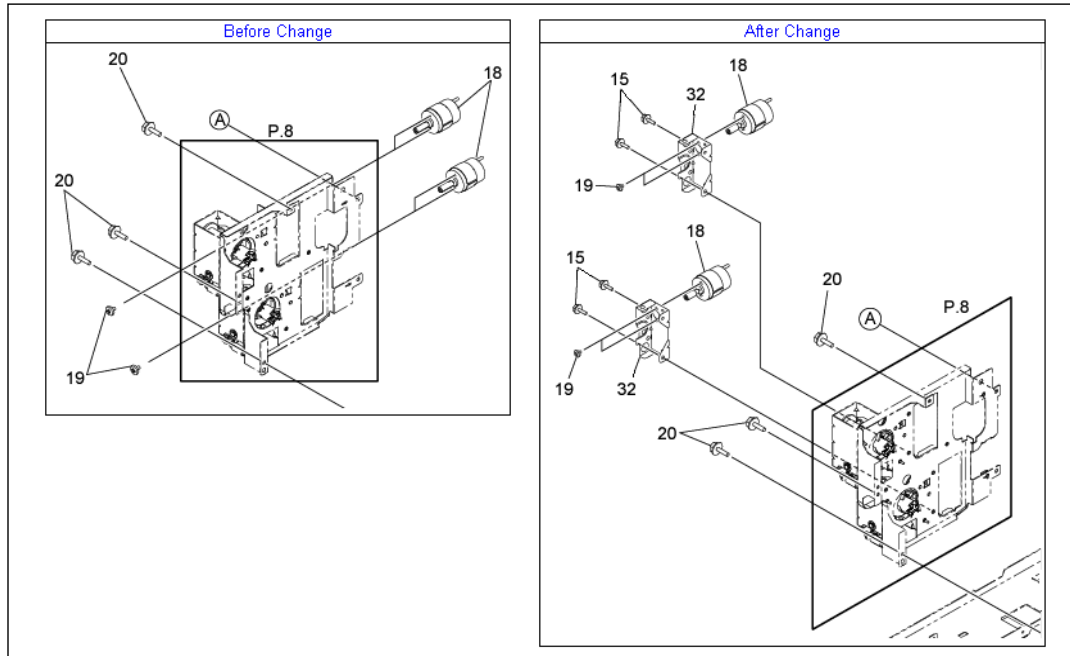
Fig. 8

→ The configuration of the tray-up motor installed section has been changed due to the countermeasure to unmeshing.
 The applicable production lots for each destination are as follows.
 If unmeshing occurs, even if any problem is found after checking [1] and [2], replace the drive unit of the drawer tray-up with a new one.
 (Refer to BSI No. G09H114 for details)

→ If the screws are loose, tighten them firmly.
