Service Information Bulletin

NUMBER: 8–10–13 **S.M. REF.:** Listed in Table **ENGINE:** EPA07 Series 60 **DATE:** August 2013

SUBJECT: DOUBLE HYSTERESIS TEST

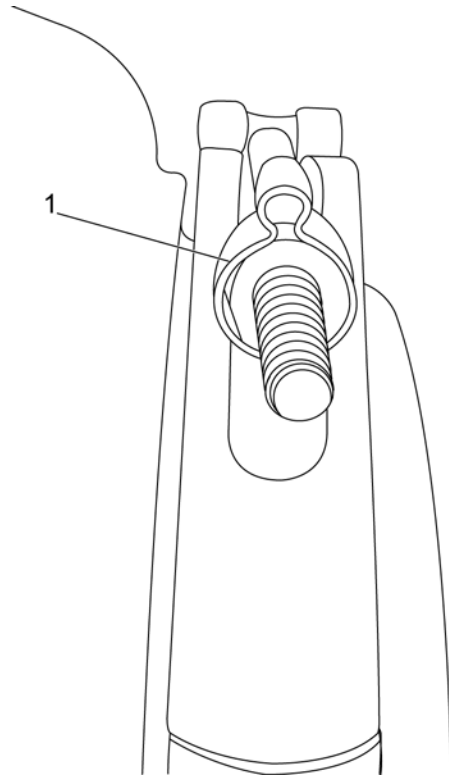
d090107

1. Remove the turbocharger. Refer to section .
2. Lubricate the turbo V-band clamp threads.
3. Slide a deep well socket over the clamp and strike the socket to remove the anti-tamper clip (1) from the nut.

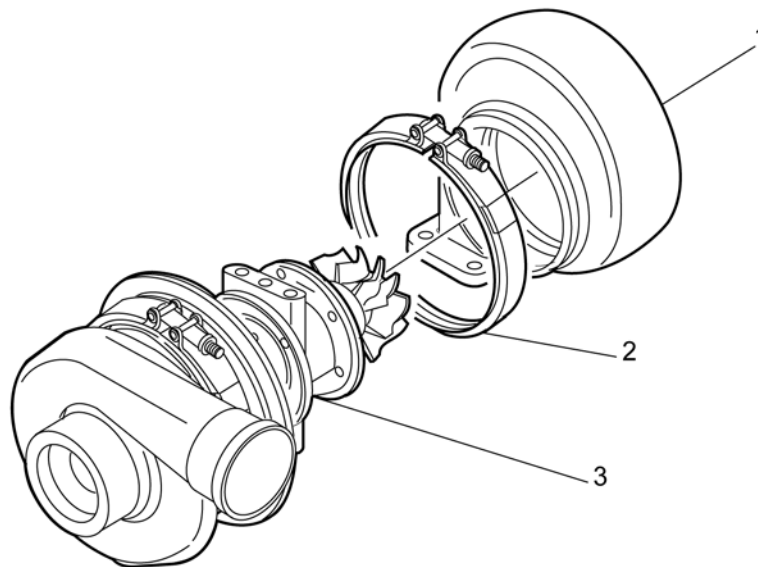
d090106

7. Separate the turbine housing from the bearing housing.

8. Inspect the VGT vanes to identify the failure mode. Use the identification chart below to properly identify the primary failed part and take the required actions.

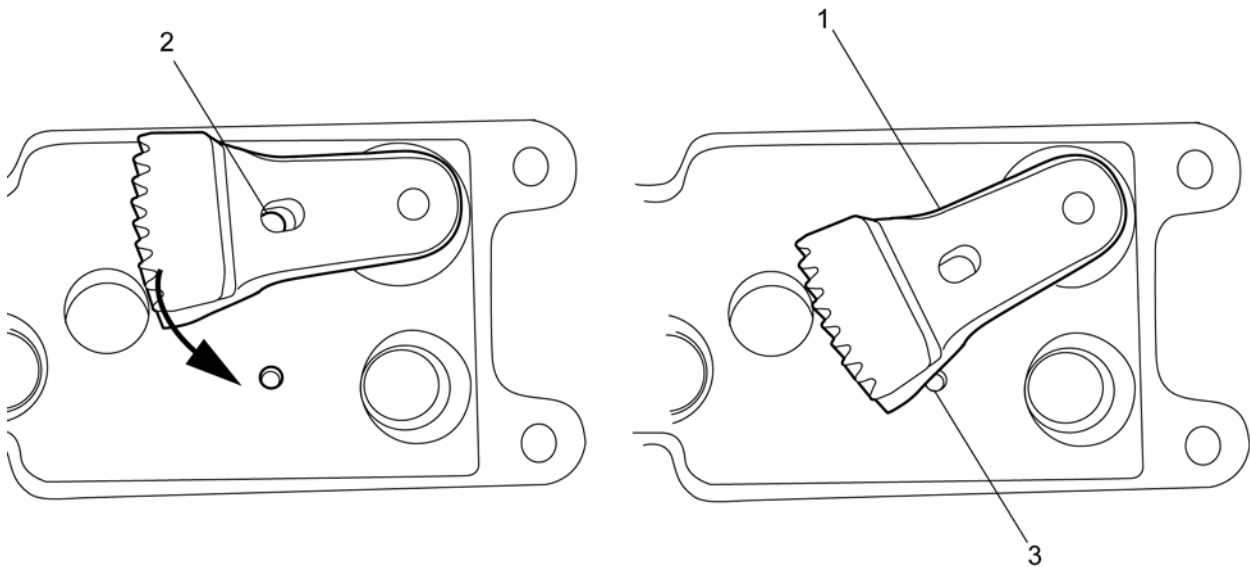
Figure 1 Sector Gear Setting

1. Rotate the sector gear clockwise by hand and check that the setting pin supplied in the service kits fits through the gear and engages in the 5mm reference hole (2) in the bearing housing. Remove setting pin.

2. Rotate sector gear (1) counter-clockwise and verify that the flank of the sector gear covers a portion of the smaller 3 mm x 2mm (3) deep sight hole.
3. Moderate force may be required to rotate sector gear from stop to stop. Do not use any tools to force the sector gear.
4. If the sector gear is limited in travel, do not replace the actuator. Replace the turbocharger. Refer to section .
