97-1, *Publication Date: JANUARY 2, 1997*

97-1, Publication Date: JANUARY 2, 1997

Article No.  
97-1-17

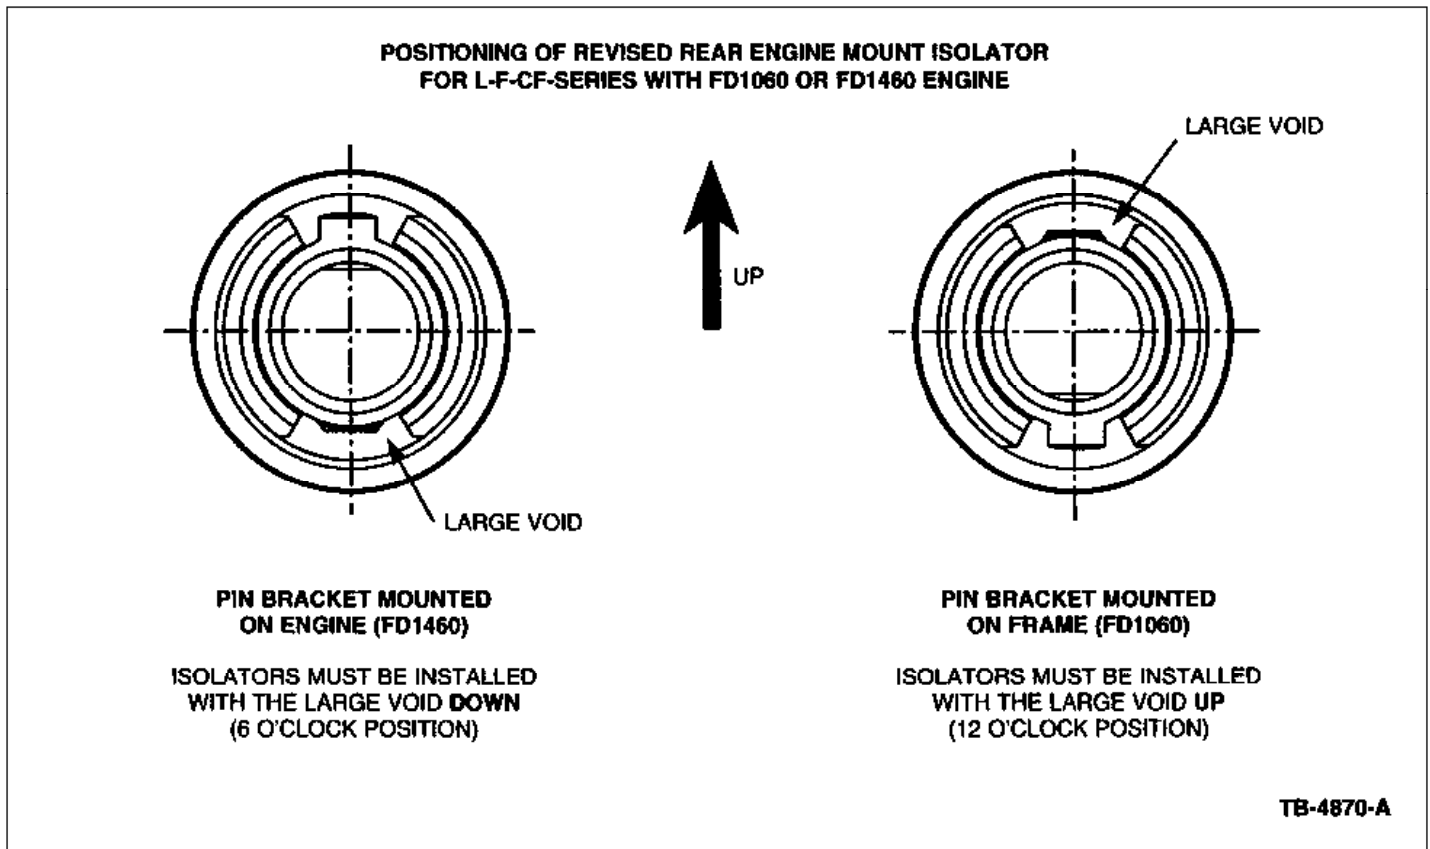
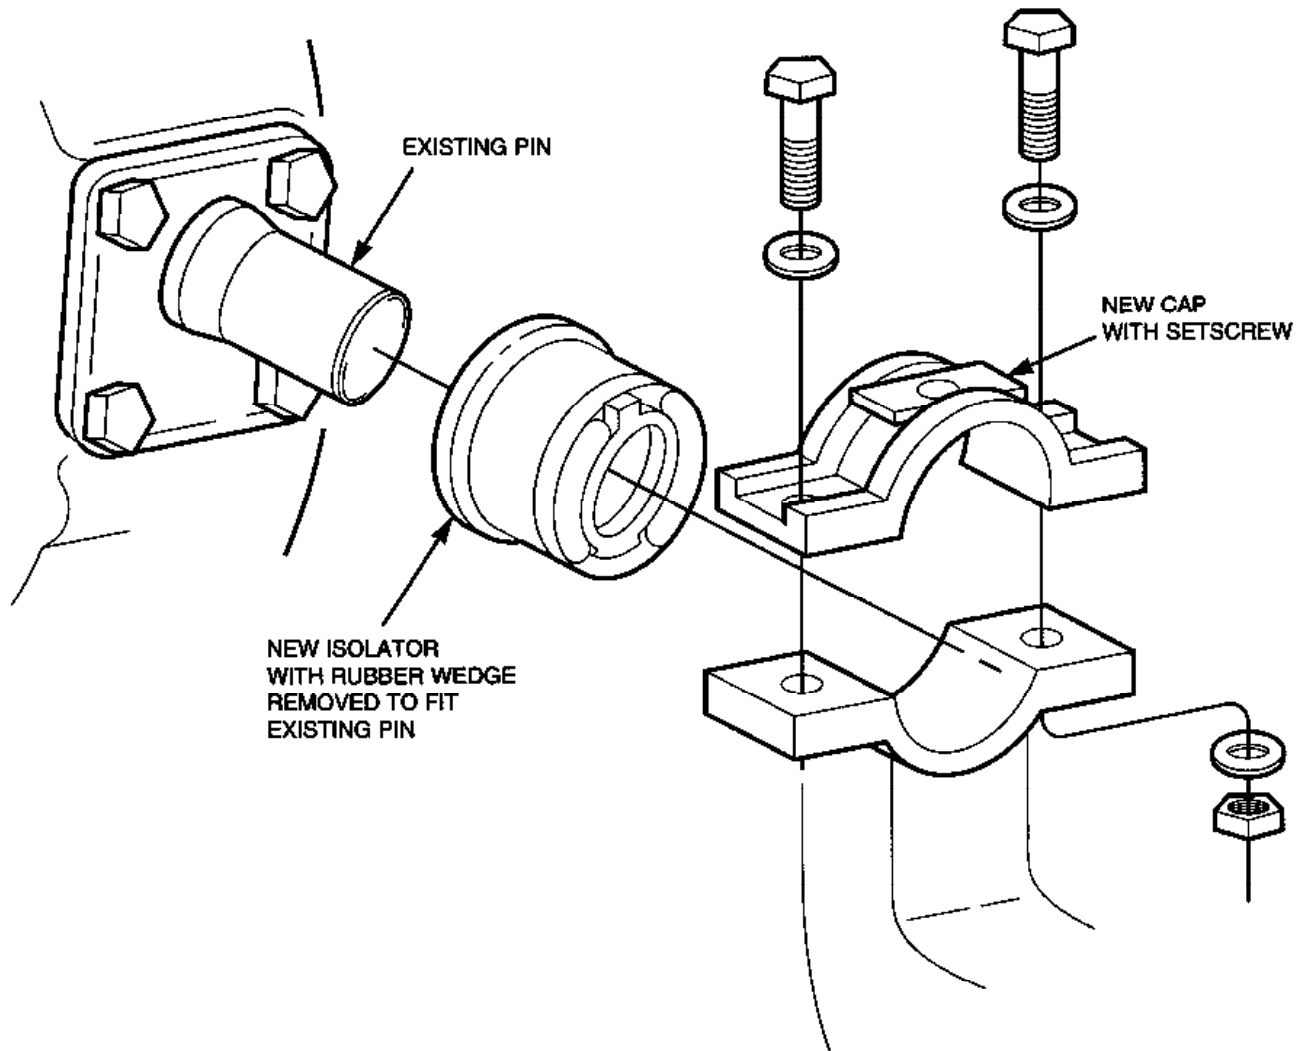
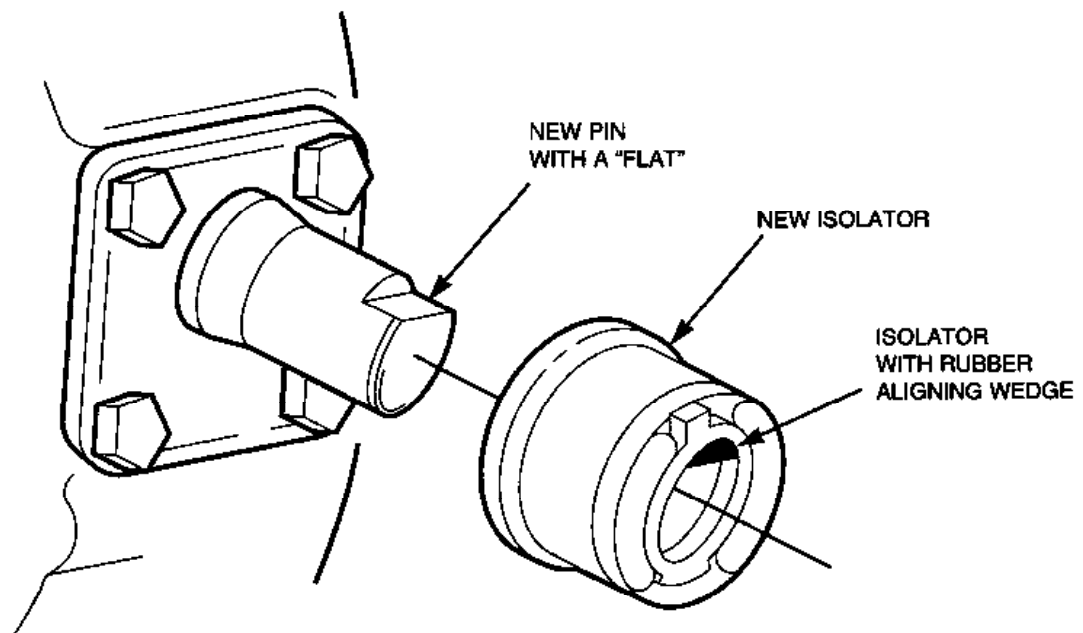
**Figure 3 - Article 97-1-18**

High engine noise/vibration/harshness (NVH) at low engine rpm may occur on some vehicles. This may be caused by a reduction in cushioning of the rear engine mounts.

Replace the rear engine mount with a revised rear engine mount. Refer to the following Service Procedure for details.

1. Remove the bolts, nuts and washers that retain both the right and left side rear engine mount/isolator caps.
2. Carefully raise the rear of the engine using suitable service jack and a wood block placed under the transmission. The engine should only be raised enough to unload the rear engine mounts/isolators and to allow their removal.
3. Remove and discard the existing rear mounts/isolators.

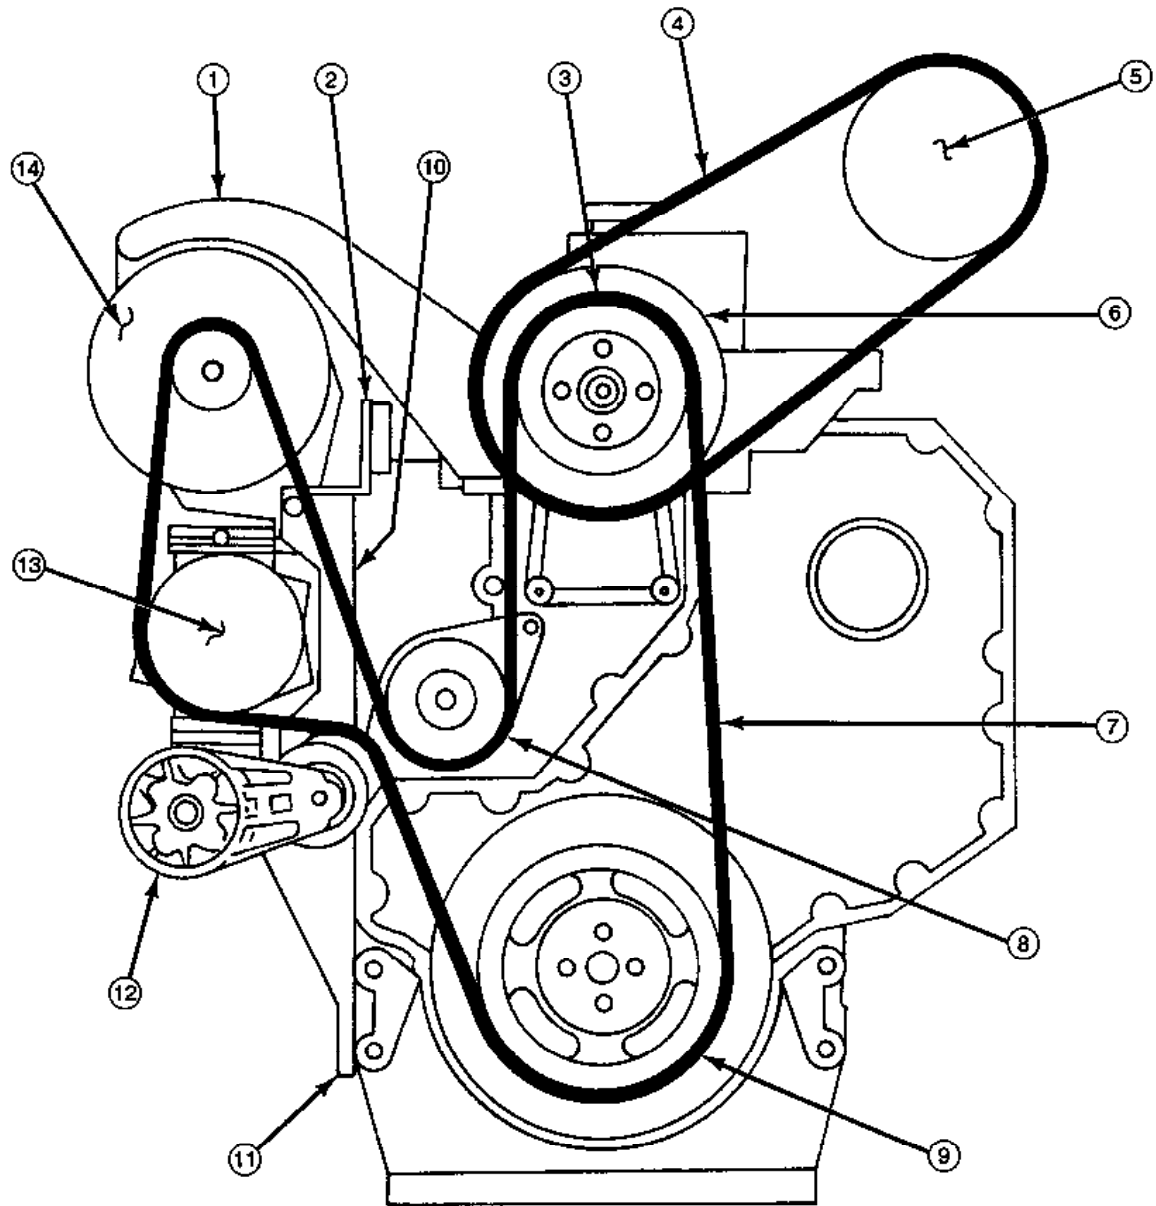
**Figure 3 - Article 97-4-11**

The Front End Accessory Drive (FEAD) belt may have high wear and/or may come off of the drive pulleys on some vehicles. This may be caused by the belt tensioner support plate and/or the idler pulley support plate not being flat. This can cause the tensioner and idler pulleys to be out of alignment which results in accelerated FEAD belt wear and/or belt roll off.

Replace the belt tensioner support plate and if equipped, the idler pulley support plate. The revised plate(s) should allow both pulleys to be in proper alignment which should reduce the possibility of belt wear and/or belt roll off. Refer to the following Service Procedure for details.

9. Install the new belt or verify the original belt is wrapped properly around the crankshaft, fan, generator and A/C compressor or idler pulley (Figure 3). The belt must be completely seated in the groove of each pulley.

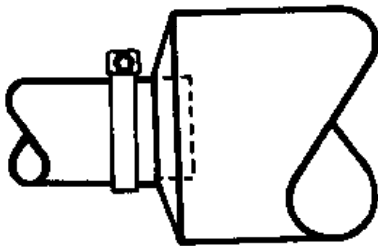
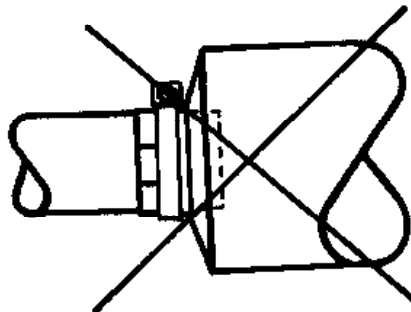
### TORCA CLAMP POSITIONING

THE TORCA CLAMP SHOULD BE INSTALLED SO THAT THE CLAMP BOLT IS POSITIONED BETWEEN THE TORCA SLOTS AND THE CLAMP IS FLUSH WITH THE FRONT EDGE OF THE INLET PIPE OF THE CCM.

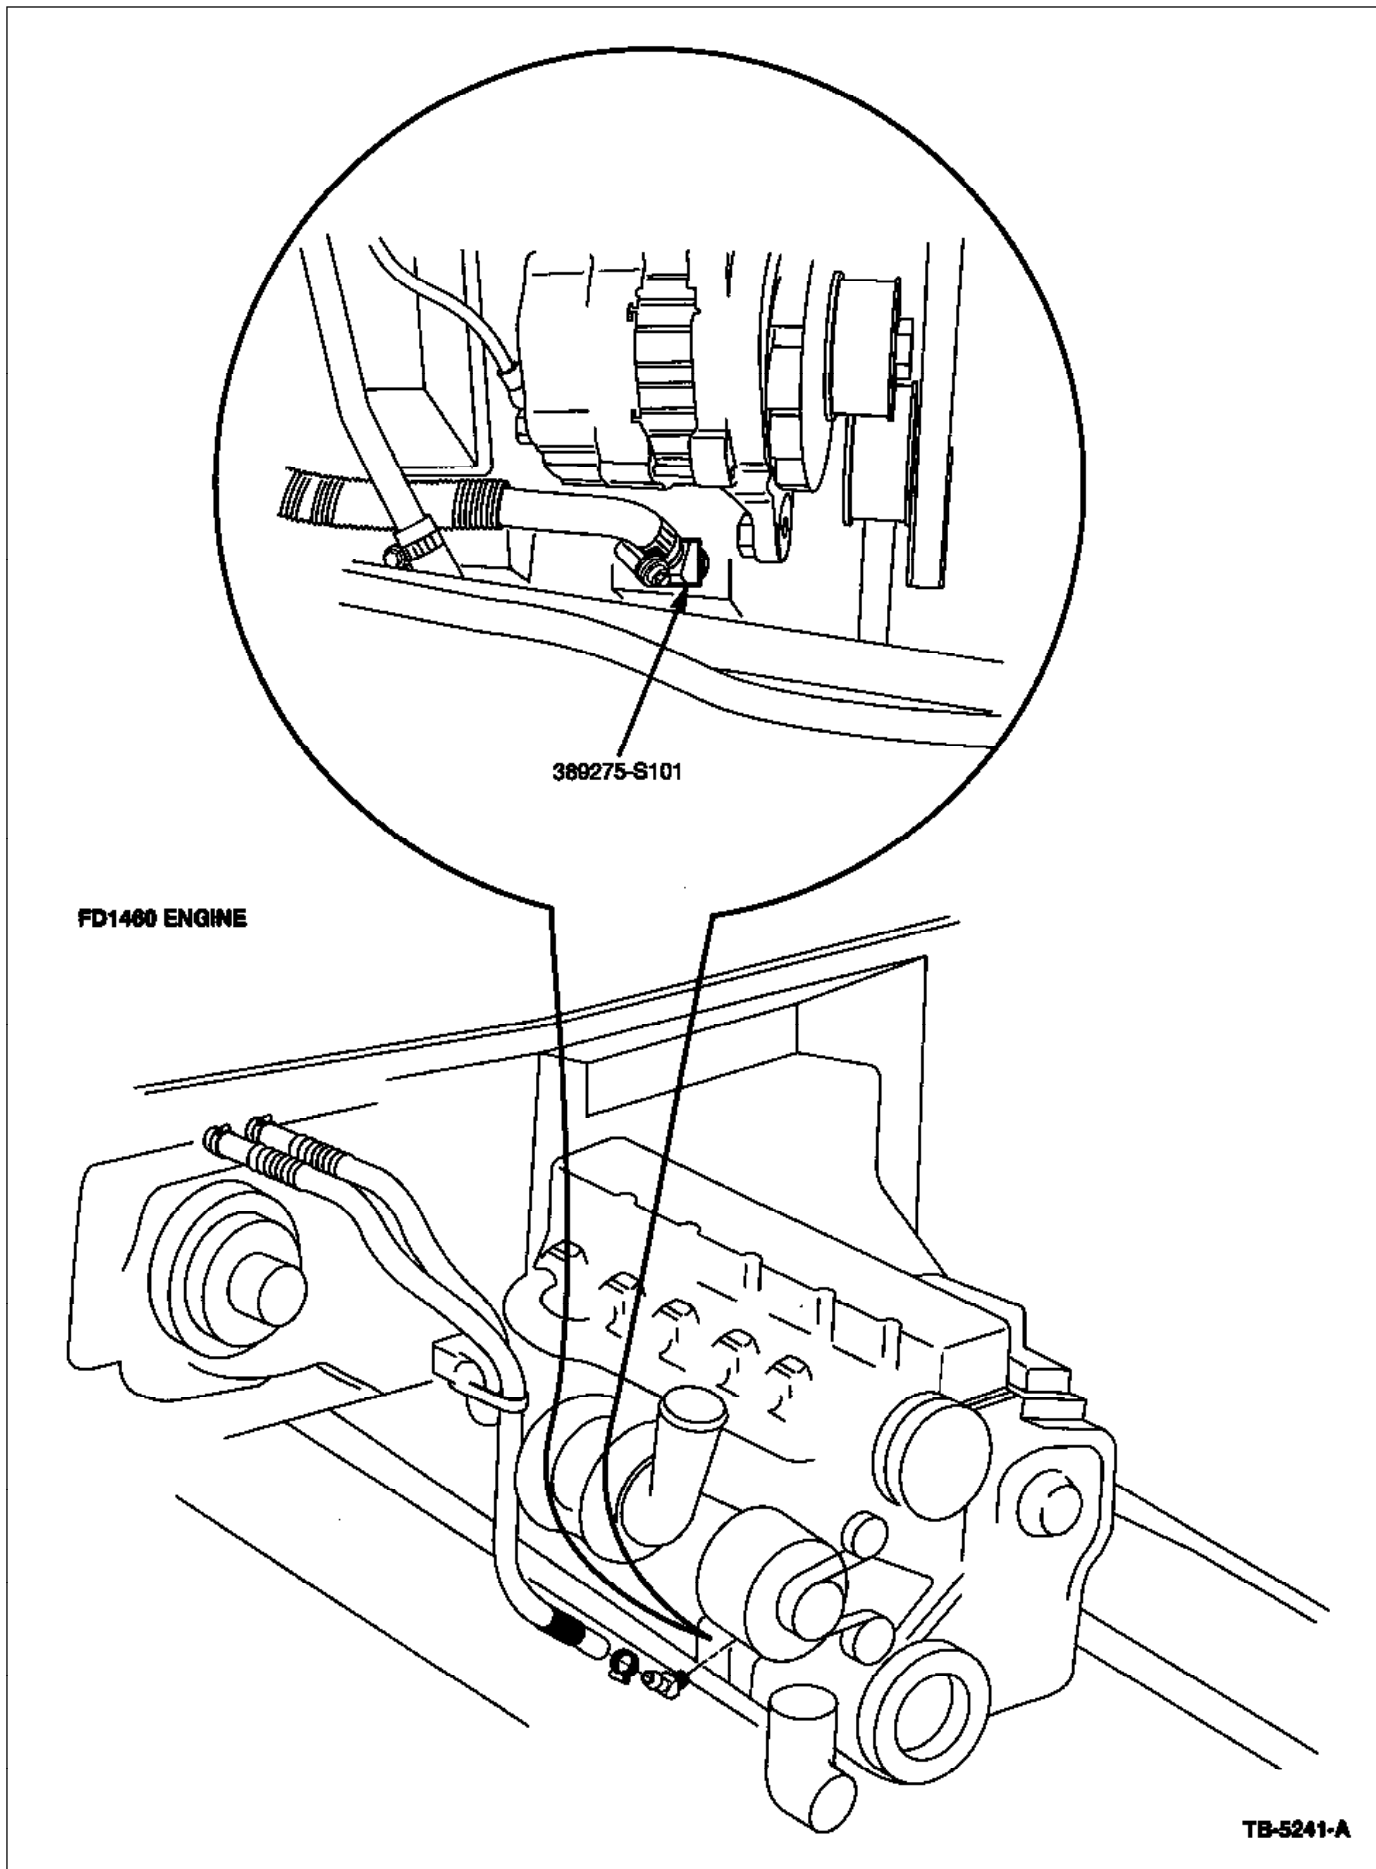
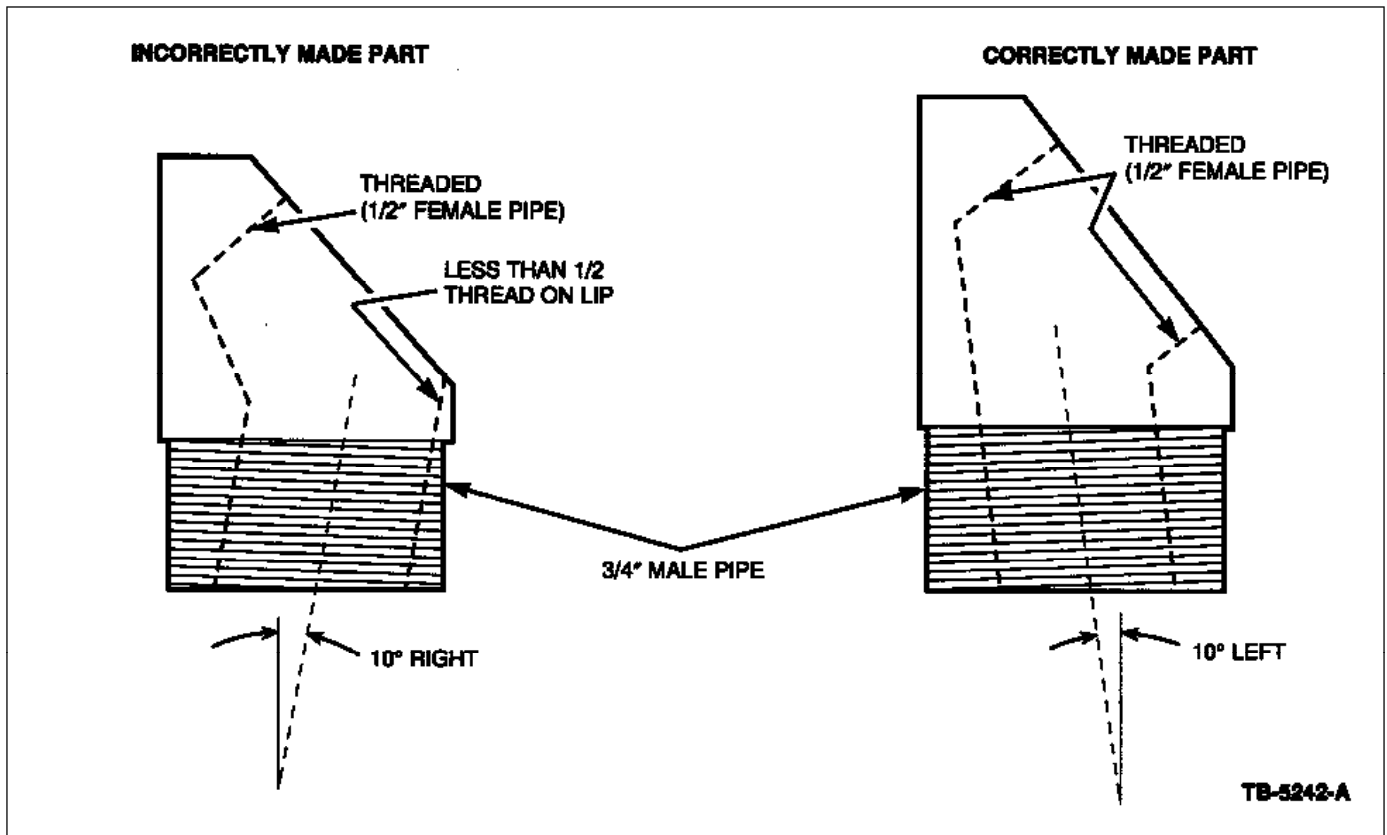
Figure 3 - Article 97-20-21

Some vehicles may have been built with a 45 degree elbow that is missing some threads. The elbow is located within the heater plumbing and may result in a coolant leak and/or poor/slow heat.

Replace the 45 degree elbow in the heater plumbing. Refer to the following Service Procedure for details.

4. Replace the 45 Degree Elbow (F7HZ-18599-SA) fitting.
5. Refill cooling system. Verify the repair.

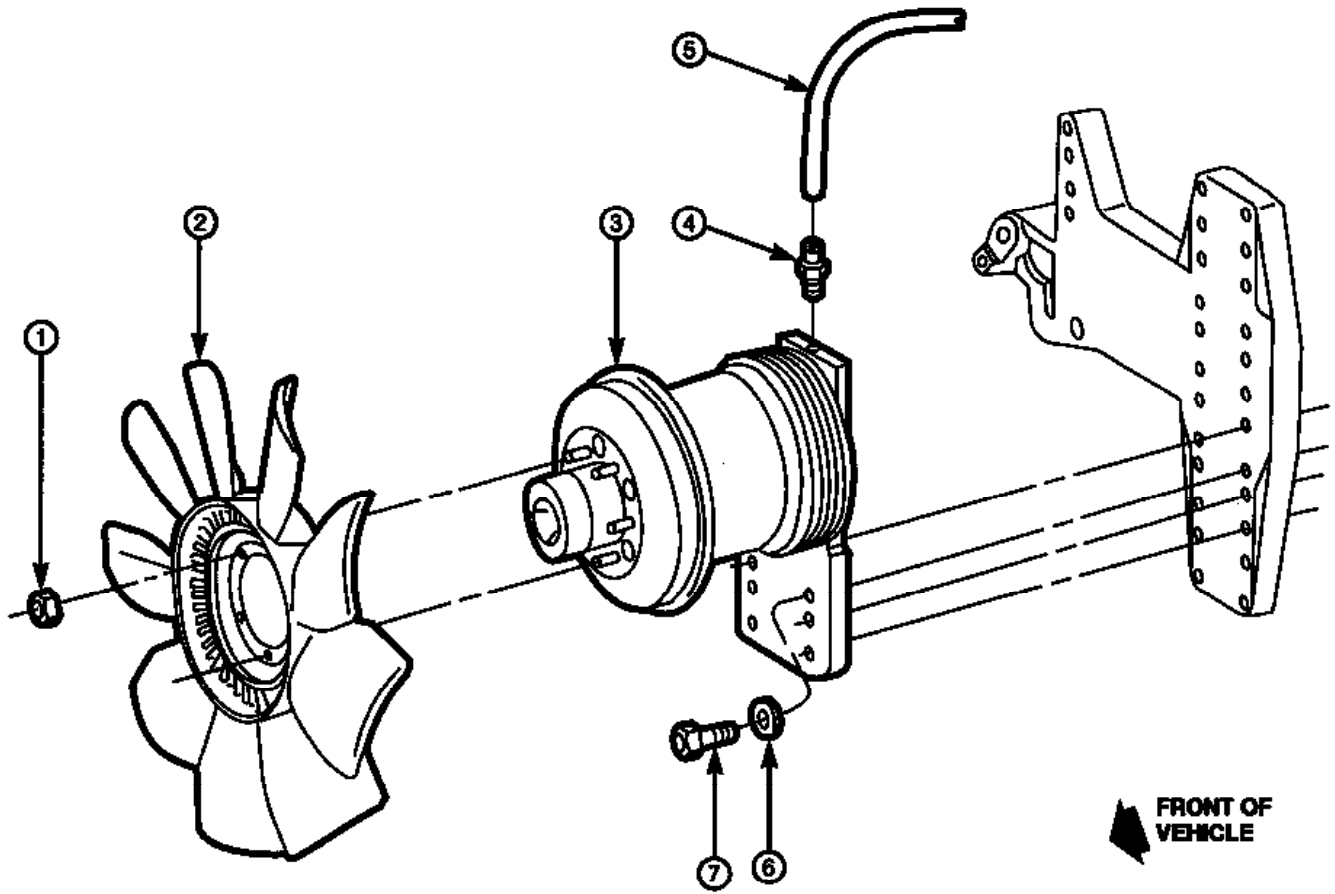
**KYSOR FAN CLUTCH WITH 26" FAN**

The fan clutch attaching bolts may become loose on some vehicles equipped with the Kysor on/off fan clutch. This may be due to the original fan mounting hub not being robust enough.

Modify the existing mounting of the fan clutch hub and add two (2) additional attaching bolts. The additional bolts should help prohibit the possibility of the fan hub from becoming loose. Refer to the following Service Procedure for details.

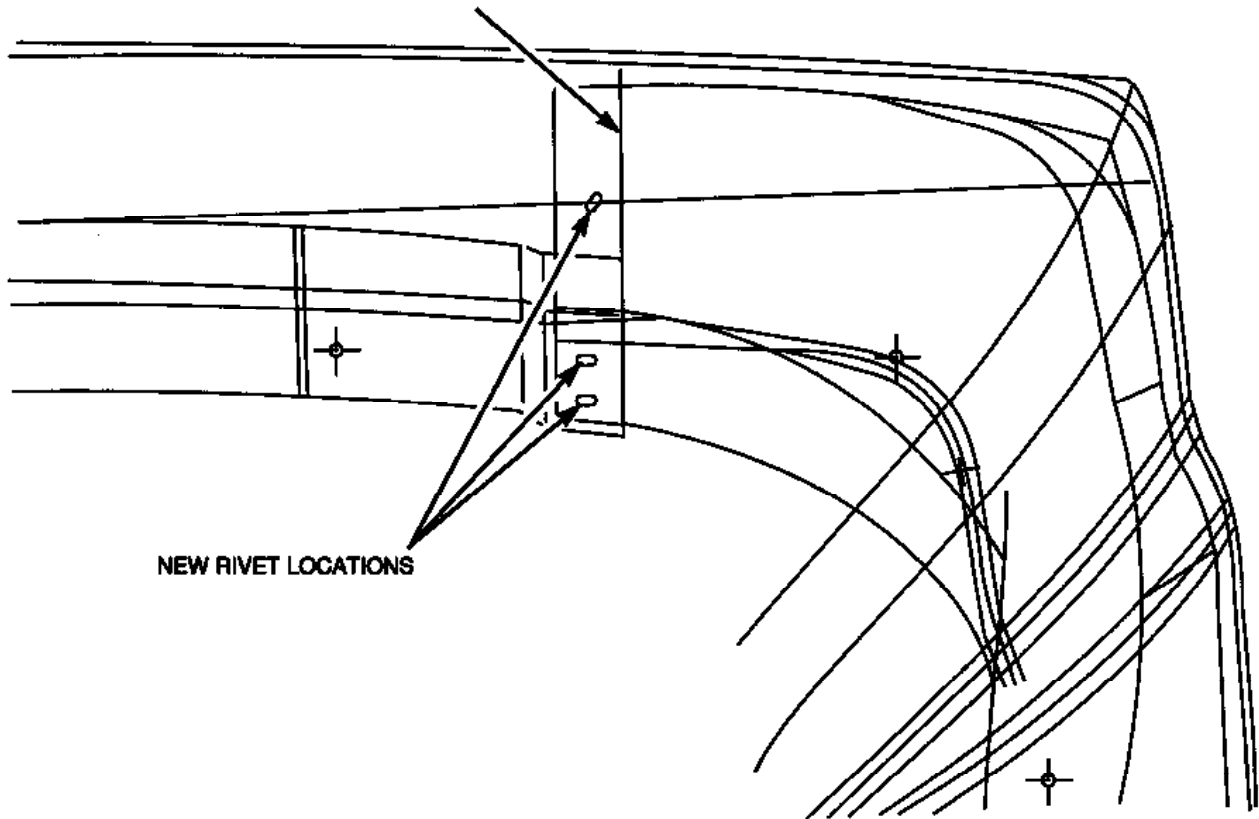
**Figure 2 - Article 97-23-16**

The hood may separate at the inner hood reinforcement bond on some vehicles. This may be caused by the bonding design between the hood center rear reinforcement and the hood side reinforcement.

SEAM (LOCATION OF POSSIBLE HOOD REINFORCEMENT SEPARATION)

Repair the hood by securing the hood center rear reinforcement to the hood side reinforcements. Refer to the following Service Procedure for details.

2. Using the information provided in Figures 1-5, determine and mark the location for all six (6) new rivet holes on the hood center rear reinforcement. Six (6) rivets will be used, three (3) on the left and three (3) on the right side.
