September 15, 1982

S83-008

The affected model, indicated below, may have three possible defects involving the outer steering arms, the sheet metal plate which positions the lower portion of the main steering shaft, and the forward edge of the track slider frame.

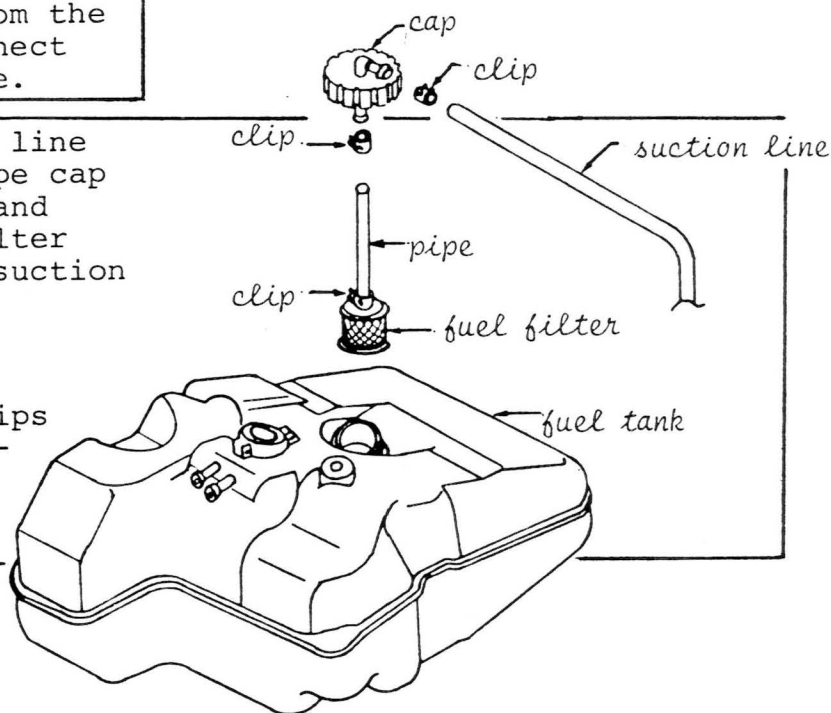
The affected models listed below are equipped with a suction pipe cap on the top of the fuel tank. This cap may have been overtightened at the factory, causing possible cracking of the suction pipe neck on the fuel tank to occur. Some fuel leakage may thus result when the tank is filled to capacity or the machine is tilted on its side.

5. Inspect the neck (threaded area) of the suction pipe cap for cracks.

If no cracks are found, the fuel tank does not need replacing -- proceed to step 6.

If cracks are found, the fuel tank must be replaced before proceeding to step 6.

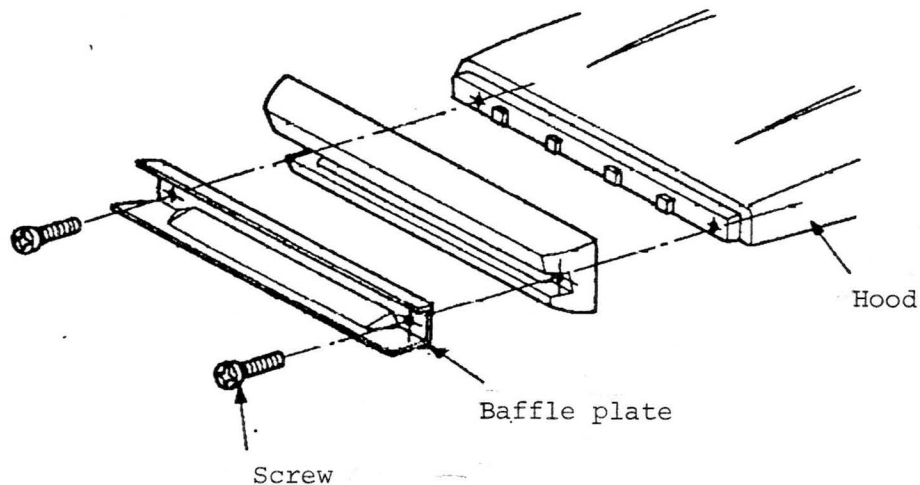
The affected units listed below may encounter icing of the carburetor throttle shafts under certain riding or weather conditions. If this occurs the engine will not return to its normal idle speed and partial loss of machine control could result.

- 2) Install the baffle plate onto the front of the hood using the hood hinge securing screws; see illustration.

Caution: This baffle plate must be removed when the machine is operated at temperatures greater than 0° C.

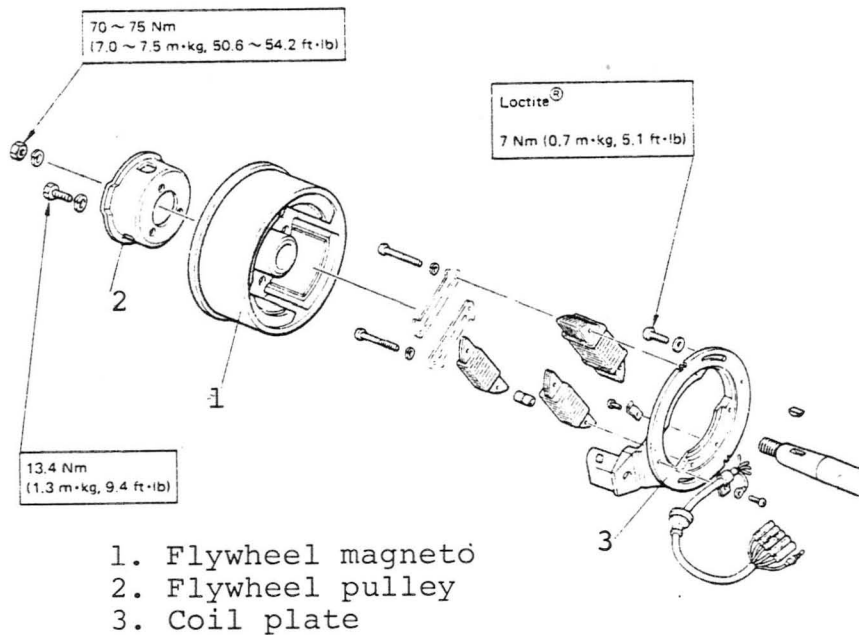
It has been determined that the water pump case cover has not been machined properly. This results in uneven seating of the C.D.I. magneto stator plate and may cause the plate to become cracked or damaged through engine vibration.

1. First, remove the engine from the chassis. To save time, you may choose to remove only those components which allow the right-hand end of the motor to be tilted for access to the recoil starter and magneto.
2. Remove the four bolts holding the recoil starter.
3. Remove the three bolts holding the starter pulley.
4. Using the flywheel puller, remove the flywheel magneto rotor and key.
5. Using a hand impact tool, remove the magneto stator plate bolts and check the stator for any cracks or damage.
6. Install the spacer between the stator plate and the pump cover as shown below.

| (b) Sheave centre-to-centre | - $305 \pm 1.5$ mm ( $12.01 \pm 0.06$ in.) |
| (c) Sheave offset | - $11 \pm 0.5$ mm ( $0.433 \pm 0.02$ in.) |

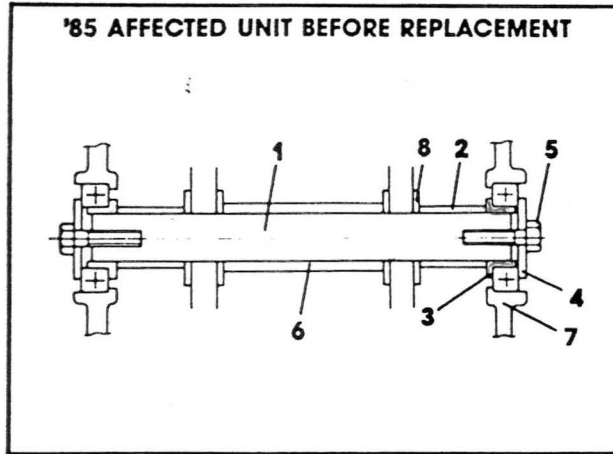
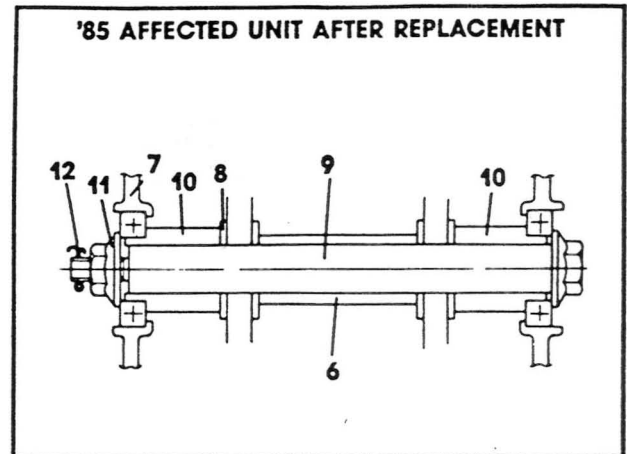
1985 ET340J; EC340J; PZ480J/EJ;  
XL540J SHAFT-5 REPLACEMENT PROCEDURE

Shaft-5 is located near the front of the rear suspension system. If you have a broken or damaged Shaft-5, replace it with the replacement kit discussed in this bulletin.

Replace parts #1, #2, #3, #4, and #5 on the affected units with the parts in the replacement kit. Parts #6, #7 and #8 on the affected unit must be reused with the replacement kit.

NOTE: When installing a new Shaft-5 assembly on an '85, use the new shaft to push out the old one. This will eliminate the need to remove the entire suspension assembly.
