TS 940 Mods

Expanded xmit for Kenwood TS-940S

TS-940S AGC circuit improvements

TS-940S Factory Assembly Mistakes

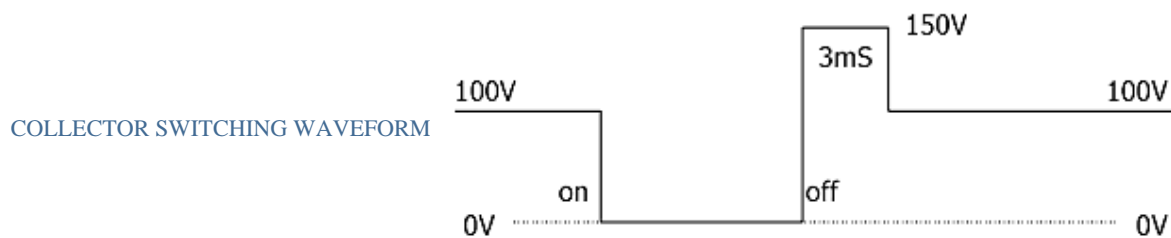
For use with a TL922 amplifier it is necessary to use a high-voltage transistor such as the MJE340 and a zener diode of 150V as it has a 100V DC relay coil that must be grounded for TX operation. This modification will work on any amplifier requiring pull-down for TX. If the pull-down is only for 12V, the zener diode voltage can be lowered to 15V or eliminated all together if there is no relay.

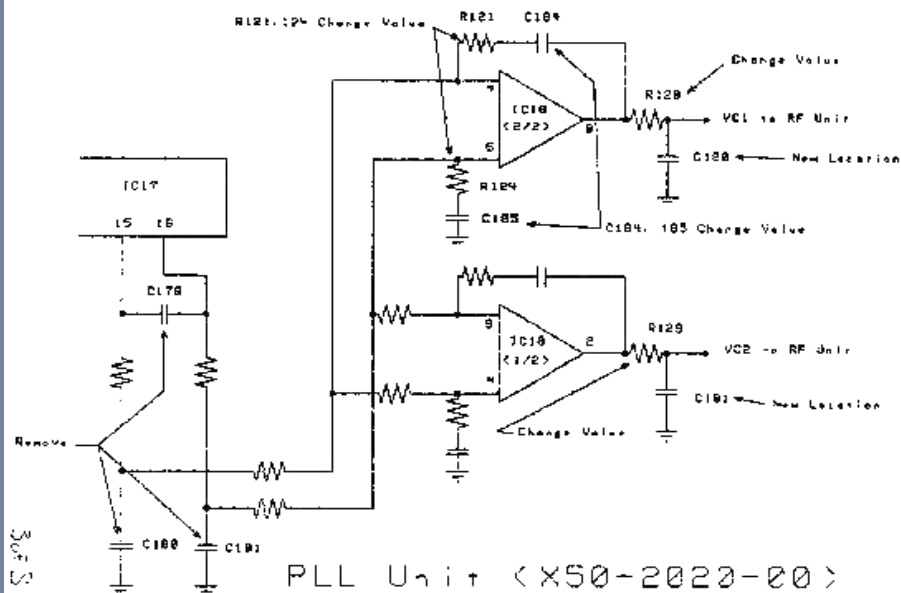
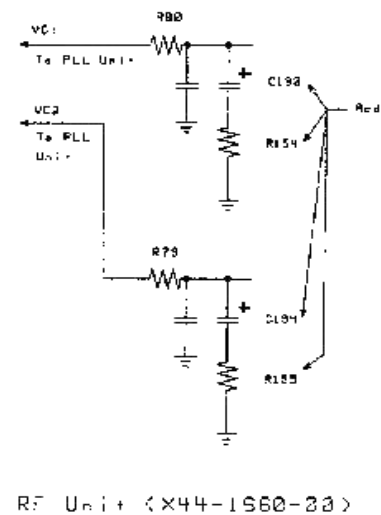
Some users of the TS-940S have reported a blanking of the display accompanied by a loss of transmit and receive. Readjustment of the PLL unit will correct this tendency.
