01621 Version 1

AcuraLink[®] System Status Indicator Is Red and DTC B1403 Will Not Clear

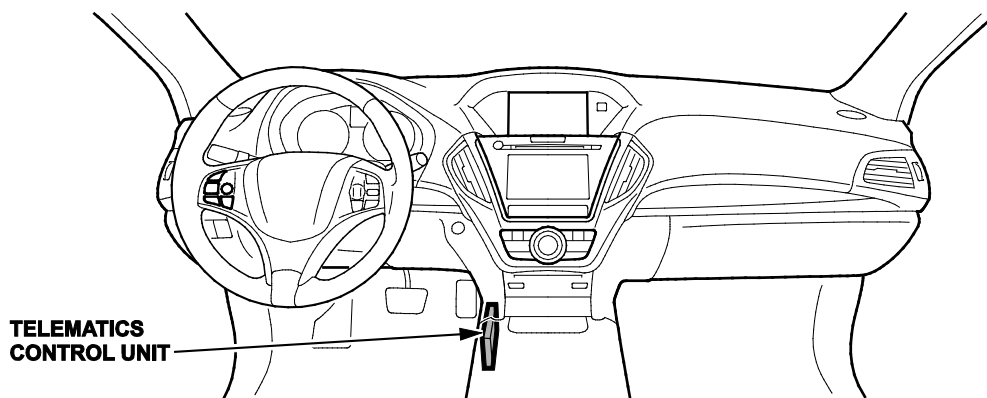
1. Find the TCU. It is behind the center console side cover on the driver's side. See the electronic service manual for details.

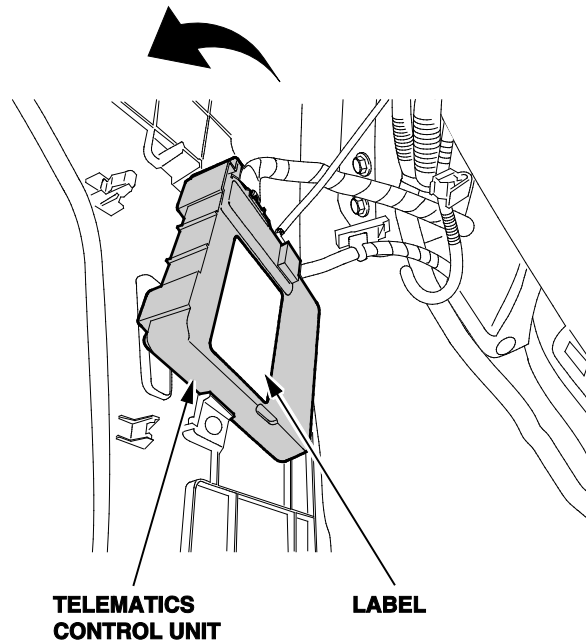
2. Pull the cover to the side without damaging the harness and connectors so that you can access the TCU label.

3. Check the label for the latest Visteon part revision number.
 - If the Visteon part revision number is 13 or above and the software revision number is 02.07.000 or above, the TCU is okay and this bulletin does not apply. Continue with normal troubleshooting.
 - If the Visteon part revision number is 12 or less and/or the software revision number is 02.06.000 or less, replace the TCU and go to step 4.

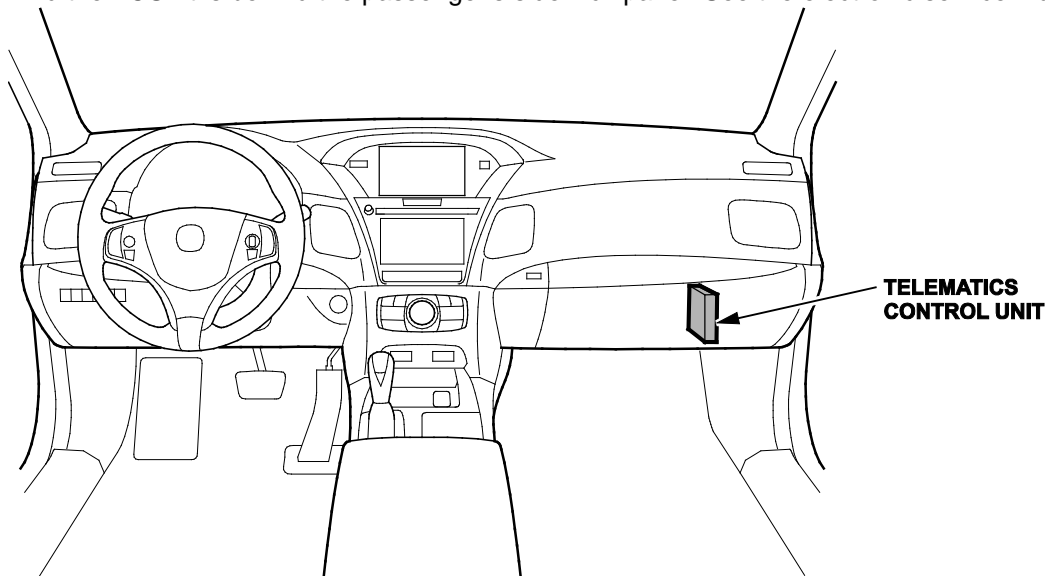
1. Find the TCU. It is behind the passenger's side kick panel. See the electronic service manual for details.

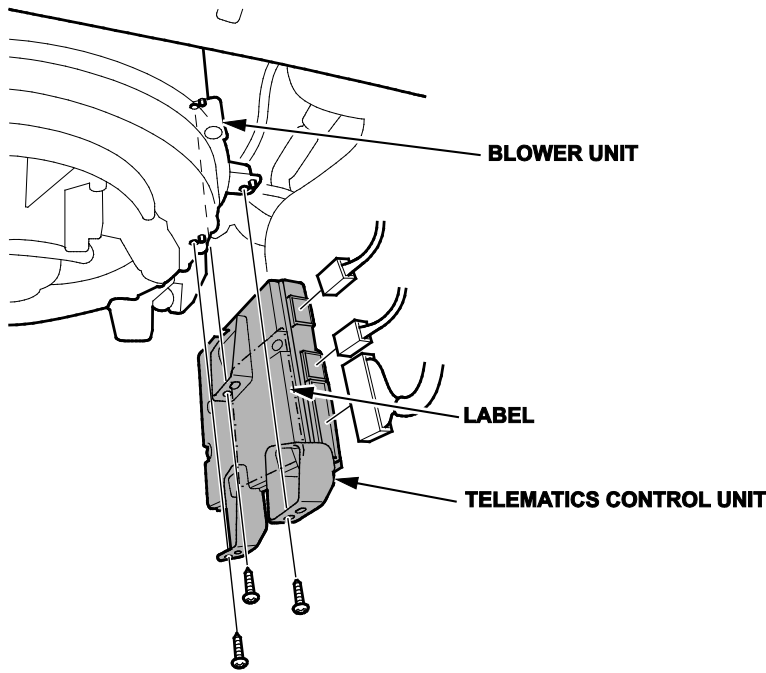
2. Remove the screws and disconnect the connectors.

3. Check the label for the latest Visteon part revision number.
 - If the Visteon part revision number is 13 or above and the software revision number is 02.07.000 or above, the TCU is okay and this bulletin does not apply. Continue with normal troubleshooting.
 - If the Visteon part revision number is 12 or less and/or the software revision number is 02.06.000 or less, replace the TCU and go to step 4.

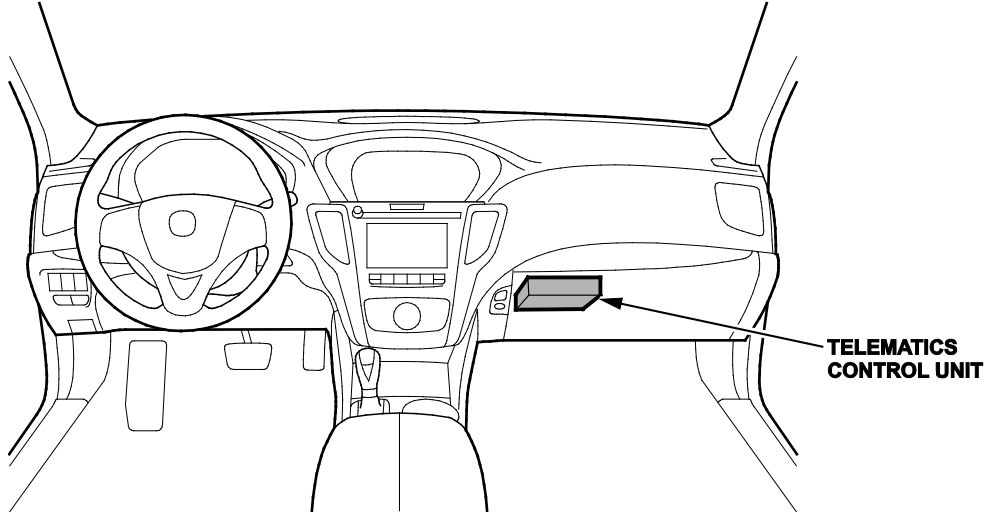
1. Find the TCU. It is behind the passenger's dashboard undercover. See the electronic service manual for details.

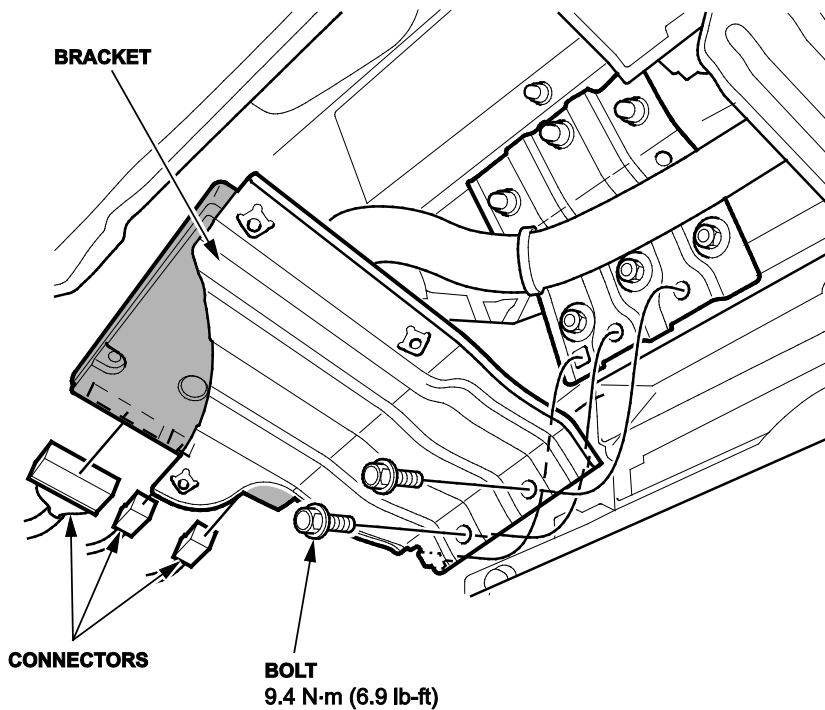
2. Remove the two bolts, then remove the bracket and disconnect the connectors.

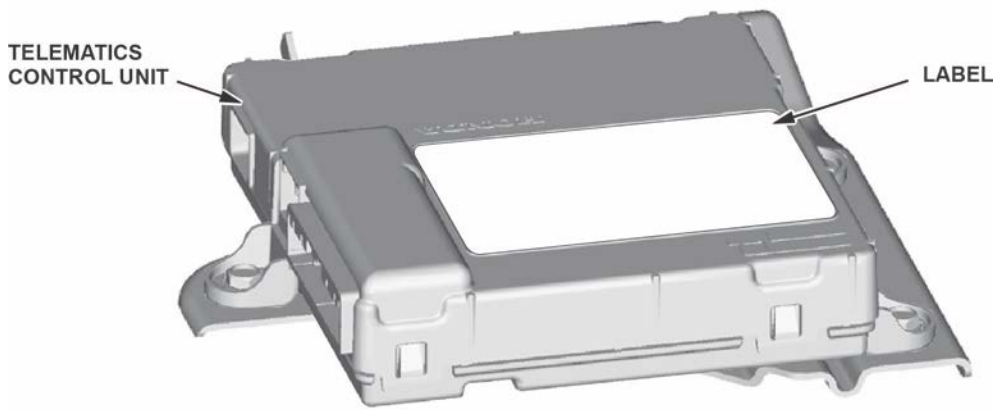
3. Locate the TCU label.

4. Check the label for the latest Visteon part revision number.
 - If the Visteon part revision number is 11 or above and the software revision level is 01.05.000 or above, the TCU is okay and this bulletin does not apply. Continue with normal troubleshooting.
 - If the Visteon part revision number is 10 or less and/or the software revision number is 01.04.000 or less, replace the TCU and go to step 5.
