Improved cylinder head gasket for type H engine

Saab 99 Service Information

Nr/No. 234-52 sE

Fuel hoses of more diffusion-resistant material

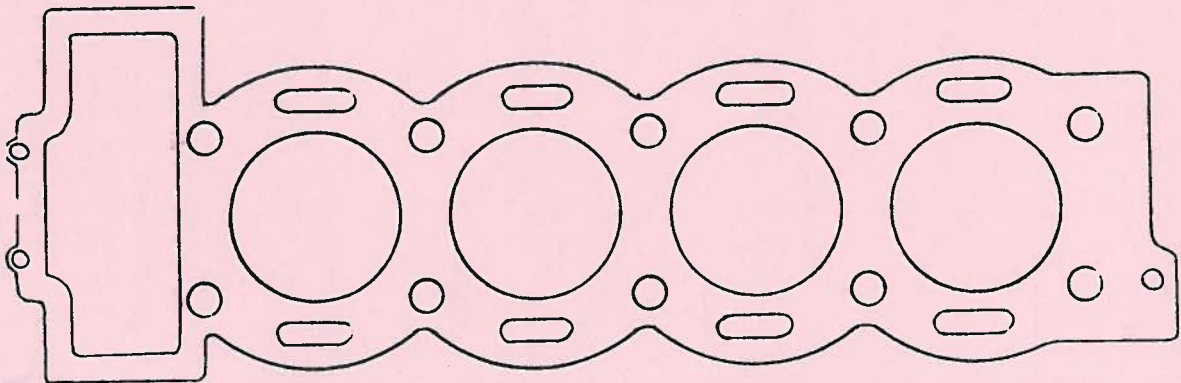
Head gasket for machined cylinder heads 9354176.

A cylinder head gasket is now available as a spare part for use with cylinder heads which have to be refaced.

The gasket is 0.3 mm thicker than the standard item and will prevent the compression ratio from exceeding the standard value.

Note: The maximum amount which can be safely machined from the "H" engine cylinder head is 0.4 mm (0.016").

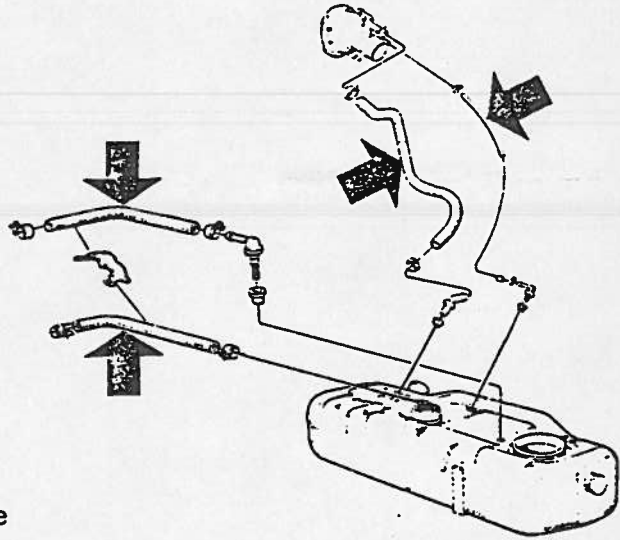
The picture shows the arrangement on the Saab 900

1. Leakage at connections and rubber grommets will cause a distinct smell of fuel.
2. Diffusion through the hoses will produce a smell that is difficult to define.

If leakage is found to occur at the rubber grommets in the tank, the first action should be to replace the grommets. If this is insufficient, Bostik Ve-Ve Seal 1760 Part No. (45) 302 1250) should be applied.

No other type of sealant should be used, since it may be dissolved by the fuel and may cause engine stoppage.
