Repair Hints

Service Level 3 & 4

6310 / 6310i

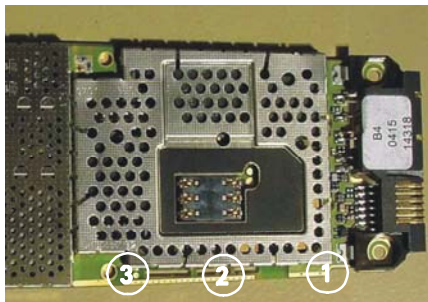
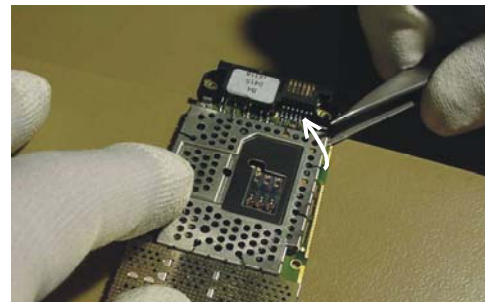
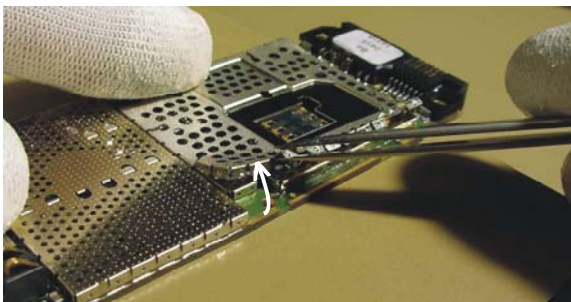
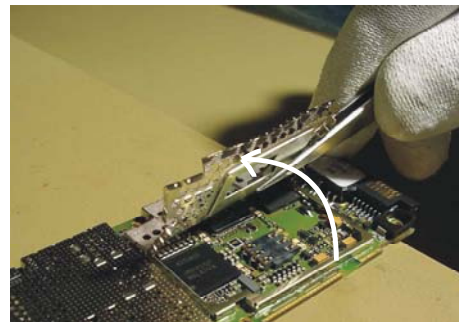
When removing the BB shield, be very careful because the Flash D450 could be damaged (see pictures on the next page). Start by lifting and bending the lid with tweezers at the marked points 1- 3 (see pictures below). Do not use too much force on the frame because it could be damaged and also the PWB could be mechanically stressed.

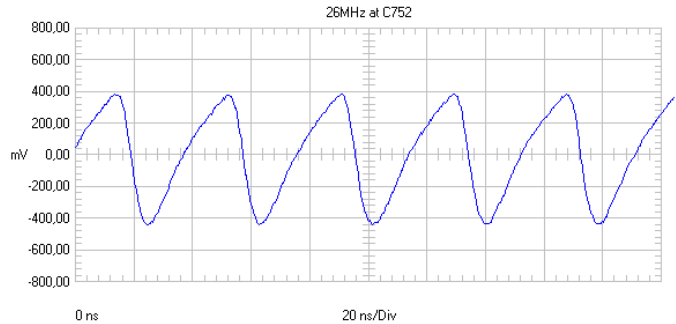
Check V_{CORE} = 1.8 VDC at C400; PURX = 1.8 VDC at V130 Pin 44. If not ok, check UEM D200.
Check System Clk = 26 MHz, V_{pp} = 800 mV at C752 for NPE-4, and at R618 / for NPL-1 (See picture below)

If not ok, check 26 MHz G740 (NPE-4) circuit /B601 (NPL-1) circuit.

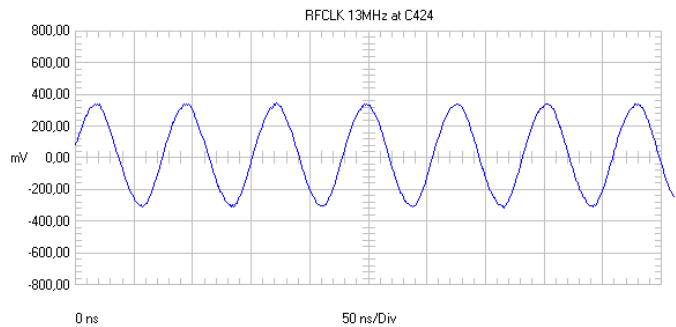
Check RFClk = 13 MHz, V_{pp} = 600 mV at C424.
If not ok, check/change N600 Hagar.

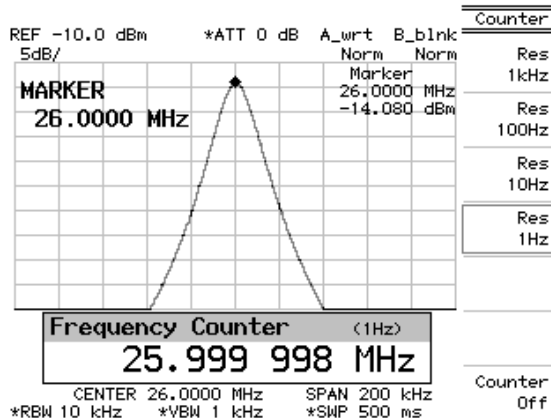
Figure "26 MHz"

Open the Phoenix menu Testing/ RF controls and activate local mode RX GSM900. Check 26MHz +/- 100Hz at C752 or R752 on spectrum analyzer and active frequency counter (see figure 26 MHz)

If the frequency drift is higher than +/- 100Hz, check VR3 (VCC) = 2.8 VDC at R740 and check AFC (1.3 – 2.3 VDC) at C744 - If not ok, check UEM D200.

Check if fault is getting stronger by pressing the top of the 26MHz oscillator G740. Change 26MHz oscillator if necessary.

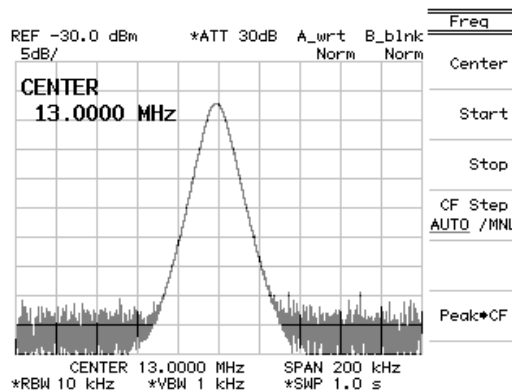
Figure "13 MHz"

Check 13 MHz +/- 100Hz at C424 with spectrum analyzer (see figure "13 MHz").

- If not ok, check /change Hagar N600.

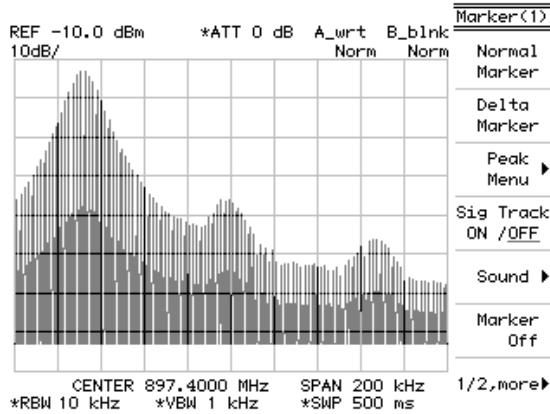
Check EGSM TX signal at R656 / R657 (see picture below).
Set spectrum analyzer to TX EGSM 897.4 MHz, channel 37.
Set phone to TX mode, EGSM 897.4 MHz, channel 37 and power level 10.

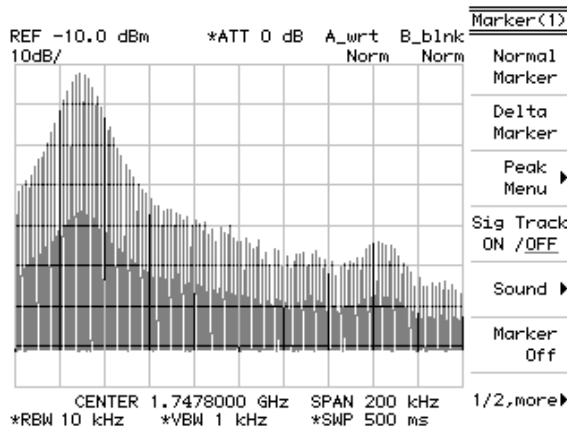
If there is no signal measurable, check PCN TX signal at L662 (see picture below).

Set spectrum analyzer to TX PCN 1747.8 MHz, channel 700.
Set phone to TX mode, PCN 1747.8 MHz, channel 700 and power level 10.

If both TX signals ok, check EGSM/ PCN TX lines between Hagar N600 and antenna connector X802 for shorts or disconnections

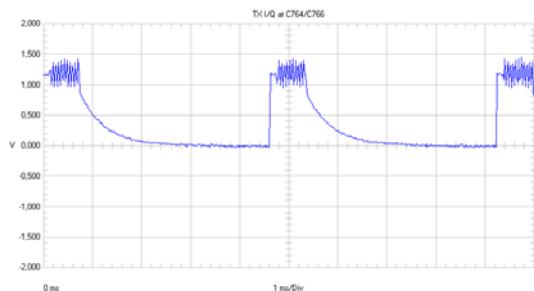
If there is no TX signal measurable at L662, check TX I/Q at C764 and C766 on both sides of capacitors. (see picture below).

If the TX I/Q signal is not ok, check UEM D200

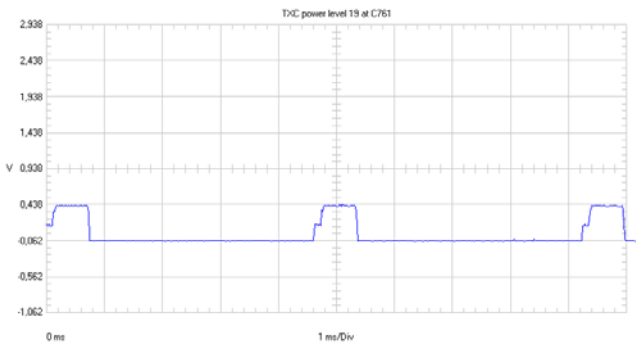
Power level 19

Check TXC at C761, power level 19 and 5 (See picture below).

If the TXC signals are not ok, check UEM D200.

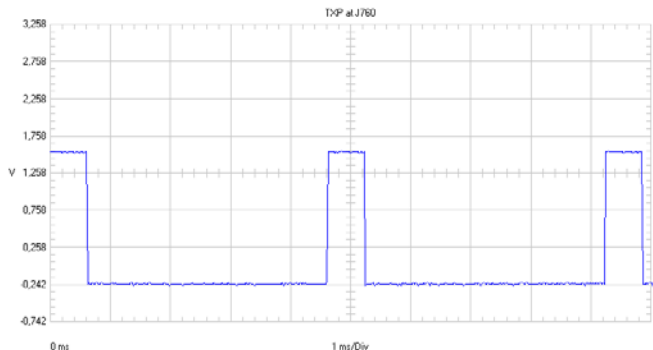
Check TXP signal at J760 (See picture below).

If the TXP signal is not ok, check UPP D400.

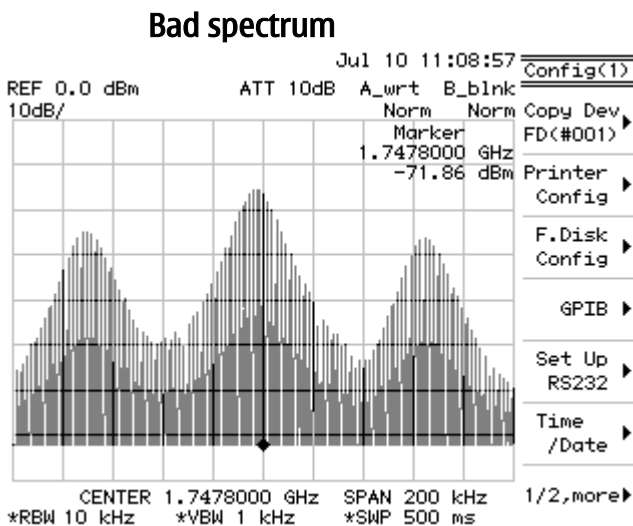
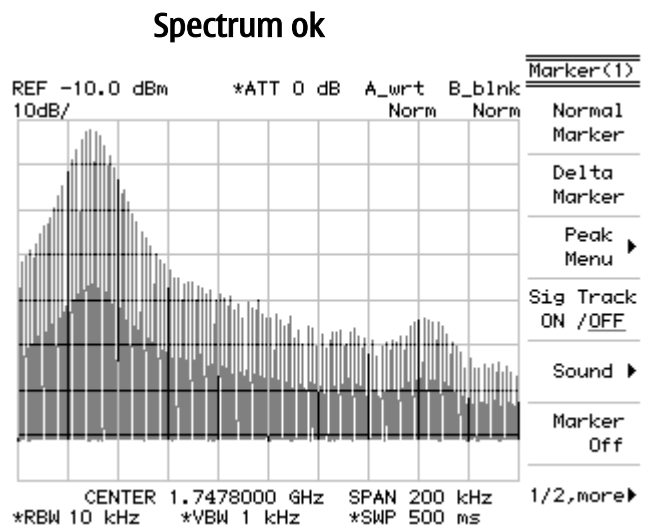
If, in all GSM Bands, a connection is possible, but the bit error rate is too high and the connection is bad, set phone in local mode and check TX spectrum at R805 (GSM900) (see picture below)

If the spectrum is not ok, check following measurement points:

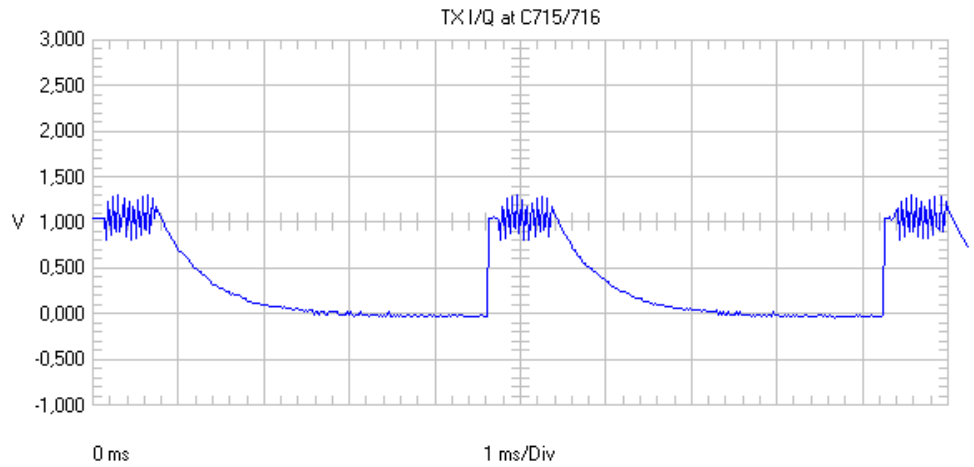
- VIO = 1.8VDC at R630
- VR1A = 4.7VDC at R623
- VR2 = 2.8VDC at C622
- VR3 = 2.8VDC at R610
- VR4 = 2.8VDC at C296
- VR5 = 2.8VDC at R628
- VR7 = 2.8VDC at C299
- TX I and Q at C715/C716 on **both sides** (see picture below)

If one of the four TX I/Q signals is missing or too low (TX IN, TX IP and TX QN, TX QP), check R713 on both sides.
 If TX I/Q signals towards UEM D200 are not ok, UEM or PWB is faulty.
 If one of the voltages described is missing, probably UEM D200 is faulty.
 If all signals towards RF-IC N601 are ok, change Mjoelner N601.

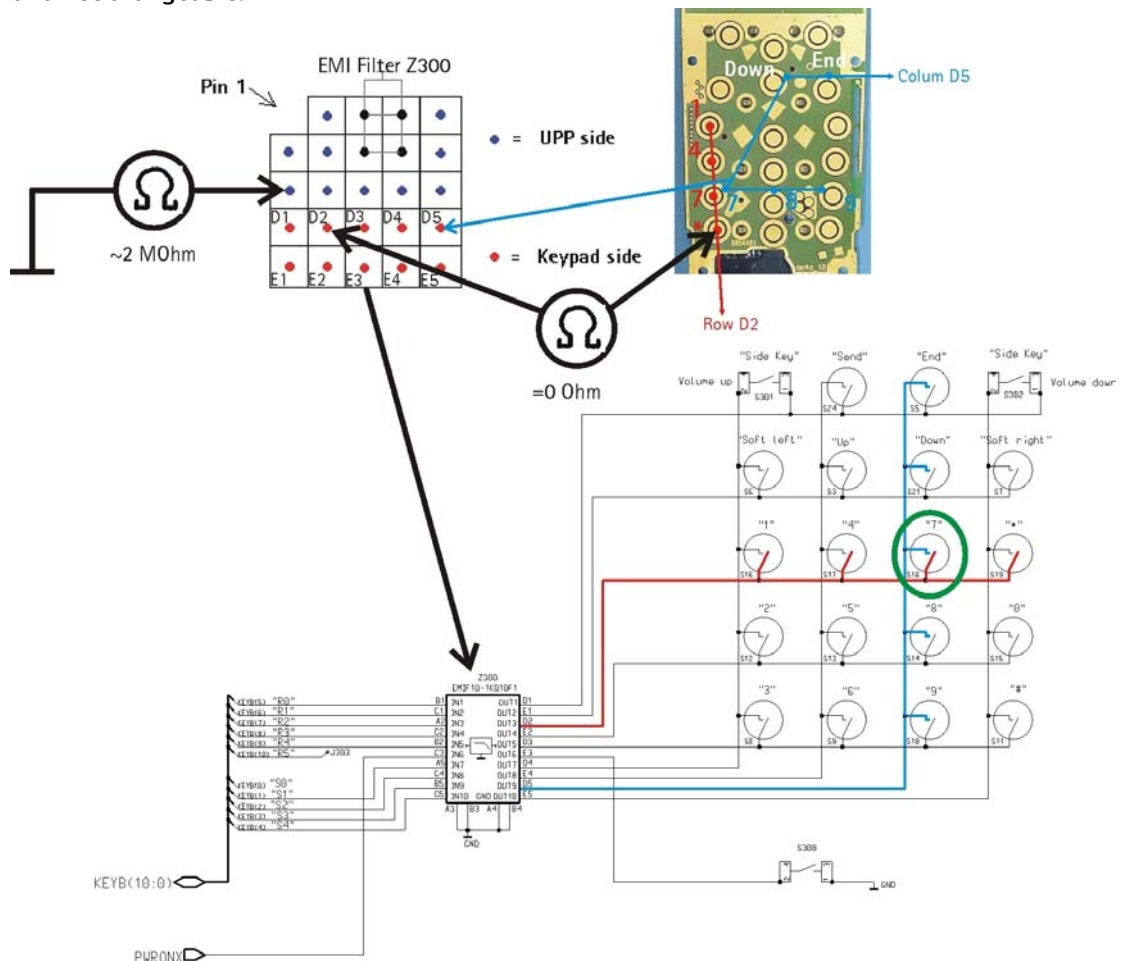
Check column D5 → keys “End”, “Down” 7”, “8”, “9” → resistance between the one and the other keys = 0Ω

- If between two keys the resistance is approximate MΩ, change PWB because of broken connection.
- If all resistance = 0Ω, remove Z300 EMI-Filter and measure the connection between keypad and red marked solderpads from EMI-Filter. If connection is not ok, change PWB, because of broken connection.
- If connection is ok, check with ohmmeter the resistance between ground and blue marked solderpads → resistance around 2MΩ
- If resistance is lower than 1MΩ or higher than 10MΩ, scrap the phone, because the UPP D400 is faulty and not changeable.
