Aging Aircraft Concerns on Comanche Airplanes

ICS National Convention

15 August 2007

Hans Neubert

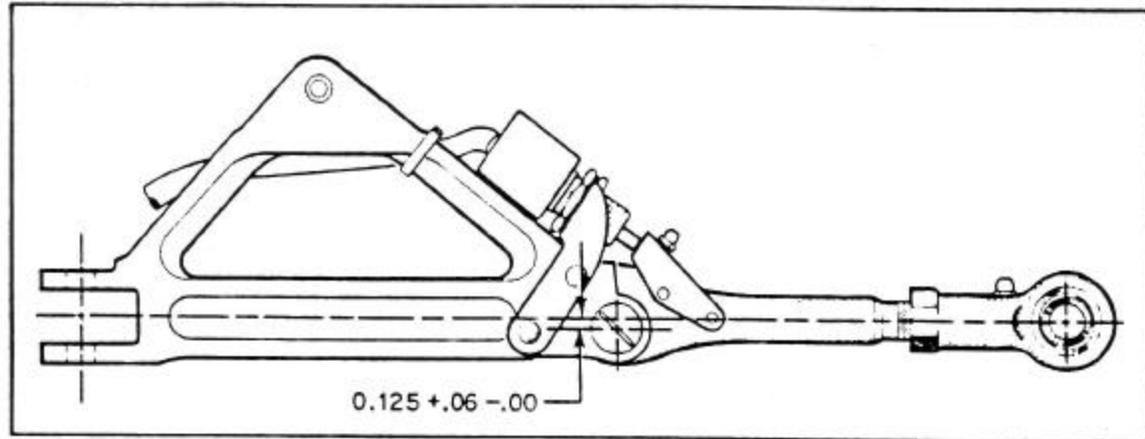
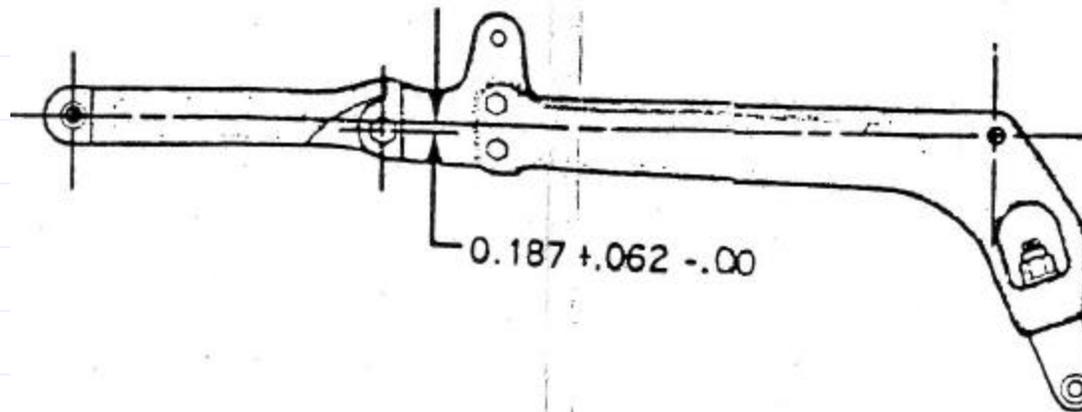
Landing Gear Overcenter Positions

- ◆ Maintenance Neglect
 - Worn out parts – Insufficient lubrication
 - Misadjusted switches – fatigued wires
 - Excessive friction in gear cables and bearings
 - High amperage draw on motor and solenoids
 - Improper rigging and cable preload
 - Main gear pivot fitting & nose gear clevis failure
- ◆ Vagueness in Service Manual
 - Preload on cables not well written

Adjustment of Down Limit Switches

- ◆ Service Manual (Twin) Paragraph 7-44 d, Items 3 & 4
 - 3. Disconnect the retraction transmission by pulling up on the release lever and manually retracting the landing gear using the emergency extension lever.
 - 4. At the point where the green light goes out, apply reward pressure on the nose gear and inward pressure on the main gear. The gear should not unlock.

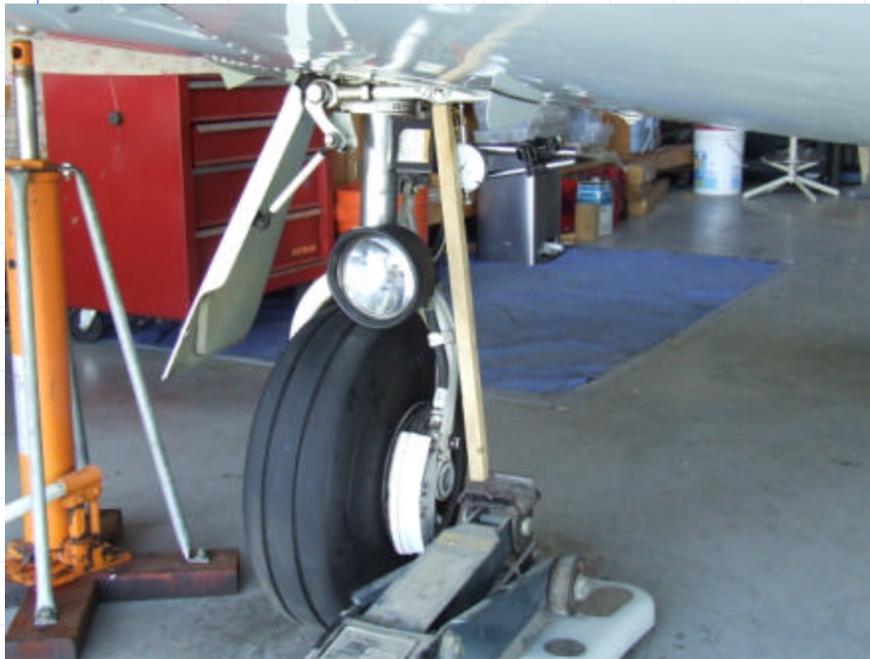
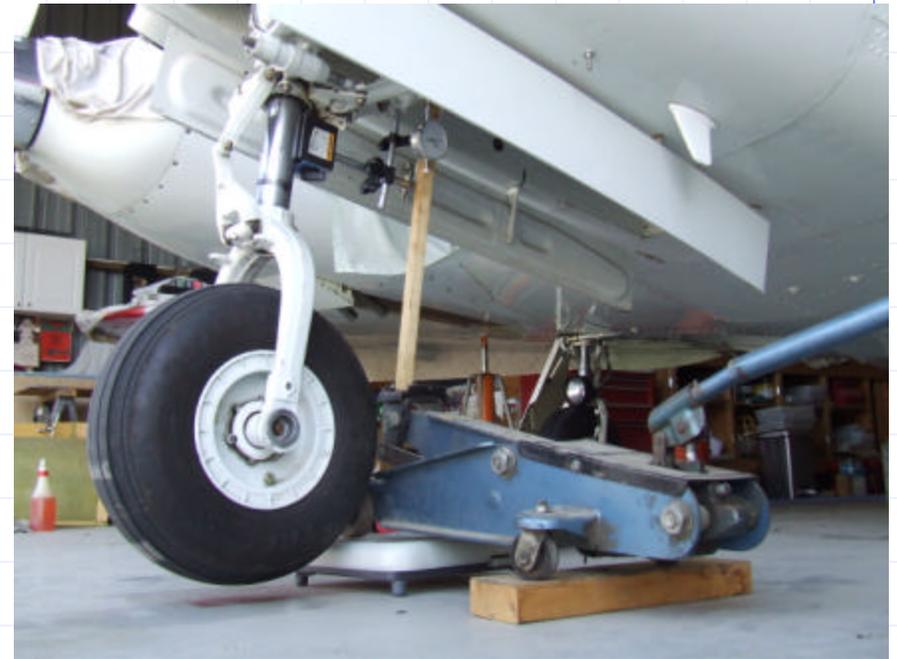
Test of Over-Center Force and Movement

- ◆ Simple set-up using bathroom scale, jack, long stick, and dial indicator
- ◆ Push up at pivot point
- ◆ Measure load and displacement
- ◆ Transmission is disconnected
- ◆ Plot up results

Transmission disconnected

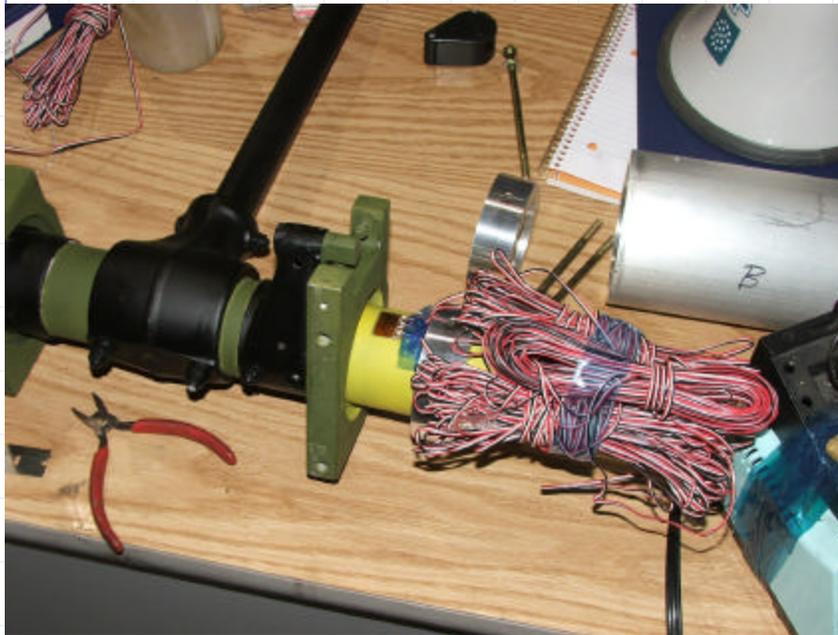
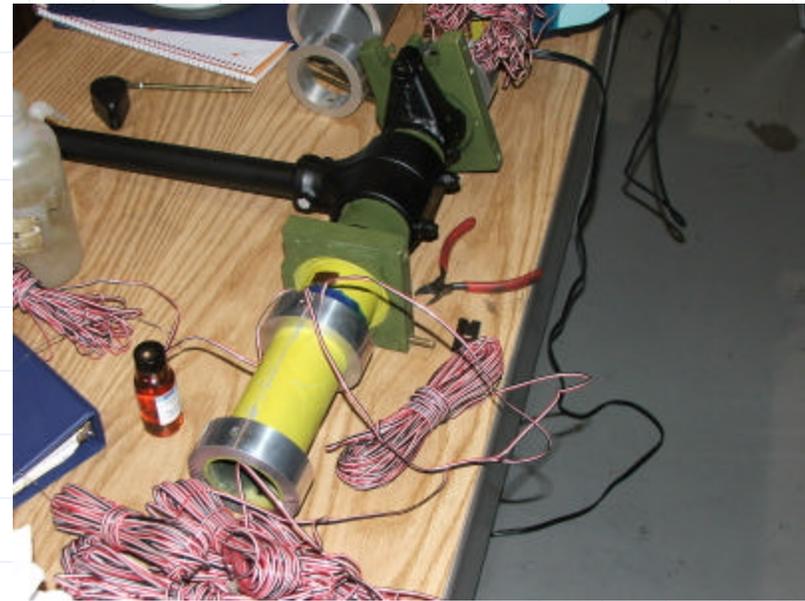
Strain Gaged Specimen

- ◆ An unserviceable torque assembly was re-furbished and life cycle tested to DLL, and subsequently to DUL.
- ◆ Strain and displacement measurements show that during the life cycle testing, the torque tube exhibited linear, elastic characteristics.
- ◆ Corrosion on a torque tube, if found, is a Maintenance issue. These tests show conclusively that a corroded torque tube is not an Airworthiness issue.

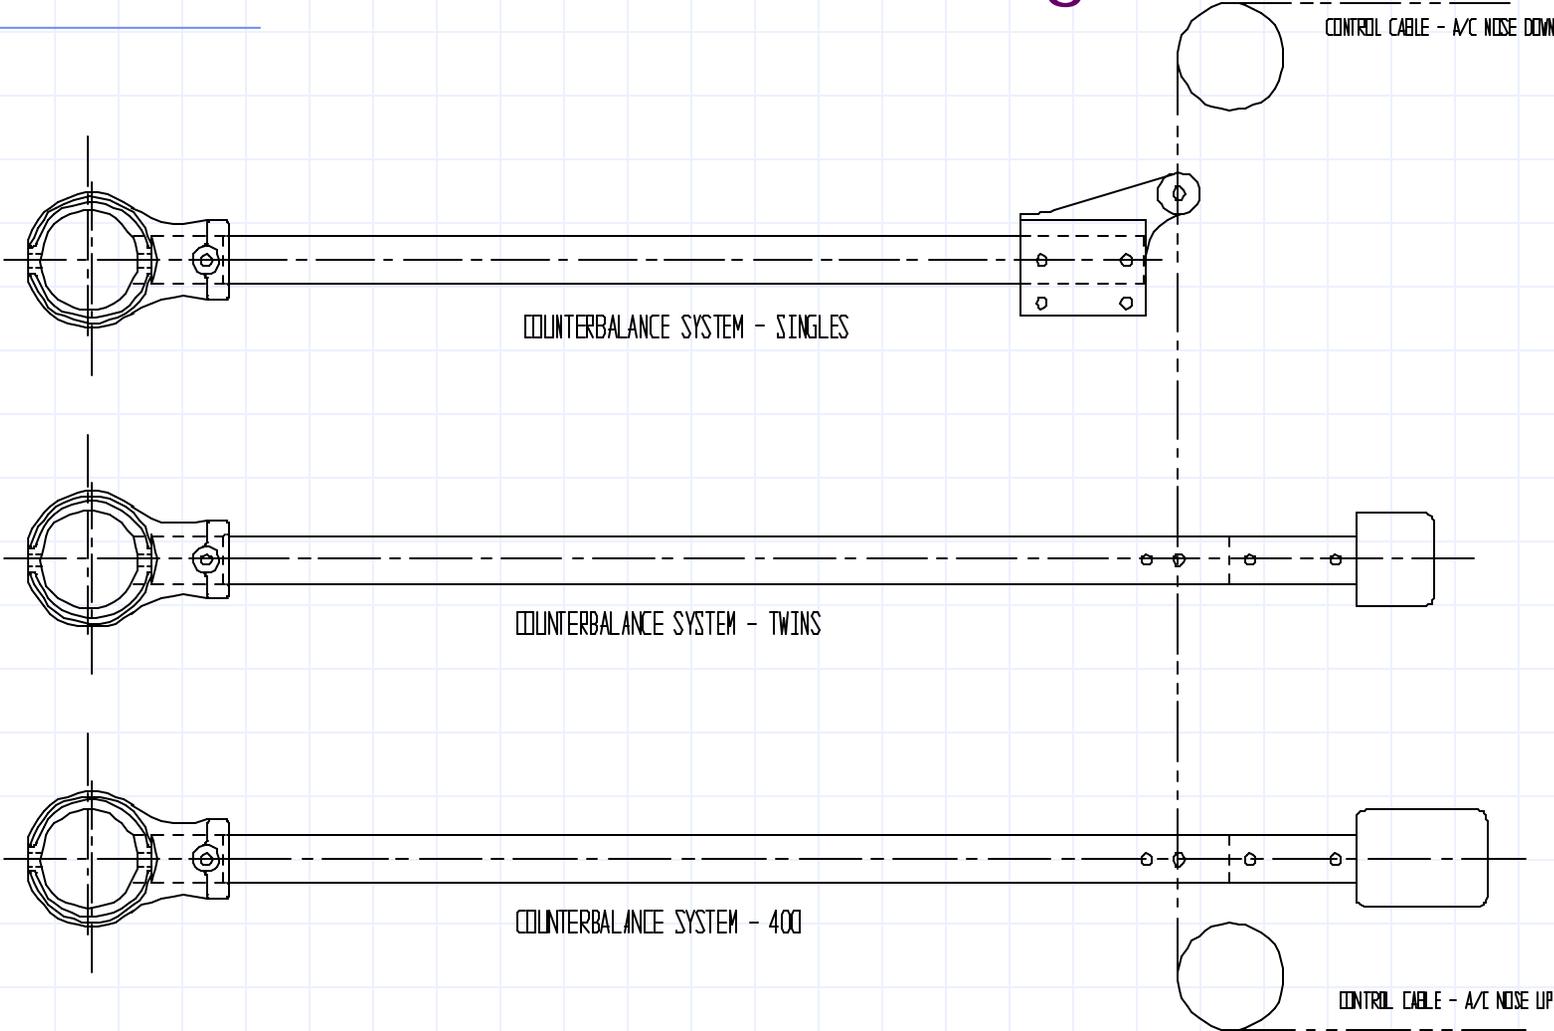
Counterbalance Arm and Weight

- ◆ Significant differences in design to Twins/400
- ◆ Significant differences in balance to Twins/400
- ◆ Prop wash inboard
- ◆ Thinner torque tube wall thickness
- ◆ Smaller Stabilator attachment bolt size
- ◆ Thinner Stabilator skin thickness
- ◆ Different trim drum support structure

- ◆ Sharp edge between primary & secondary bores gives a 5.6 stress concentration factor
- ◆ Play in trim tab causes stabilator to respond to high frequency impulses from propeller
- ◆ Looseness of control cables allows counterbalance tube and weight to oscillate
- ◆ High frequency oscillations create bending stress in horn, amplified 5.6 x at the bore intersections
- ◆ Cracking migrates to aft side of horn after forward portion cracks and loses circumferential stiffness
