### Modifications for the Kenwood TS-930

## TS-930S PLL Unlock

Service Bulletin no. 869 (29-3-1983)

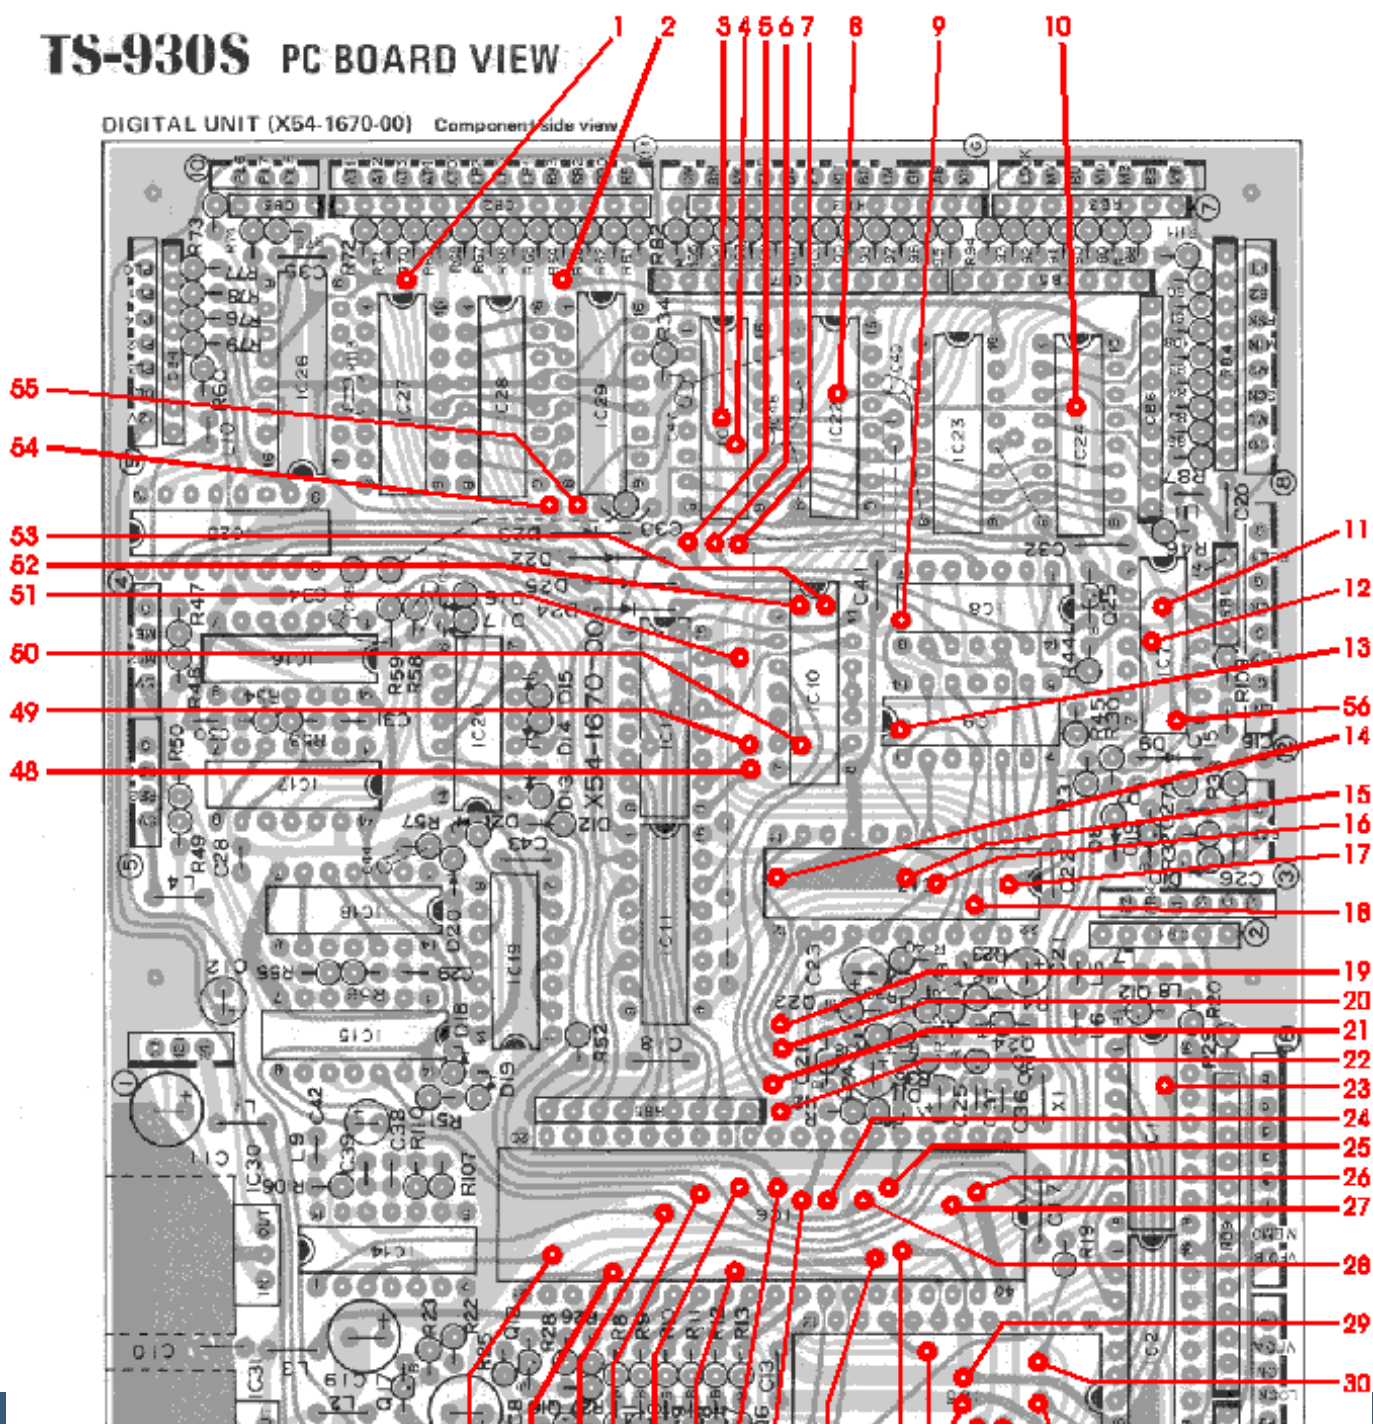
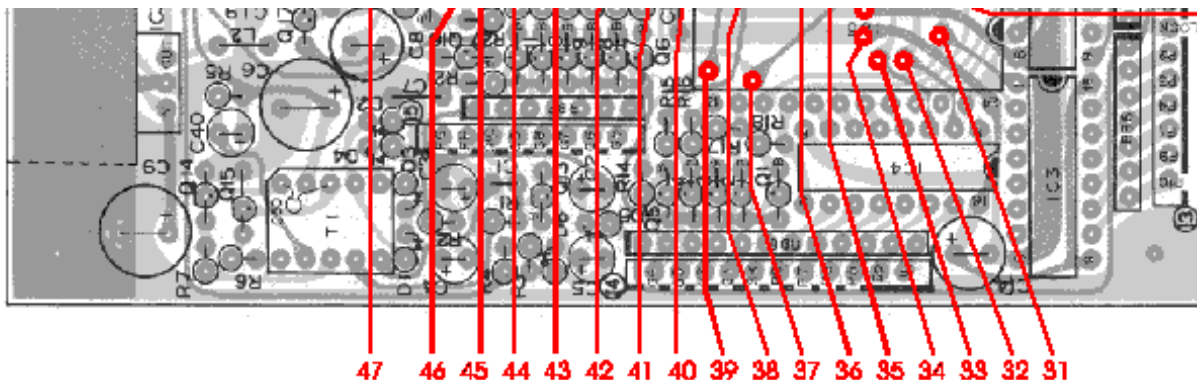
The unit shows symptoms as listed below, when any of the 56 Digital Unit through-plated holes are open. These examples were compiled by Mr. Negishi of the Kanto service center. Make full use of the Material as a technical reference for repair.

33	The "DP" segment remains continuously lit.
34	Analog values from 0 to 700 are displayed, but values from 700 to 1000 are not.
35	Segments "b,g" only are not displayed. Some of the analog pointers do not light.
36	
37	No display because UL.
38	No display, continuous tone.
39	Three digits of values are not displayed ex. 14.XXX.5
40	
41	
42	
43	
44	
45

46	
47	
48	(The main dial does not operate.) 14.000.0 is displayed. Turning on the RIT switch displays 14.100.00.
49	Continuous tone. Display is locked, RIT is turned ON and 14.001.4 is continuously displayed. Transmission is no possible.
50	Frequency varies.
51	As if scanning were being performed. Transmission is possible.
52	
53	
54	
55	
56

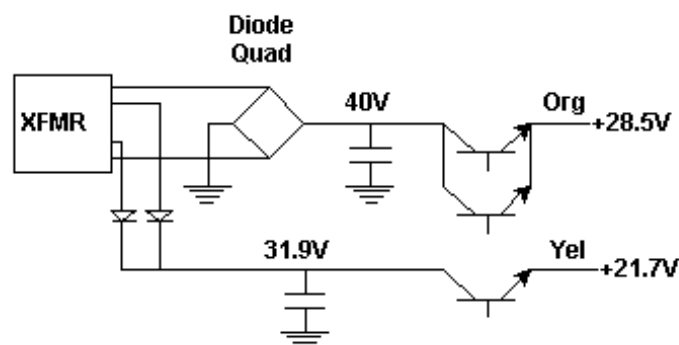
The TS-930 power supply for serial numbers higher than 310xxxx generates two voltages, 28.5V for the power amplifier and antenna tuner, and 21.7V for the digital board and the signal board. The 28.5V is regulated by the two TO3 pass transistors on the heat sink, and the 21.7V is generated by separate transformer secondary taps and diodes that generate 31.9V which is reduced to 21.7V by the TO220 transistor on the power supply heat sink.

The power switch has a pole that opens the +28.5V to most of the radio, including the circuit that runs the 21.7V regulator. This is apparently so the radio will just turn off without the time delay and rude noises of the filter capacitors discharging.

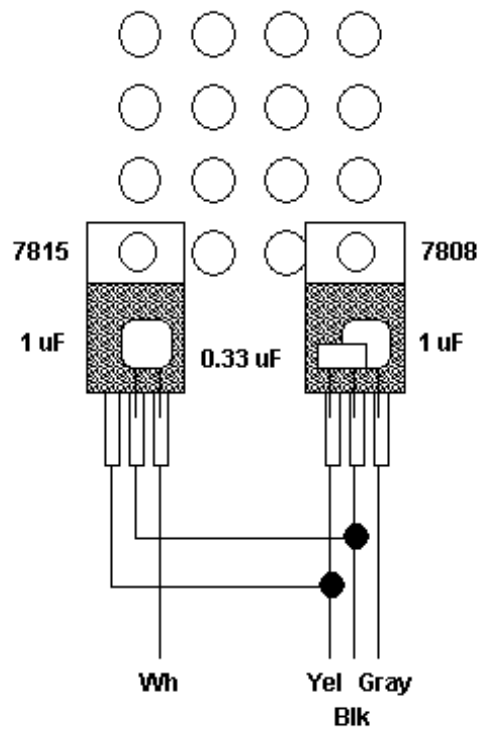
Locate the field of small holes near the upper edge of the heat sink, near the outside edge of the radio. As viewed from inside the radio, the two regulators mount to the holes in the bottom row (the top row is also OK, and easier to reach if you are not removing the heat sink). Before you do anything else, route the wires from the regulators beneath the heat sink so they can be connected to the terminal strips in the fan case.

The 4-40 small pattern nut just fits between the heat sink fins. Use a thin tool that can hold the nut on the end, and orient the flats of the nut to go between the fins. It's helpful if the parts are magnetic, so you can recover a dropped nut (be sure to cover the holes in the chassis with tissue or a rag). Use a 4-40x3/8" screw to fasten the regulators to the heat sink. The same nuts and screws are used in DB9 and DB25 connector shells. I use some heat sink compound on the back of the regulators. No insulation is required. Check again to be sure the screw for the TO220 pass transistor is tight and the transistor is oriented up so you can get to the terminals.

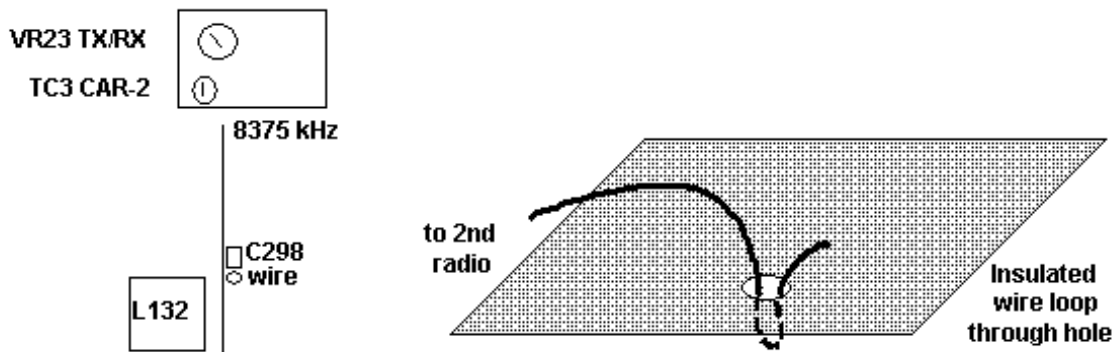
As another example, consider the alignment of the Carrier-2 oscillator used to provide variable bandwidth. The variable bandwidth tuning (VBT) uses two IF filters, one at 8830 kHz and the other at 455 kHz. The conversion oscillator at 8375 kHz determines the degree of overlap of the filter passbands. If the VBT knobs are set to widest position, the conversion oscillator should be at exactly 8375.0 kHz.

This can be done by connecting a counter (for example, an antenna impedance bridge counter) through a DC-isolated probe to C298 of the signal board, but if there's no other work to be done leave the case closed and use an insulated wire loop poked into the hole as an antenna to hear the oscillator on a second radio.

Adjust TC3, the small trimmer capacitor, so the frequency is exactly 8375.0 kHz

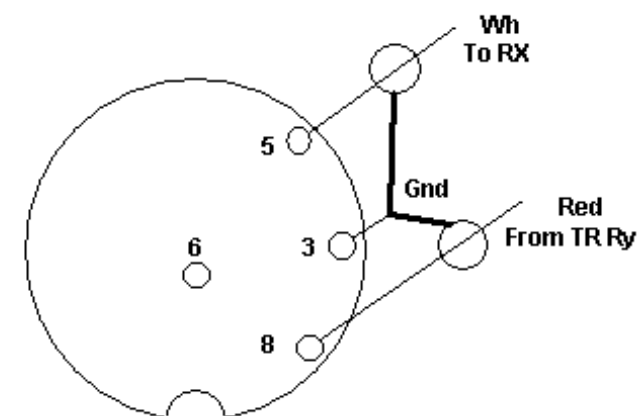
For use with an external receiving antenna, one needs the hard-to-find 262 degree 8-pin "horseshoe" DIN-8 connector used to bring a separate receiving antenna in and out of the transverter socket (available from Kenwood and Yaesu, and HRO, but seldom found when needed). In an emergency we found that a standard DIN-5 connector will plug in and provide access to the receiver input and ground, while the small slide switch makes the transmit antenna output available at the adjacent RCA phono connector to connect to an receive-antenna selector switch (inadvertent mis-setting of this switch is a source of occasional complaints of deaf receiver).

From back of  
connector P/N E07-0851-05  
Special Kenwood part  
DIN-8 262° (not 270°)
