# A-BOOM<sup>TM</sup>

BOOM ARM MOWER

# BULLETINS

Manual P/N 02980499  
(01/04)

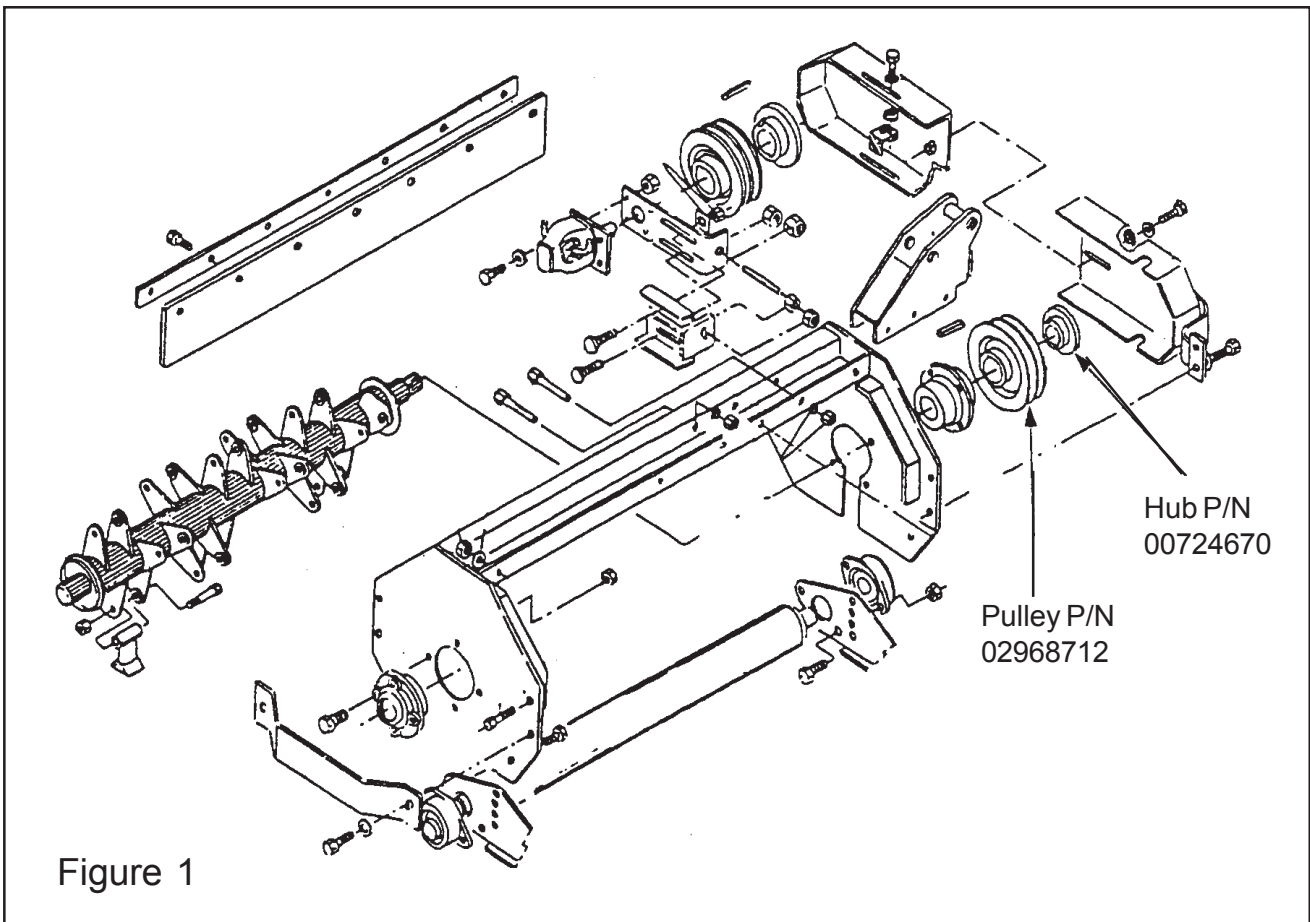
A new method has been devised to secure the pulley to the cuttershaft. A new pulley, P/N 02968712 and a QD Pulley Hub P/N 00724670 has replaced the old pulley with setscrew, washer, lockwasher and bolt. The new pulley and hub are a keyed, taper lock design which will provide a better fit and longer service life for the shaft.

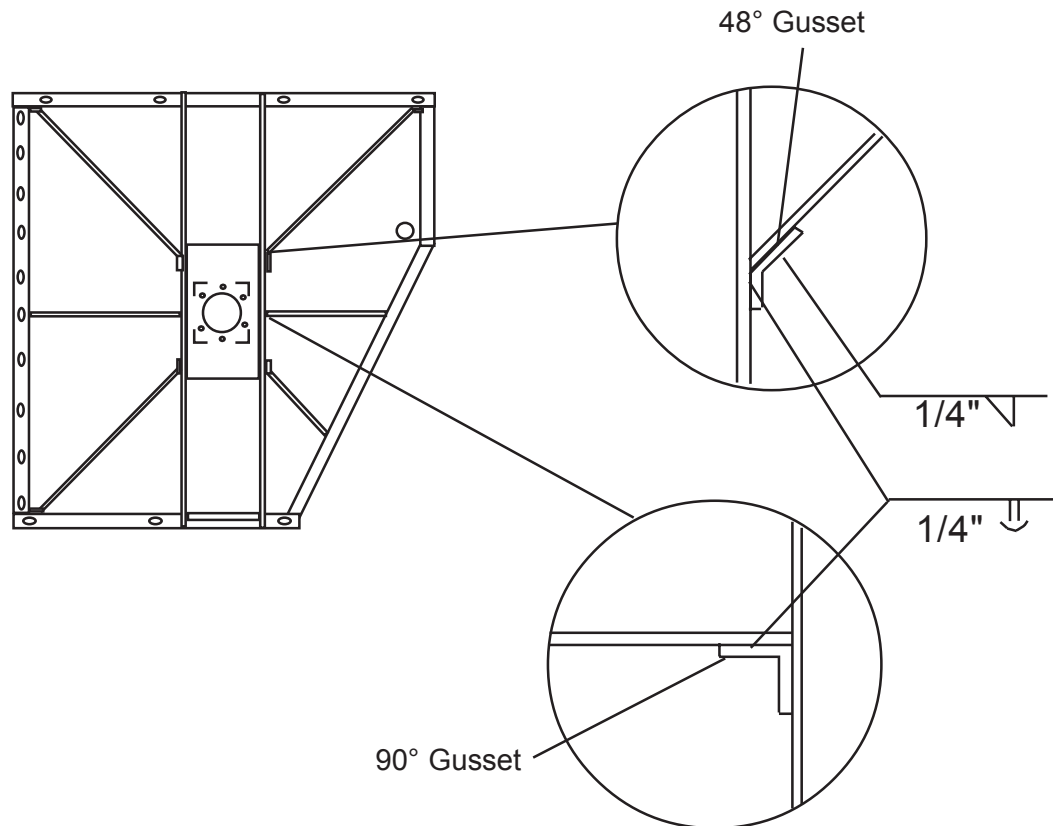
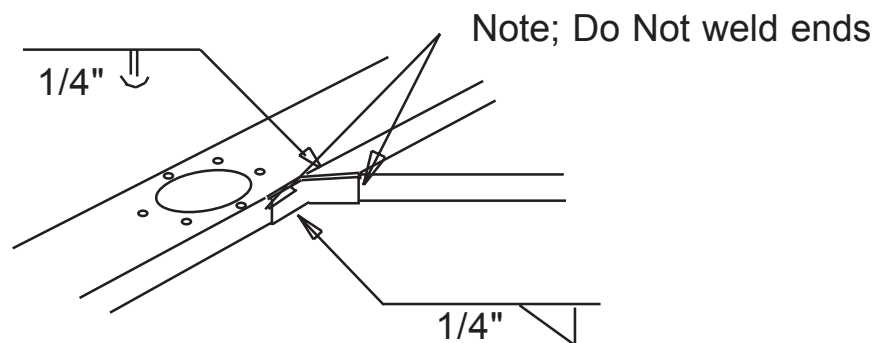
**Repair Procedure for Welding Cracks in Boom Heads:**

If cracks appear in the welds at points "A" as shown above, use the following procedures to repair head.

1. Grind a groove at the site of the crack and clean the area to be welded.
2. Weld the crack making a 100% weld.
3. After repairing the cracks, prepare the sites for installation of the gussets.
4. Position the reinforcing bar gusset part no. 02970111 if 90° or part no. 02970112 if 48° over the X-Bar as shown in drawing next page. Weld with a 1/4" fillet weld on the bottom and an edge weld on top. DO NOT weld the ends.
5. Clean and paint the area.
6. Reassemble any parts that were removed.

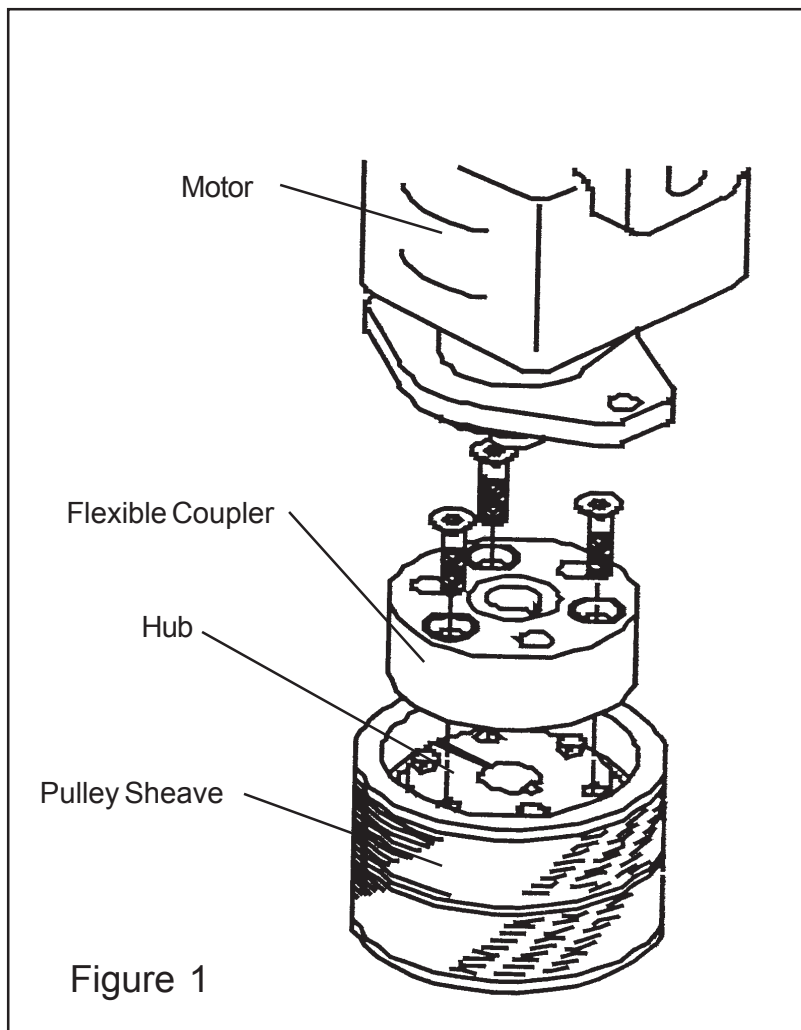
## Buzz Bar Drive Coupling Design change:

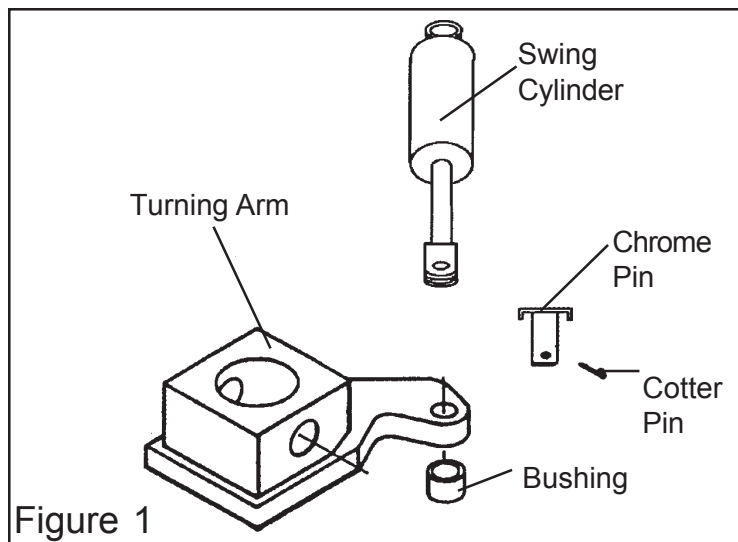
Figure 1

Premature wear of teflon coated swing cylinder bushing. To replace the swing cylinder bushing on unit built prior to June 1994 if premature wear in swing cylinder bushing occurs.

1. With Boom Arm extended outward and Head resting on the ground, Tractor secured in a safe manner. You will not have to remove any hydraulic lines to perform this repair.
2. Remove Swing cylinder pin, this is the old pin that connects it to the turning arm. The swing cylinder will pull away from turning arm far enough that only this end will have to be disconnected.
3. Using a suitable driver remove the old bushing from the turning arm.
4. Check the condition of the bore in the turning arm, if damaged repair or replace turning arm.
5. Install new bushing (P/N 02965548) using a suitable driver. Slide cylinder back and align the holes, insert the new chrome pin (P/N 02966767), install the cotter pin (P/N 00606000).
6. Run and test operation of unit.

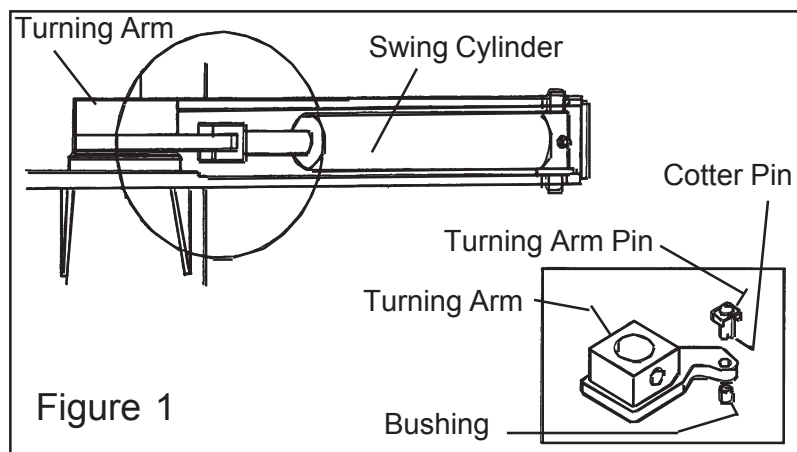
Replacement of the Turning Arm Pin and Bushings on certain A-Booms and Versa Booms. Some turning arm pins were not chamfered during machining during manufacturing process. This may result in damage to bushing during assembly and shorten bushing life. If pin is removed and it is not chamfered on the end it should be replaced. This repair should be done at the same time as work is done on service bulletin SB-951701 (old # SB950002) and SB-950404 (old # SB-950007).

1. Before disassembling anything, inspect the end of the turning arm pin (Cotter Pin End). If pin is chamfered and there is no excessive play in the bushing (felt by trying to move swing cylinder back and forth), no further action is required. If Pin is not chamfered go to step 2.
2. Remove cotter pin and turning arm pin.
3. Inspect bushing in turning arm and cylinder clevis. If any damage exist, replace the bushings using suitable drivers.
4. Install the new Bushings and the new chamfered pin, making certain all parts are aligned to prevent damage to bushing. Install cotter pin.
5. Render the old pin unusable to prevent it from being used on another unit. Run and test unit.

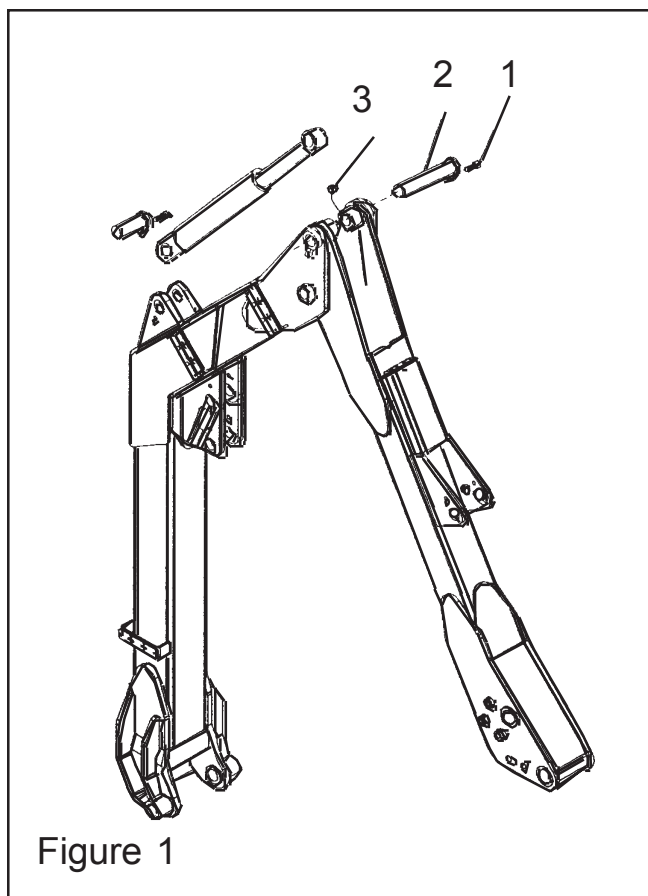
Figure 1

Replace Old Pin P/N 02966936 dipper cylinder pin with New Pin P/N 02969980, P/N 02030300 Nut and P/N 00749946 Washer. **Mowers equipped with 02966936 dipper pin (old pin can be identified by absence of a nut on the end of the pin).**

1. Rest Head on the floor (or ground) with dipper cylinder accessible. Make certain all hydraulic pressure is relieved from Hoses and cylinder system.
2. Secure and support dipper with hoist to prevent movement when pin to dipper cylinder is removed.
3. Replace the original pin P/N 02966936 with the new pin P/N 02969980, nut P/N 02030300 and washer P/N 00749946.
4. Tighten Nut and retaining bolt. Remove Hoist from dipper.
5. Run and test for operation

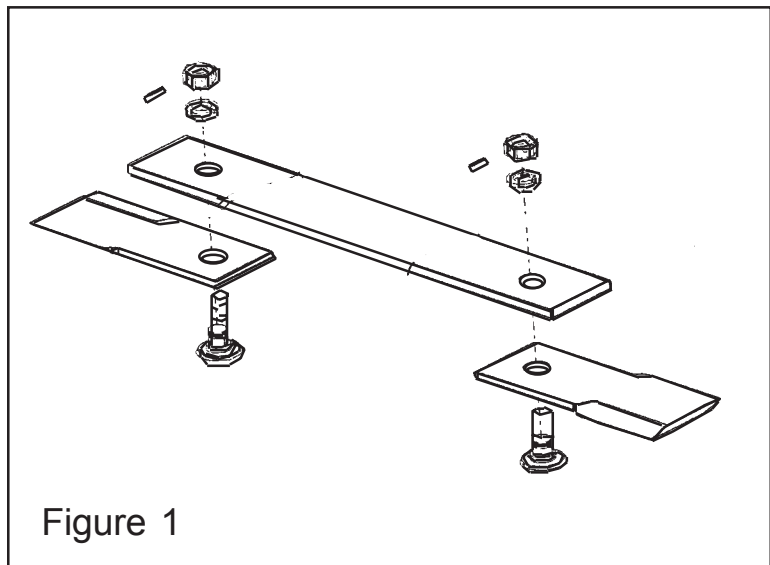
The Blade Bolt Nut Retaining Roll Pin Bore may be oversized and could allow the roll pin to become loose in the bore. The loose roll pin could therefore allow the blade bolt Nut to loose torque.

1. Visually inspect and check the fit of the roll pin. If it is loose or has come loose replace the Blade Bolt, Blade Bolt Nut and Roll Pin on the above listed serial numbered units.
2. Torque the Blade Bolt to 600 ft. lbs. before installing the new Roll Pin.

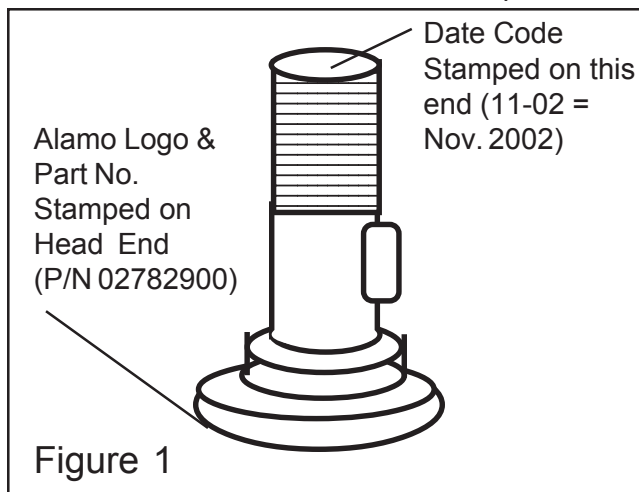
Note: Always check Date Code and Part Number of blade bolt before performing any repairs as described in this Service Bulletin as not all Blade will have the same date code. Only Blade bolts with 11-02 date code will be considered for warranty consideration.
