# MISCELLANEOUS MODELS INFORMATION & SERVICE BULLETINS

Manual P/N 0298  
(05/04)

**Alamo Industrial**  
P. O. Drawer 549  
Seguin, Texas 78155  
830-372-3551

**2004 Edition**

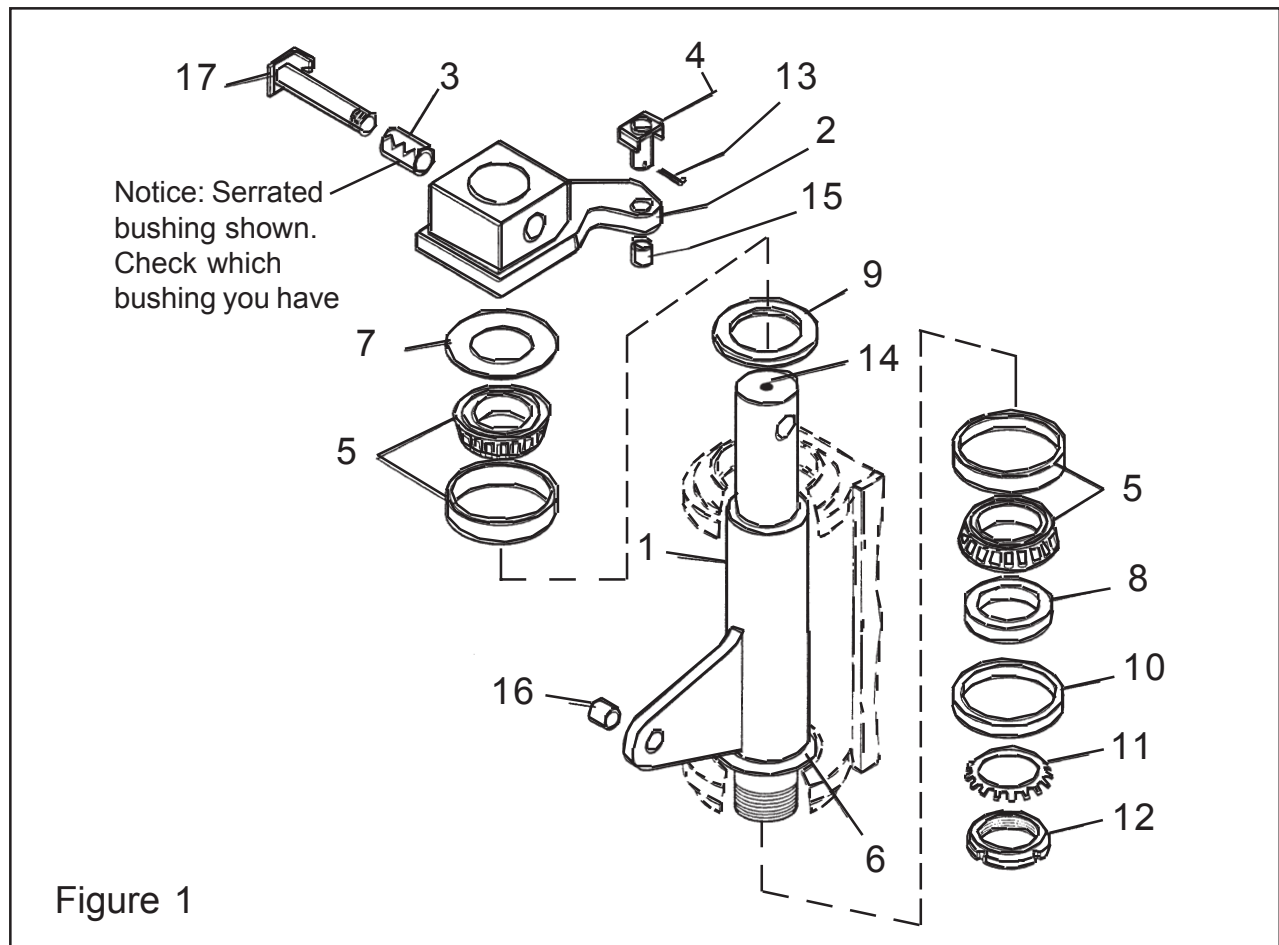
King post Attachment, A great deal of confusion exist regarding replacement parts for Alamo Industrial King Post. This bulletin should clarify which parts are currently being used in our King Post Assemblies. Refer to the Operators / Parts manual parts pages for exact part numbers.

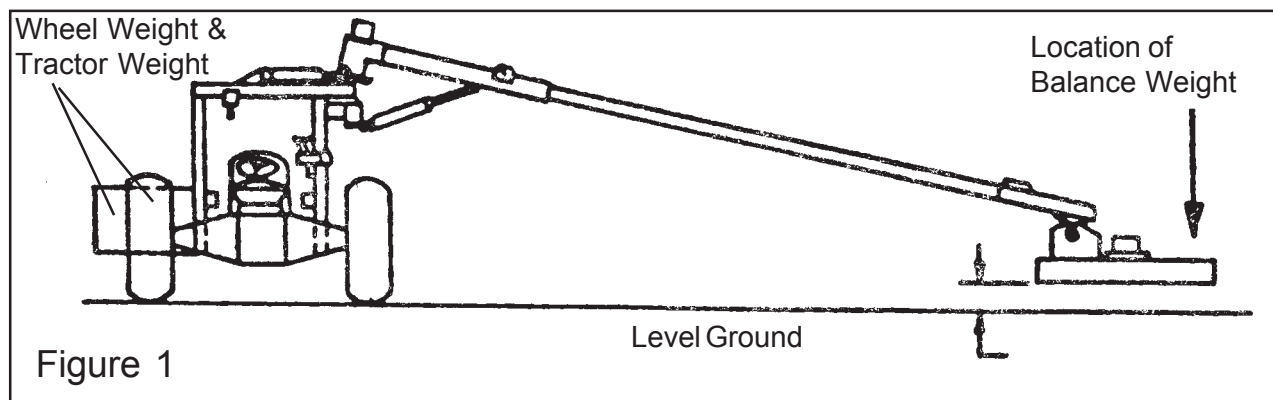
To insure the safety of the operator against instability of the tractor, it is crucial that the left rear tire of the tractor exert a minimum force (weight) of 1,000 pounds on the ground when the boom is at full extension and the cutter head is horizontal and two feet off the ground (Figure 1). An installation not meeting this requirement is dangerous and should not be operated as overturning the unit can occur resulting in injury or death. An installation meeting this requirement allows operation of the unit on slopes not exceeding 5°. For operating on slopes greater than 5°, contact Alamo Industrial Technical Service Dept. for additional information. The head and boom must be resting on the boom rest or the ground prior to removing or repairing Left rear Tire.

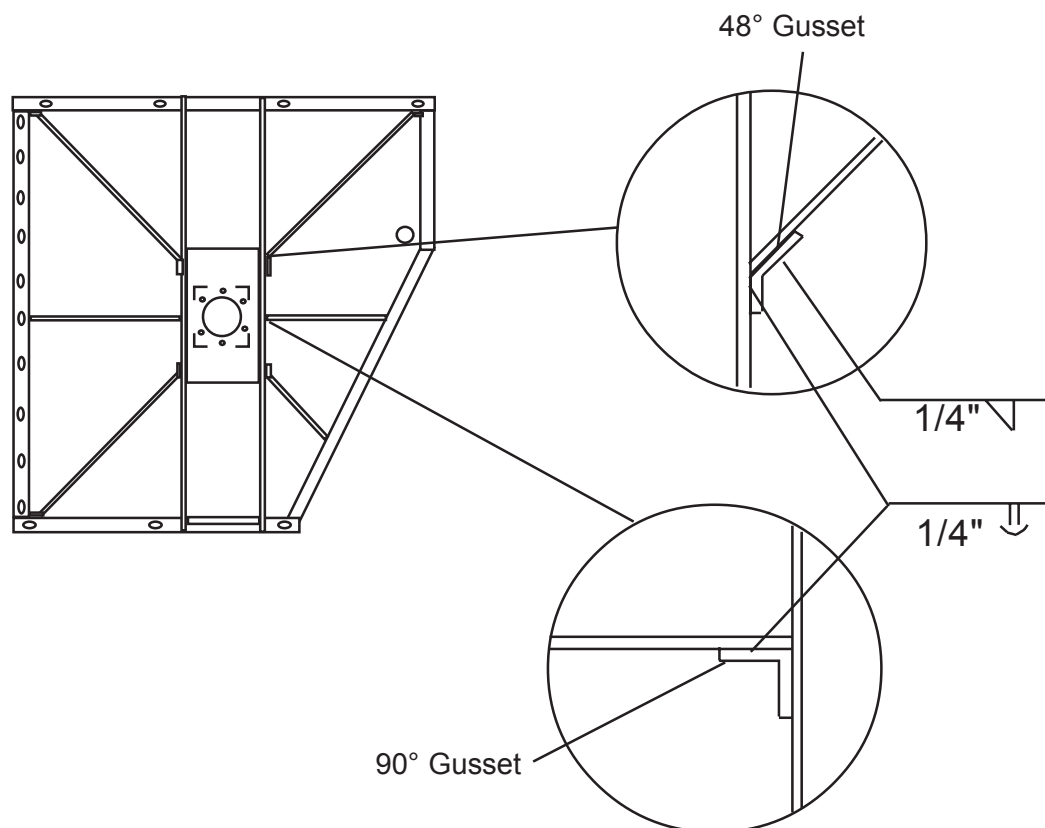
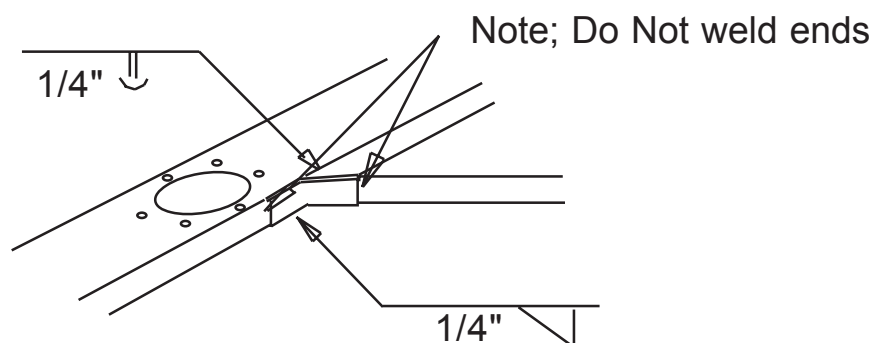
### Repair Procedure for Welding Cracks in Boom Heads:

If cracks appear in the welds at points "A" as shown above, use the following procedures to repair head.

1. Grind a groove at the site of the crack and clean the area to be welded.
2. Weld the crack making a 100% weld.
3. After repairing the cracks, prepare the sites for installation of the gussets.
4. Position the reinforcing bar gusset part no. 02970111 if 90° or part no. 02970112 if 48° over the X-Bar as shown in drawing next page. Weld with a 1/4" fillet weld on the bottom and an edge weld on top. DO NOT weld the ends.
5. Clean and paint the area.
6. Reassemble any parts that were removed.

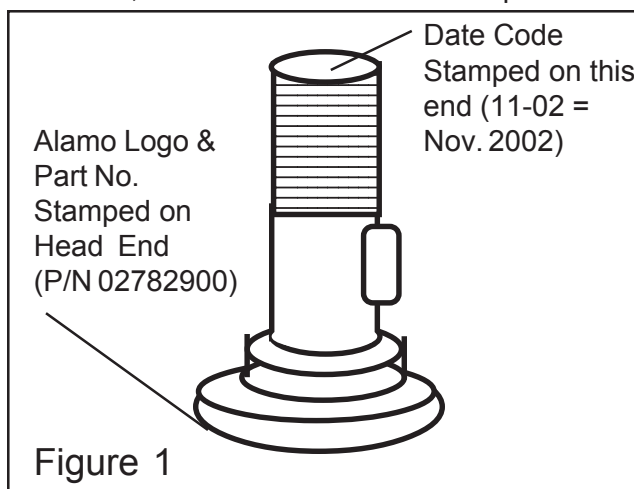
Note: Always check Date Code and Part Number of blade bolt before performing any repairs as described in this Service Bulletin as not all Blade will have the same date code. Only Blade bolts with 11-02 date code will be considered for warranty consideration.
