## Technical Tips - INSERT HEAD Module

### MaxiMailer – Service Engineers’ Technical Tips Documentation – Jan 2007

The following documentation describes all MaxiMailer field issues and corrective actions. Please refer to these documents before any service or maintenance is conducted. Items **highlighted thus** are Jan 2007 additions.

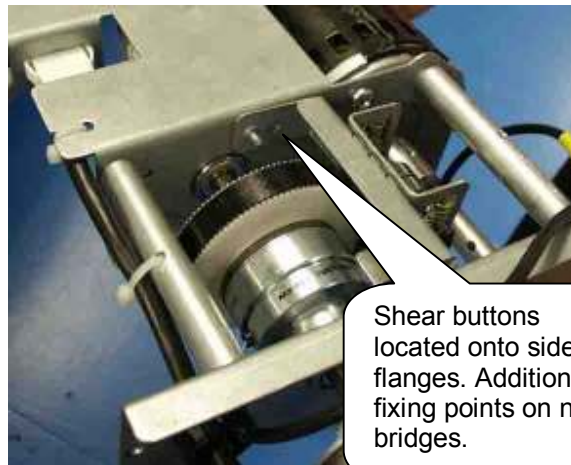
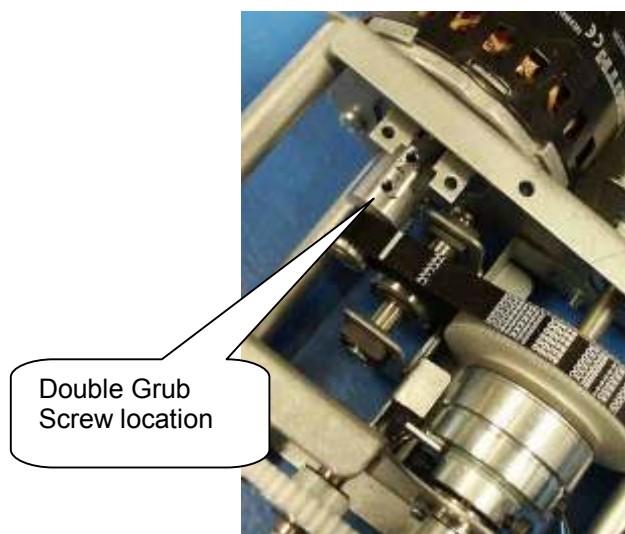
Also, on machines (pre June 05) there have been instances where the **motor pulley F1372A (220v) and F1373A (110v)** became loose resulting in loss of drive and motor stalls. The corrective actions for this problem is to retrofit a double grub screw pulley **F1372A (220v), issue 2 or F1373A (110v) issue 2**, onto the modified Primary Drive assemblies.

For a permanent fix, it is recommended a new **Primary Drive assembly A7068A (220V) or A7069A (110)** be fitted with all modifications.

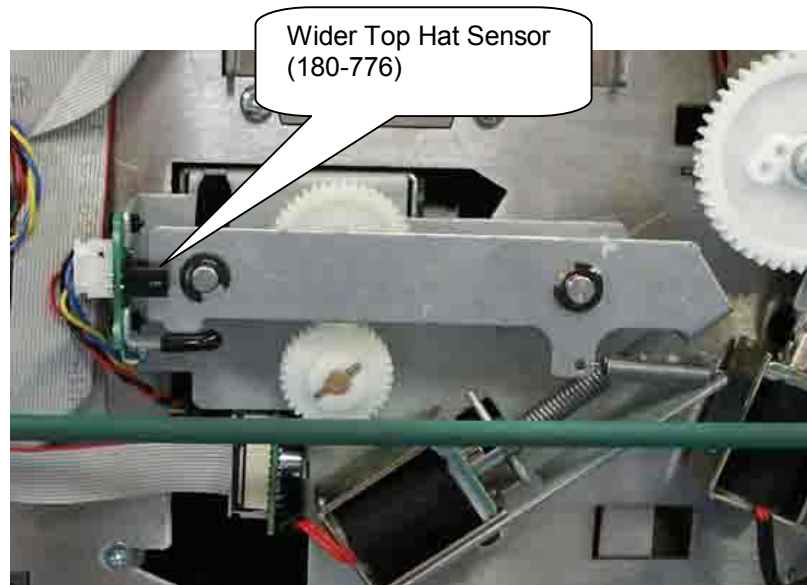
Check that the wide top hat sensor (part number **180-776**) is fitted and the flag is centralised in top hat as it returns to rest position.

Note this sensor is not compatible (except with the wetter home) for use in other areas.

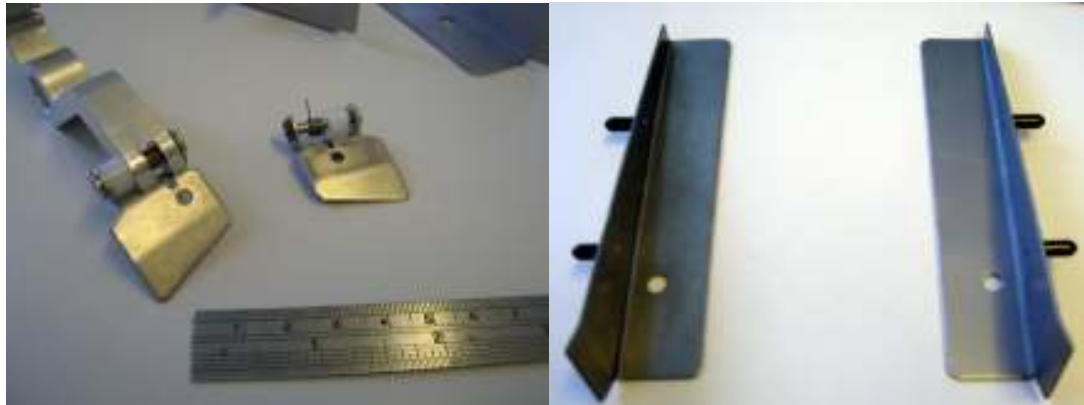
## A3287A Kit (wide collate pocket and fingers)

This new finger profile has been introduced to improve the envelope insertion caused by skewed envelopes from pick-up. These fingers (B9324A and B9325A) are shorter with a slight downturn at the tip. This also, enables inserts unto 40mm narrower than the prime document to be inserted without the need to sandwich in between other inserts.

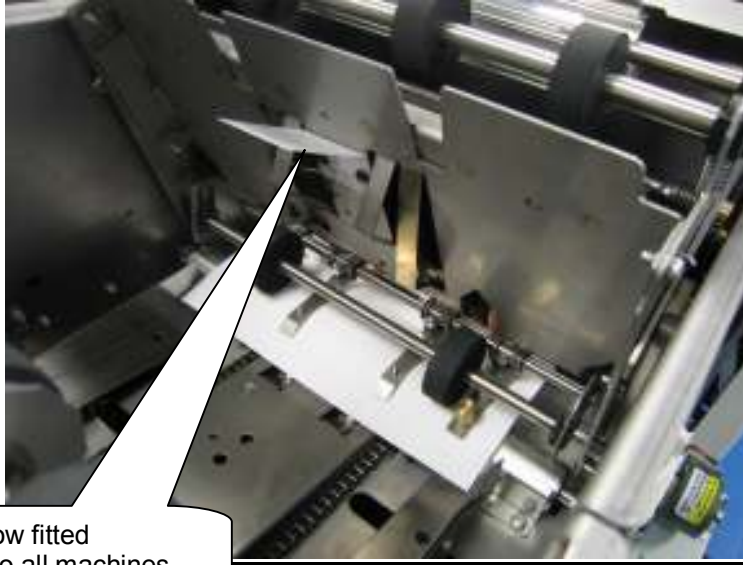
Fit tape in collate pocket – tape 70mm long x 35mm wide bent downward 35mm from one edge. Fits using double -sided tape to the middle section of collate pocket roof as shown.

Tape is now fitted standard to all machines.

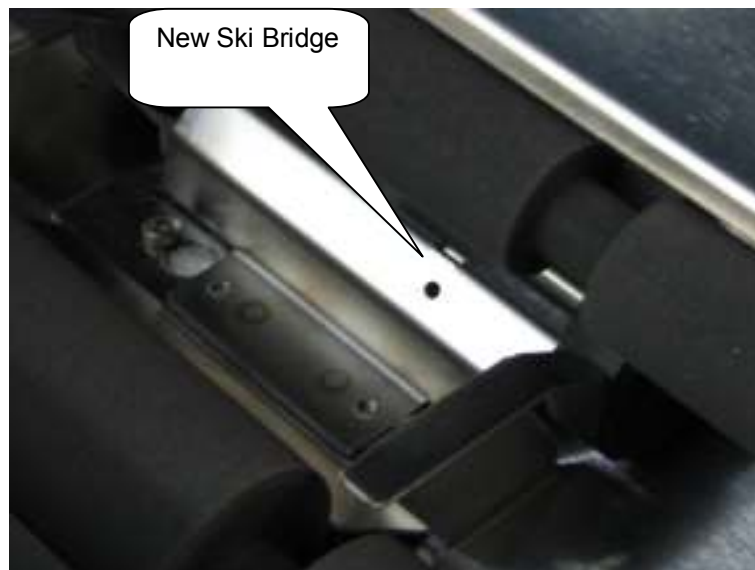
There have been instances of excess wetter causing problems with the wetter output receiver sensor (Ski Bridge) e.g. errors 36, 37 or 38. This sensor is now enclosed within the new ski bridge (B7464A). Also, the receiver sensor is replaced with a longer version (part number 182-345), preventing water spillage from the above contaminating the sensor connector.

- a) Check and ensure wetter is setup as per technical Bulletin 1420/101 at first instance.
- b) The wetter sponge should be 28mm from base to top - it should be not too tight or loose and follow profile of the metal.
- c) Check that the wetter tank assembly is setting level in the machine and 4/6mm of fluid is maintained.
- d) The amount of envelope flap that is wetted (+ve = more wetting) can be adjusted - In steps of 1mm. If over-wetting this figure can be reduced.

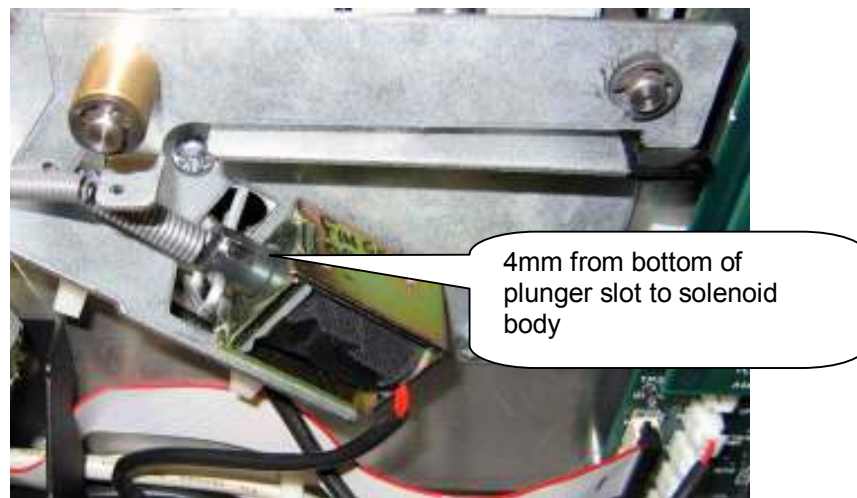
- a) Check that the fingers and collate pocket are setup correctly (Ref manual page 3-16).
- b) Check 2mm clearance in the collate pocket with widest insert (towards wetter area) - this can be adjusted if required.
- c) Engage and disengage fingers in Engineer to ensure both solenoids are pulling-in and that the stroke is balanced and setup (4mm from plunger slot to solenoid body – see photo 1). Note this can be reduced if required.

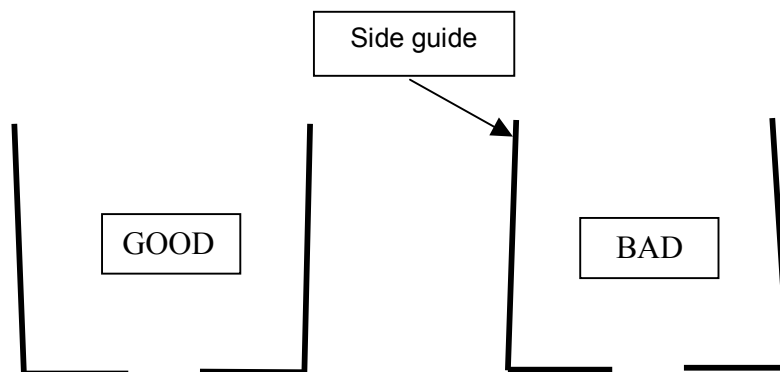
i) ensure side guides are not over-bent. Run an envelope perpendicular to the guides without the envelope going tight can check this. If so, then remove both sides and bend until correct as shown below. (PICTURE). After fitting, run a handful of envelopes up and down the hopper to set the side guides and then lock them in position, ensuring they are not too tight along of the hopper guides.

In addition, ensure the side guides do not rock side-ways and across the length. If so, it may require packing with Mylar from underneath.

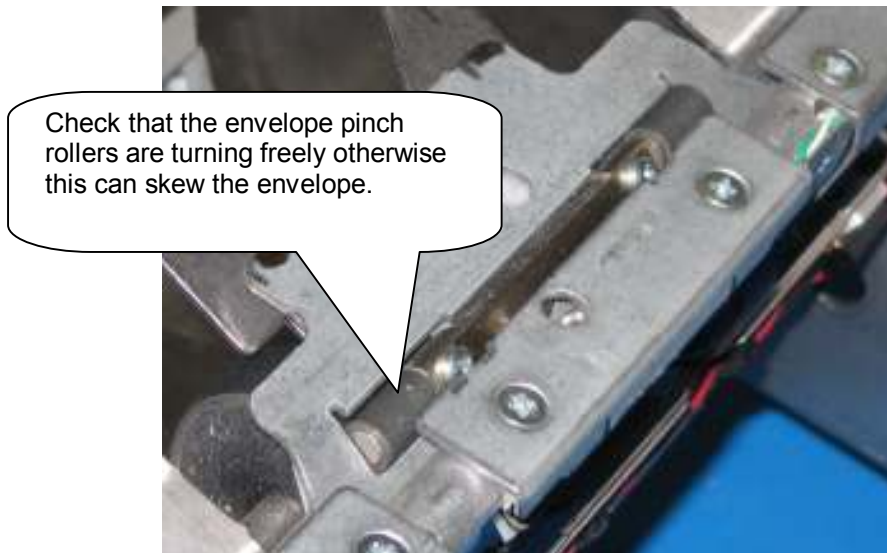
- iv) Check envelope pick-up Jogglers are aligned – if misaligned can be glued in position.
- v) Check the envelope pinch rollers are turning freely otherwise this can skew the envelope.
- vi) Check and implement Tech tip note A-20.

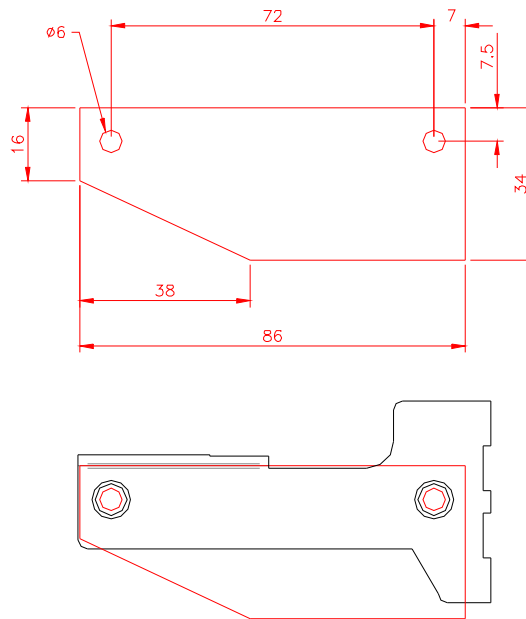
l) A Mylar strip (part number G6195A) can be fitted for particular envelopes with a short flap shoulder - this may be required to prevent the insert catching on the edge of flap during insertion.

Material: 0.25mm(0.010") Polyester Shim Stock (Mylar). Clamped between Aluminium bar and 'T' pieces (clamped not stuck down).

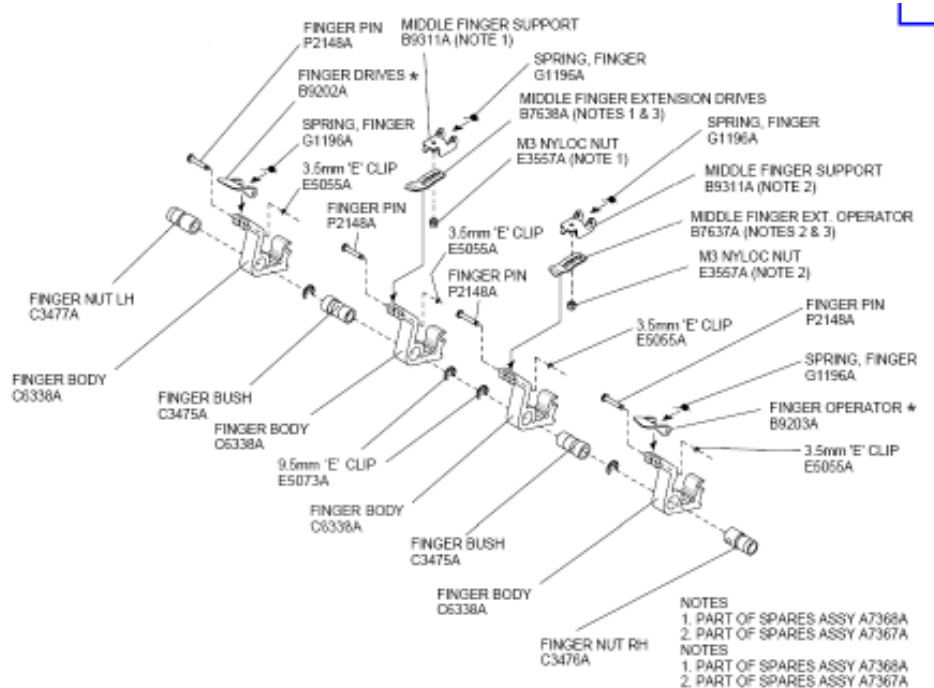
2) New profile adjustable middle fingers A7367A (Ops side) and A7368A (Drive side) – implemented after Sept 06. These fingers help to open the envelope throat to improve general insertion reliability. The fingers are also engineer adjustable so that they can be lengthened for customers running envelopes with a deep throat profile. In very extreme cases (out of Specification envelopes) where the envelope stop position has to be run very fwd (from the notch) to allow the external fingers to enter the envelope then it may be worth fitting A3325A (fingers with greater extension than above).

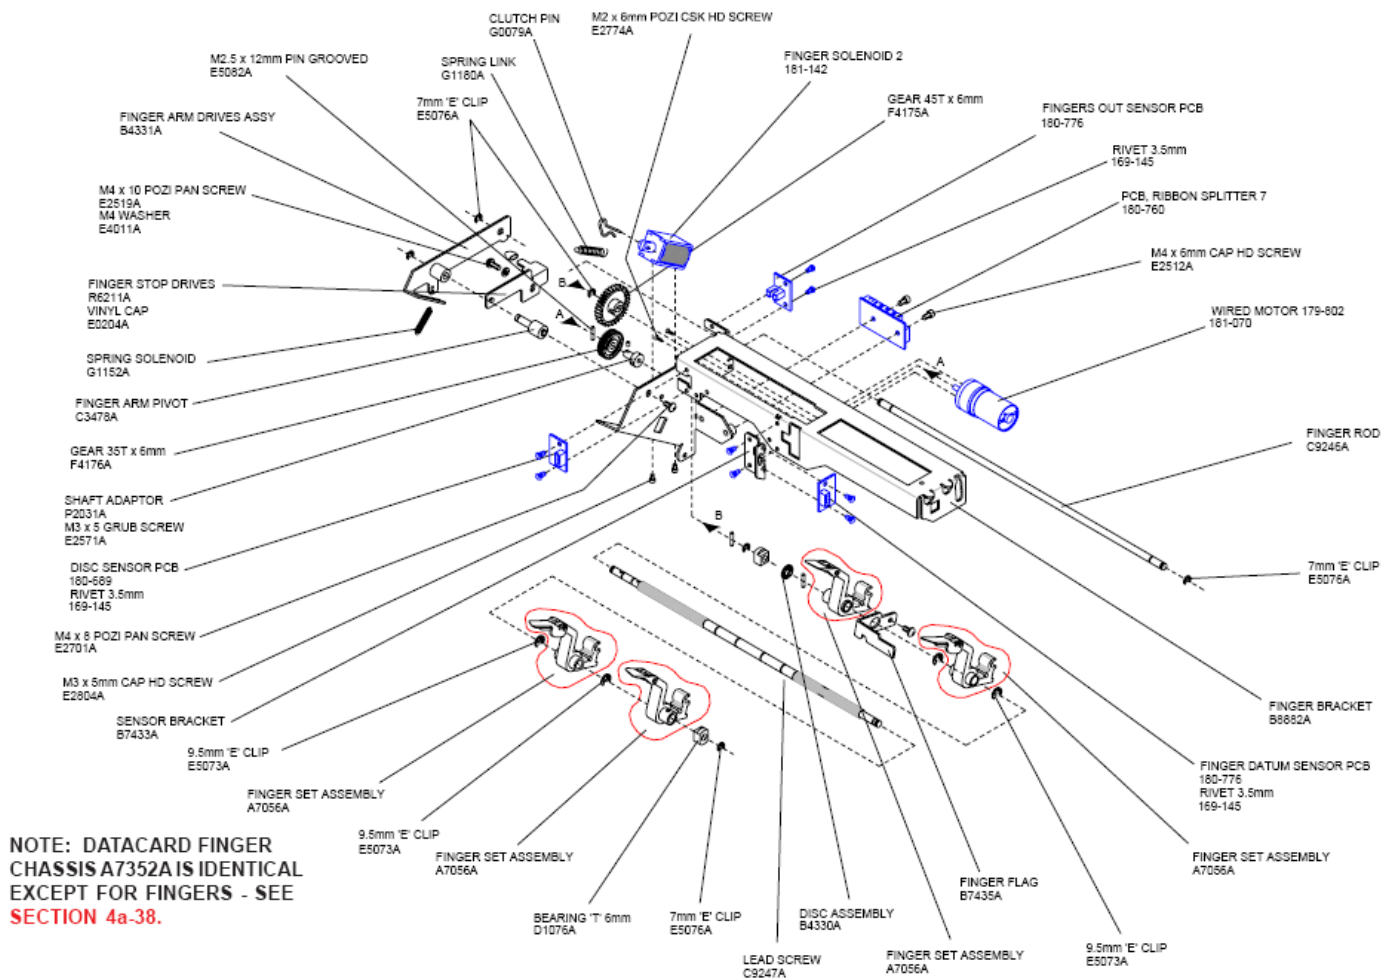
**8) Finger Chassis Assembly (A7055A) - finger home stop positions on both Operator and Drive sides are now adjustable to ease factory setup of fingers.**

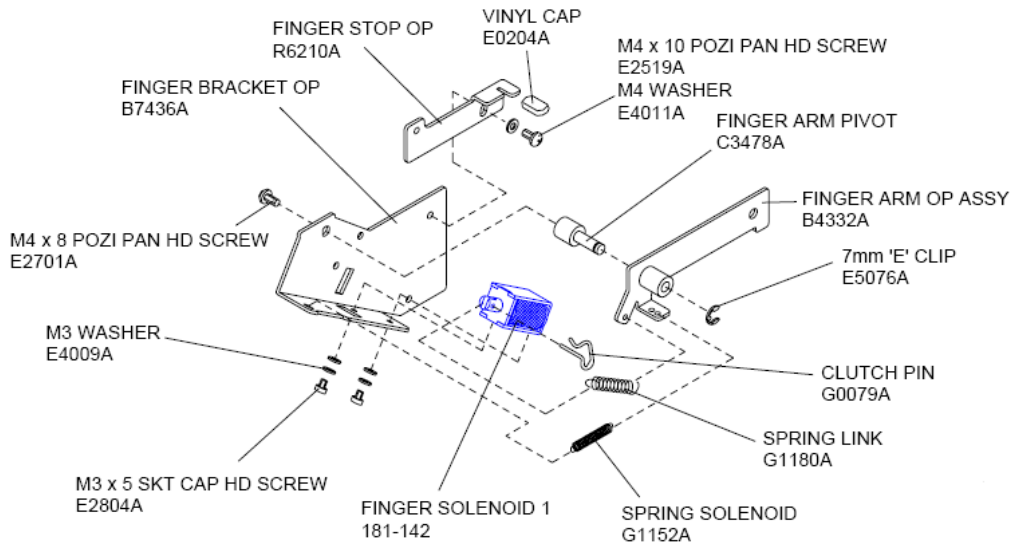
Note, a new finger bracket assembly (A7062A) must be also be fitted to the operator side to allow setup and adjustment.  
Implemented Jan 07

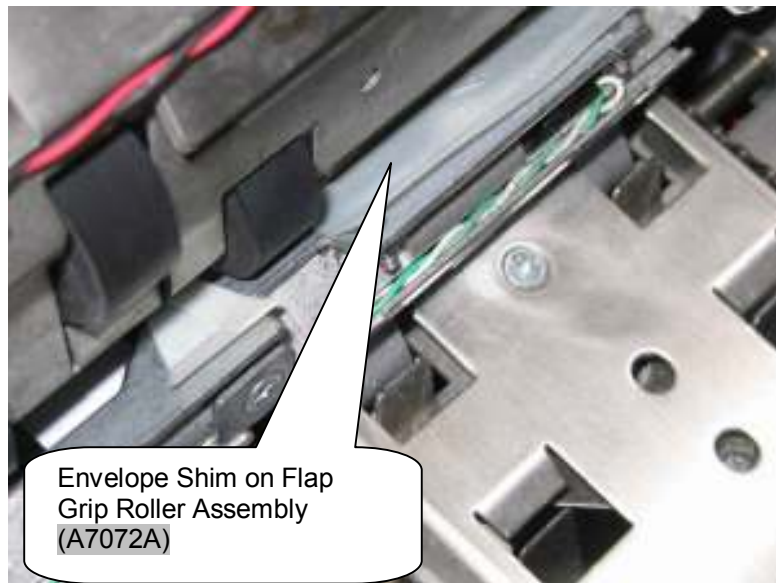
If there are instances of the envelope getting caught as shown below - then the following corrective actions can be attempted:

- i) Check by removing **Collate Roof Cover (B7502F)** that all Rollers on the Envelope Feeder Assy (A7061A) are aligned against all rollers on the Collate Pocket Clam Assy (A7060A). If misaligned this can cause envelope skew and insertion problems.
- ii) Envelope Shim on Flap Grip Roller Assembly (A7072A) can be lifted up to guide the envelope into the nip of lower rollers as per (a).  
Note, on some machines this shim has been fitted incorrectly preventing the shim to be lifted up. If this is applicable - then remove and fit correctly.
- iii) Yellow spring's (G1116A) can be fitted onto the lower rollers as per (a).

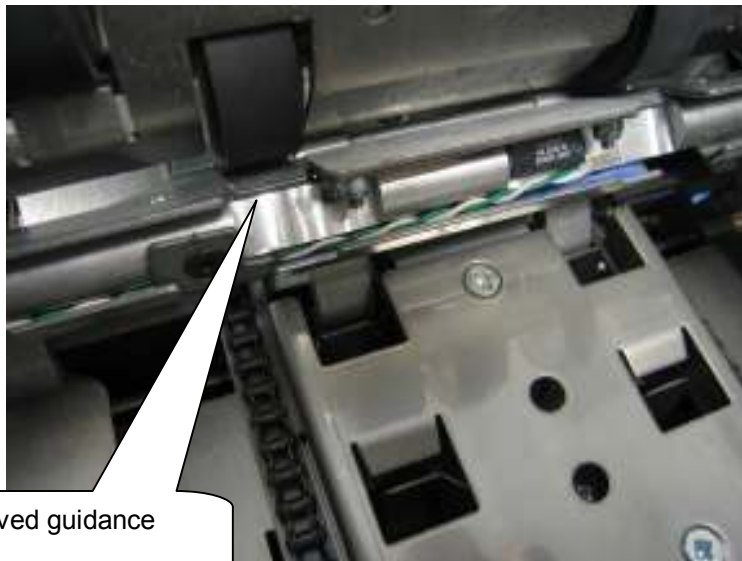
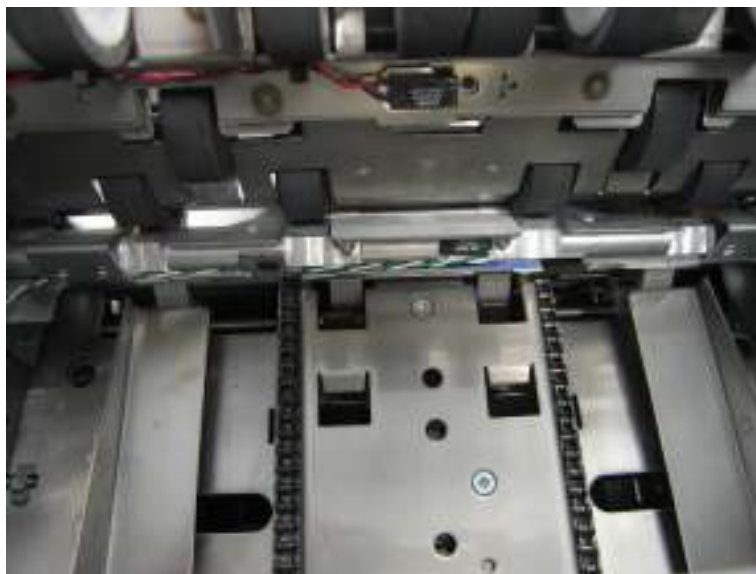
- Edge deflector B7714A improved to give better guidance into flap grip area.
- Envelope Defector R2175A improved to give better guidance into flap grip roller.
- Envelope guide bar C9436A. Chamfers added to cutaways to remove potential catch points.
- Guide tapes added to envelope feed to prevent fingers catching on edge of wheel cutouts.
- Flap grip roller bar C4363A bearing shoulder changed to remove potential bearings snag.

**Problem resolved on machine (effective from July 06) – if experiencing problems in this area then fit complete new assembly A7072A.**

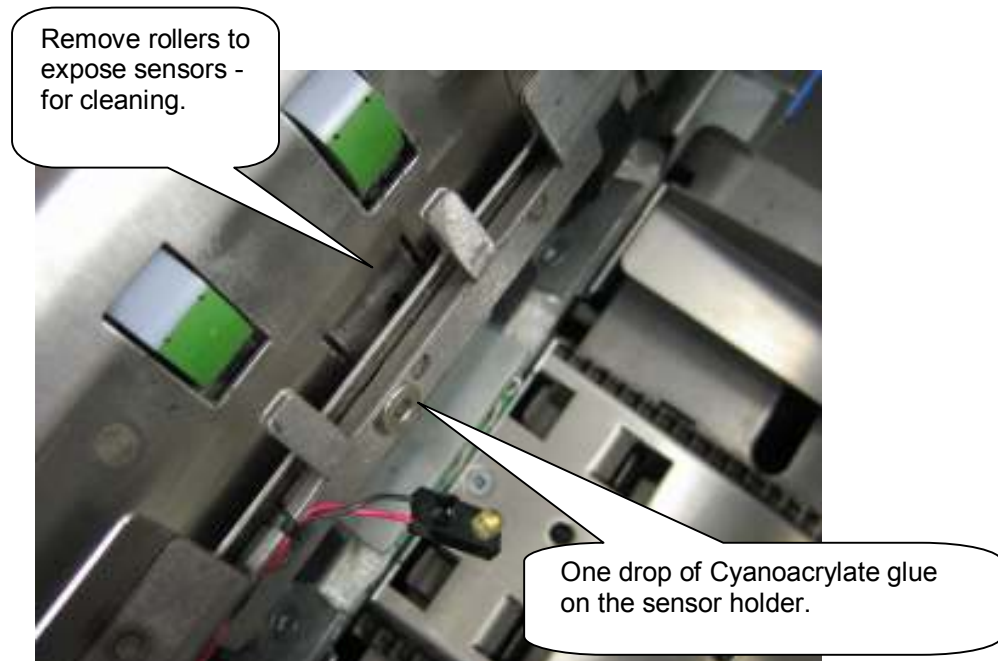
In some instances we have found there is too much movement within the sensor holder - if this is the case it is advised to place one drop of Cyanoacrylate glue on the sensor holder as shown below. Once aligned re-calibrate sensor and check by running envelopes for above error. A new sensor bridge (B1797A, issue 4) has now been modified to prevent the sensor from moving within the holder and can be fitted if required (optional).

At first instance advise customer on how to clean by removing the envelope pick-up rollers and then using PFE approved air duster blow out both parts of the sensor.

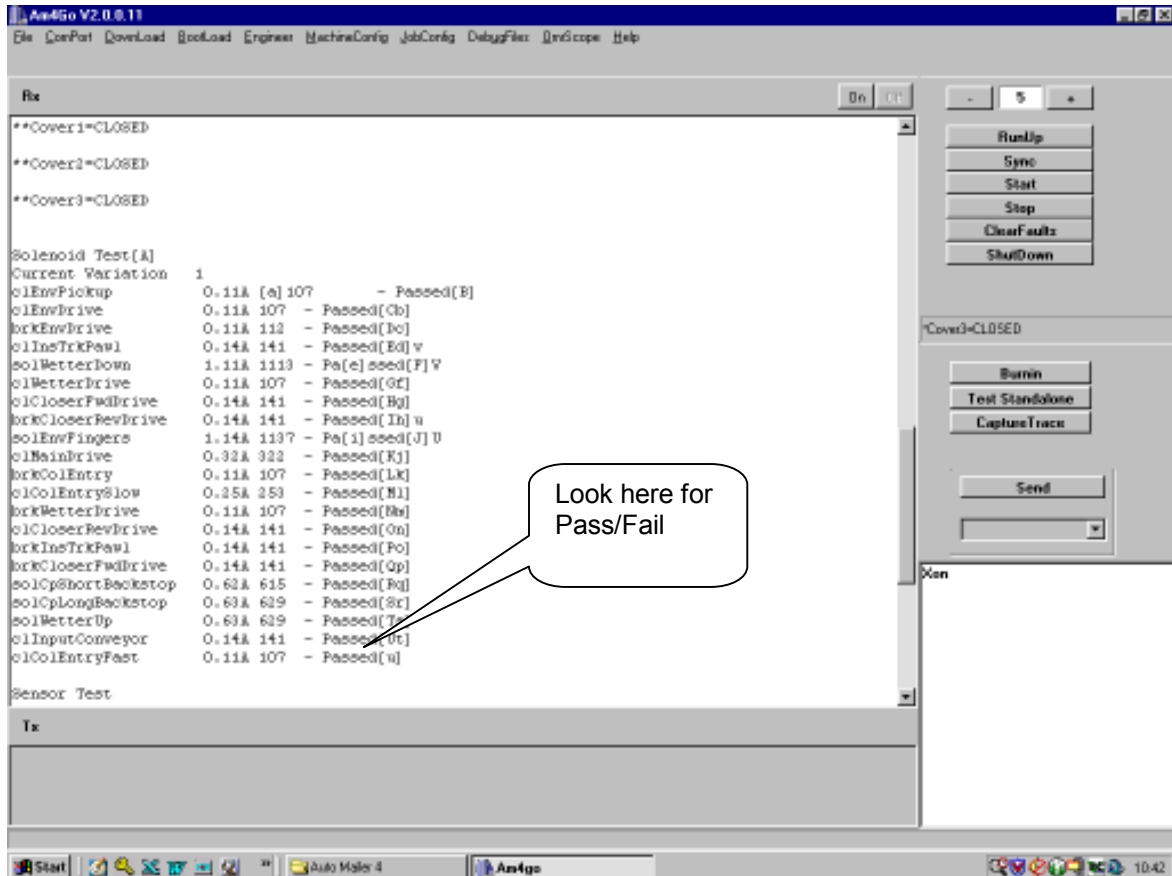
If this is displayed on the GUI at switch ON - this means there is a potential short on the applicable module.

Plug am4go diagnostic tool into the applicable module and switch ON machine to display the following as shown below (example trace from Head module). Any failures indicate potential areas in the machine that may require investigation. In the case below all have passed and no problem exists.

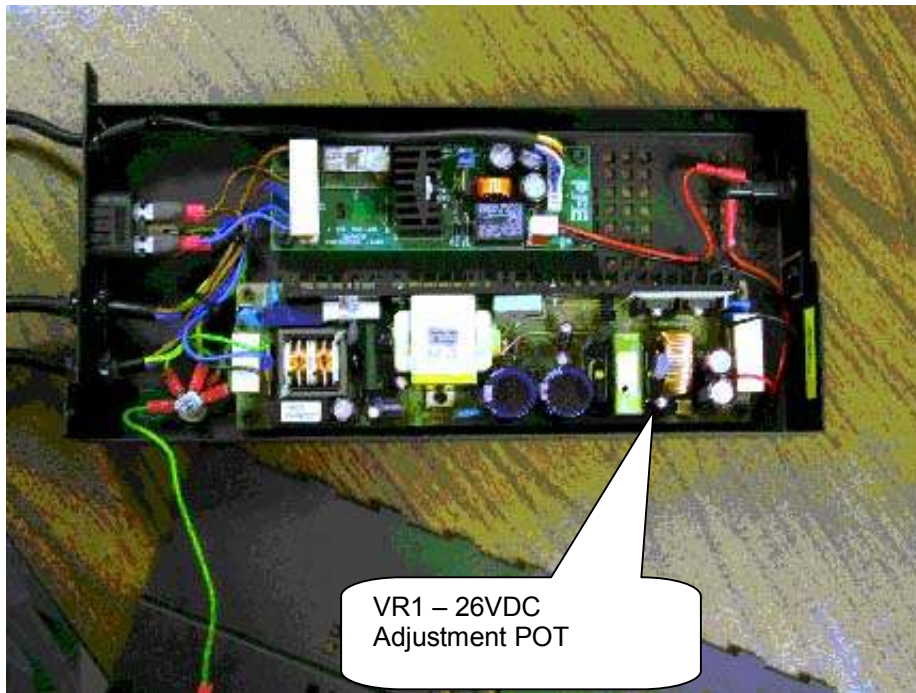
When Upgrading to Version 3 Firmware – there is a potential for the above error to occur. Version 3 of the firmware performs an analysis of all system components at power up or reset. After upgrading to Version 3 firmware you may start getting error 1054, 26Volt Supply is low. There is an adjustment that can be made on the module Power Supply board to adjust 26VDC. This potentiometer (VR1 – see picture below) is very sensitive. Very small movements can make 5 or more volt adjustments. Adjustments can be checked via the GUI display, or using a meter. To do the adjustment with a meter, dis-connect the 24v cable from power supply to the module board. Measure voltage on the power supply across YLW (pin1) and BLK (pin5 or 6) - this should be about 26v.

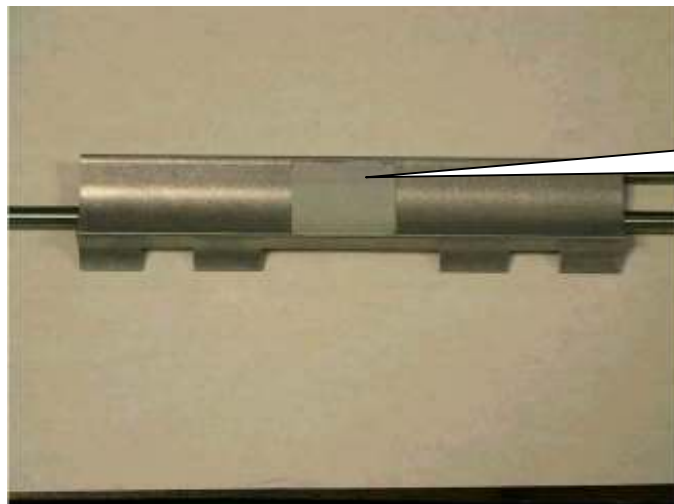
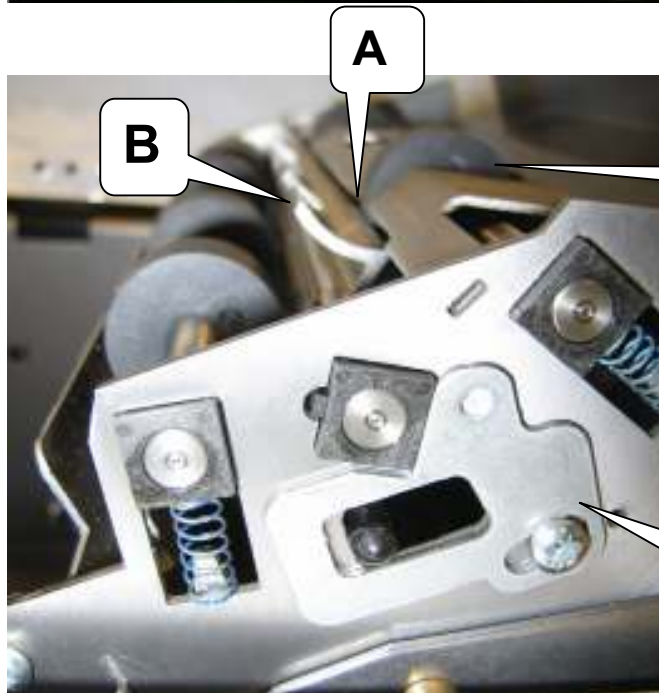
If problem persists, then cut a piece of Mylar (H0011A) about 32 to 33mm in length, depending on how much overhang is required to catch the flap as shown below.

Round or taper the corners that will overhang. Then using double-sided tape (E0188A) secures the Mylar piece to the Opener Assy, utilizing the natural curve of the Mylar.

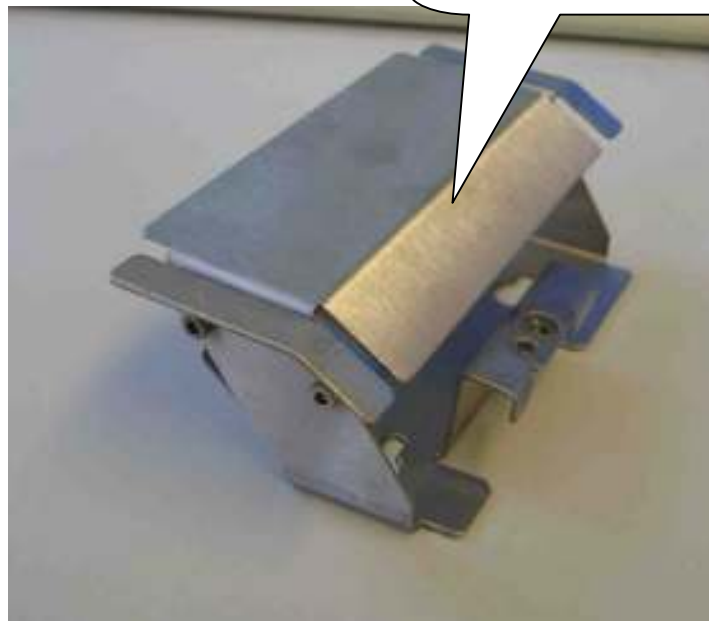
### **A-43. Envelope flap catches on the Sealer Ski (B7464A) when running in No Seal Mode - Field Option**

- 1x B9120A No seal bracket
- 1x B7464A Sealer Ski (latest version)
- 4x P2278A Pusher Pivot
- 4x E2771A M3x8 Cap Hd St. Steel
- 0.07m x E0422A Vinyl Tape

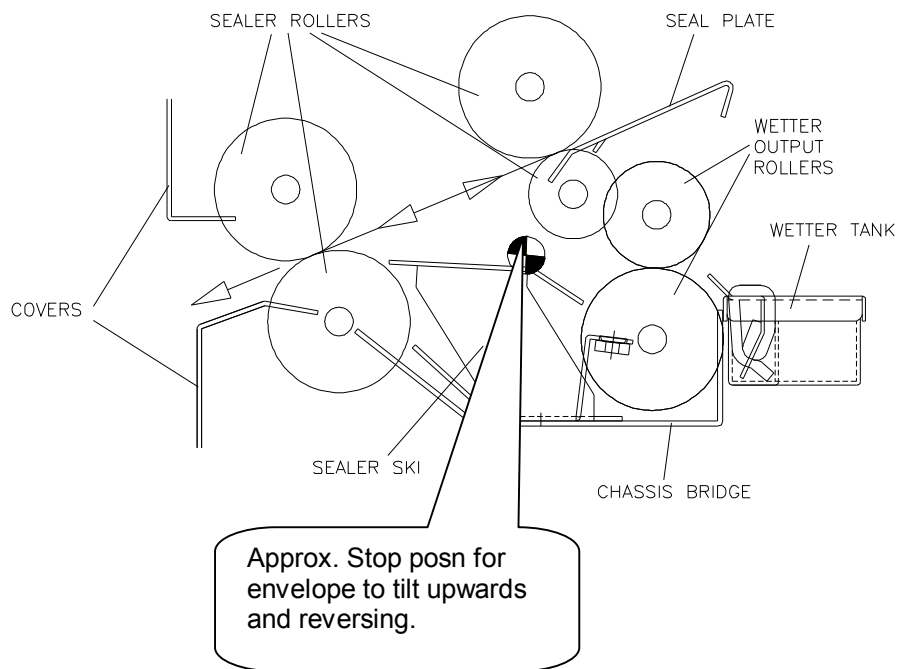
Check that the reverse position allows the envelope to tilt upwards and position itself neatly into the nip of the seal rollers near to the seal plate as shown below.

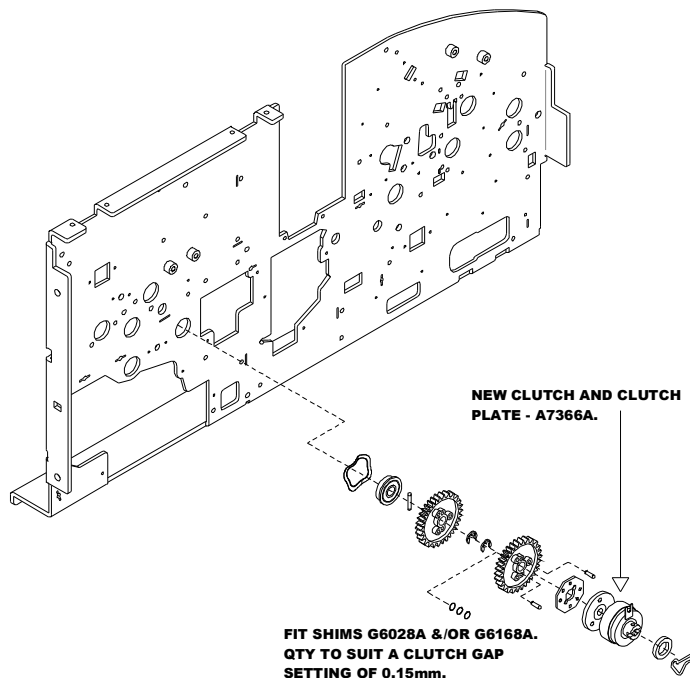
2. **Restriction of armature spring** - an Schnorr serrated cone washer (supplied with the 03 clutch) must be used under the head of the rivet. The washer should be placed with the narrow top of the cone against the head of the rivet and the wider cone base against the armature spring. It is important that the correct size cone washer is used or the flat spring function may be adversely affected.

Assembled Clutch part number = A7366A

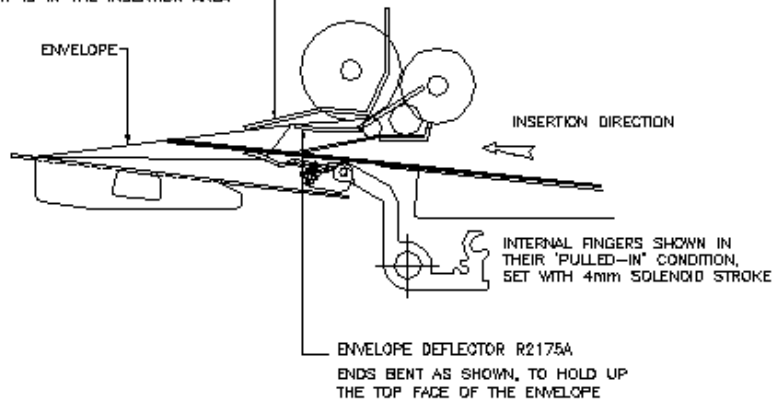
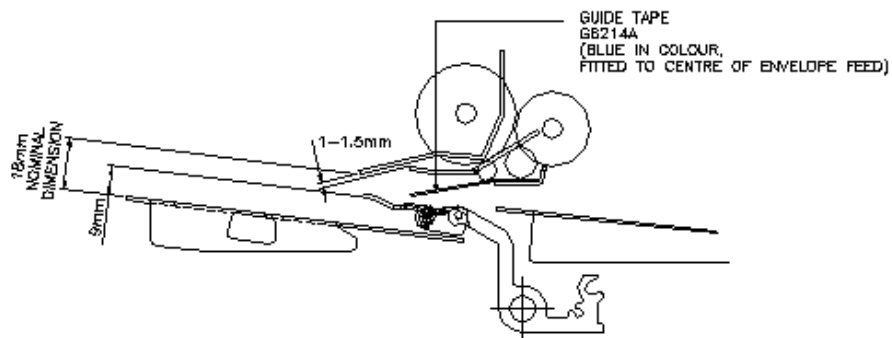
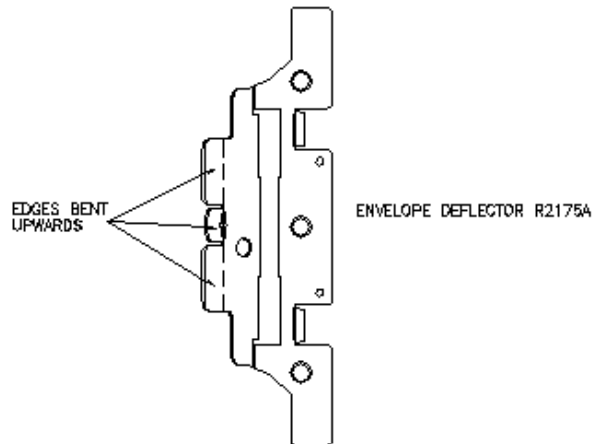
ENVELOPE SENSOR BRACKET R2636A  
 BENT UPWARDS SO THAT IT RESTS ON TOP OF  
 ENVELOPE WHEN IT IS IN THE INSERTION AREA

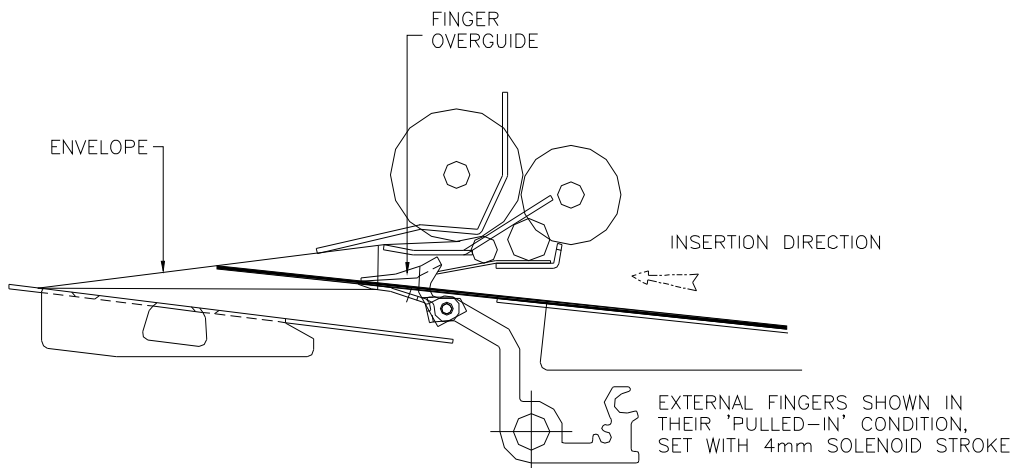
In some cases (for example, if an envelope is stream-fed) then the envelope can be pushed between the fingers and overguides (as shown in the picture below). In this case the customer must be told to remove the envelope with care. The envelope must be removed from the collate pocket clam area of the machine and not from the insertion area. If the customer does this they may bend the overguides.
