Kodak DryView

8300/8600/8610 LASER IMAGING SYSTEMS

Service Bulletins

New Solution for EC 27 or EC 28 Caused by FILM Stalling in the PROCESSOR

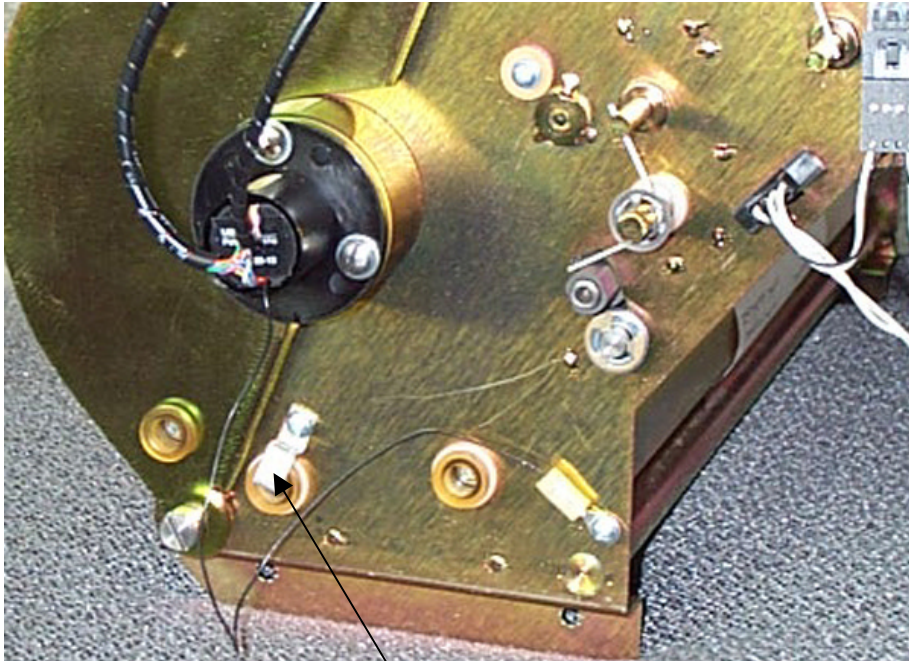
Figure 1

1. Remove

1. Remove the SPRING CLIPS from the FRAME and CLAMSHELL of the PROCESSOR ASSEMBLY (see Fig. 1).
2. Attach one end of the WIRE (supplied in the KIT) to the STRIPPER ASSEMBLY using the right mounting SCREW of the STRIPPER ASSEMBLY (see Fig. 2).
3. Attach one end of 1 small STRAP (supplied in the KIT) along with the loose end of the WIRE referred to in Step 2, to the FRAME where the CLIP was removed in Step 1 (see Fig. 2).
4. Remove the SCREW holding the ROLLER ASSEMBLY MOUNTING ROD, and using the supplied SPACER and SCREW, attach the loose end of the small STRAP to the ROLLER ASSEMBLY MOUNTING ROD (see Fig. 2).
5. Repeat Steps 3 and 4 to attach the remaining small STRAP to either side of the CLAMSHELL portion of the PROCESSOR ASSEMBLY.

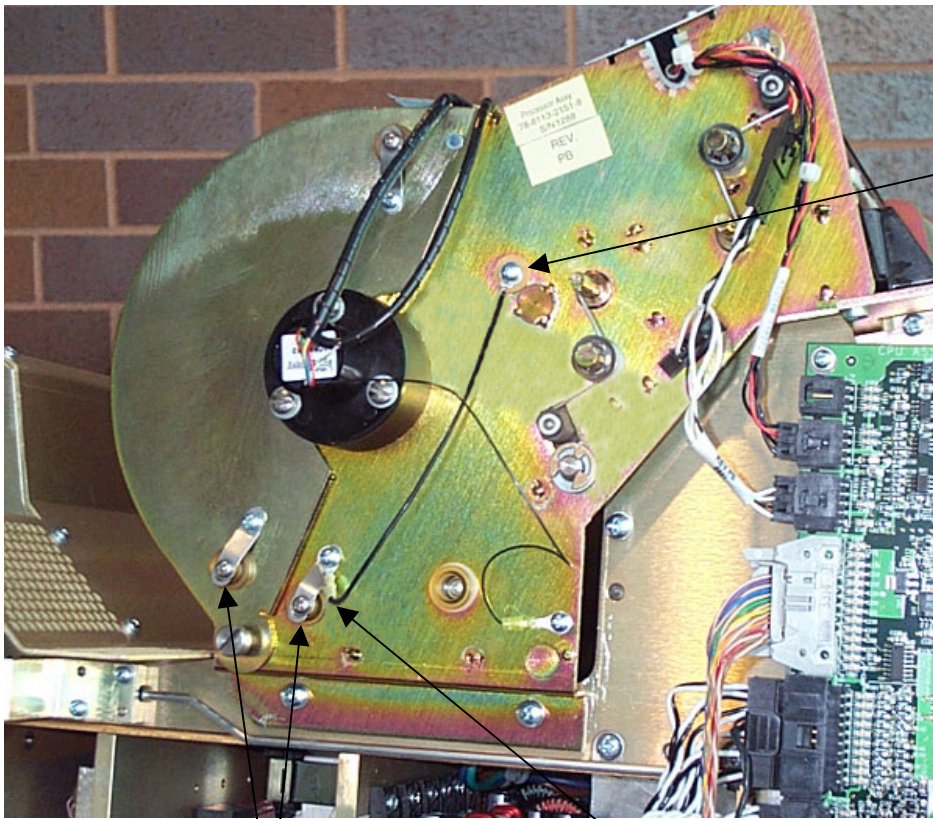
Figure 2

**2. Connect WIRE to
STRIPPER ASSEMBLY**

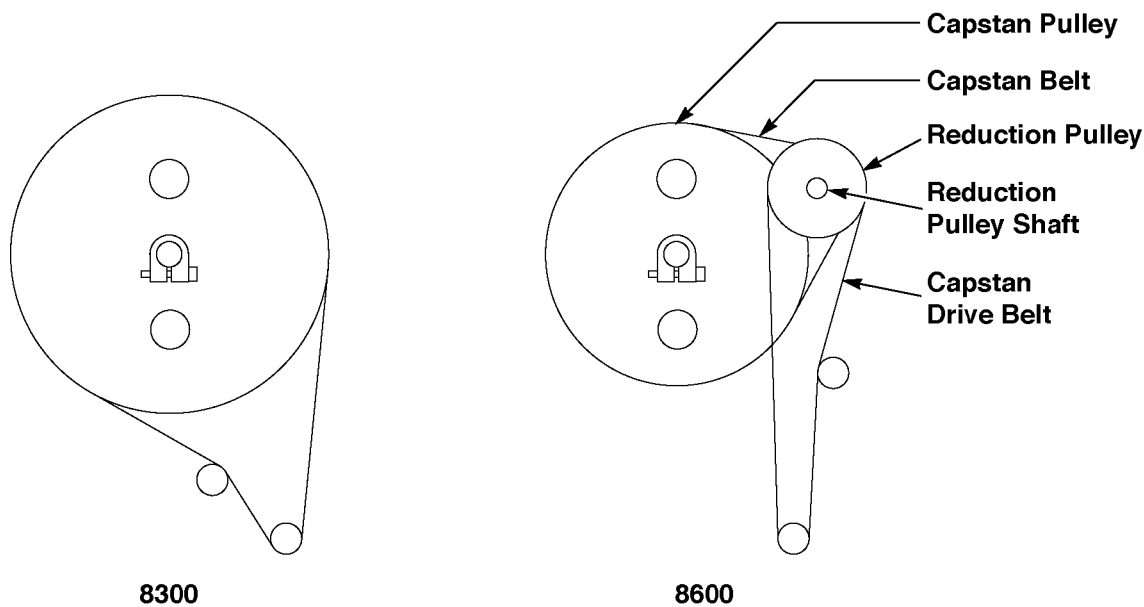
Figure 3. Comparison of 8300 and 8600 Capstan Pulley Drive Configurations

Capstan Drive Belt – Different size because it is used to transfer drive from the capstan motor to a reduction pulley. In the 8300 the capstan pulley was driven directly from the capstan motor. (See Figure 3.)

Capstan Reduction Pulley – New part to reduce the speed of the capstan roller. (See Figure 3.)

Reduction Pulley Shaft – New part to hold the Capstan Reduction Pulley. (See Figure 3.)

Capstan Belt – New part to transfer drive from the reduction pulley to the capstan pulley. (See Figure 3.)

Capstan Pulley – Different size because used in conjunction with the reduction pulley. (See Figure 3.)
