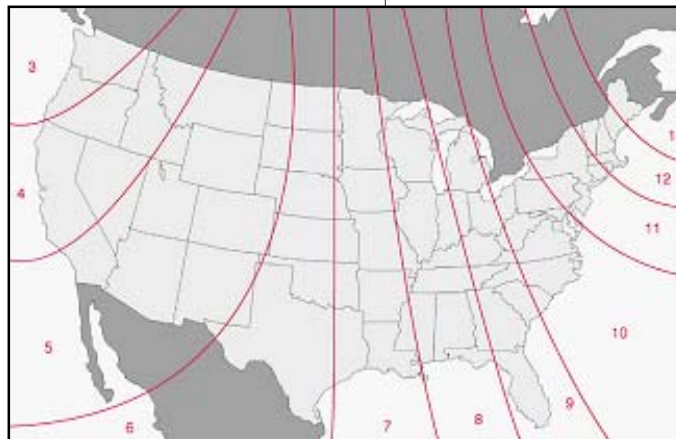
**Figure 1.2**

1. The Zone number is factory preset to Zone 8. Refer to "Compass Zone Map" (Fig 1.2) to verify that the compass Zone setting is correct for your geographical location.
2. Press and hold the right button for approximately 3 seconds until the word "ZONE" is visible in the display, then release the button. When the button is released, the display will show "ZONE" and the current Zone number. Press the right hand button repeatedly to cycle the display through all possible Zone numbers (1-15). Stop cycling when the correct Zone number for your geographical location is displayed.
3. No button activity for approximately 4 seconds will exit the Zone setting mode. The compass display will return to normal operation and the new Zone number will be set.
